核一廠 1 號機 EOC-27 大修燃料水棒連接桿斷開處理專案報告
之修訂 2 版修正內容對照表

**核一廠一號機 EOC-27 大修燃料水棒
連接桿斷開處理專案報告
(Rev.2)**

中華民國 104 年 4 月

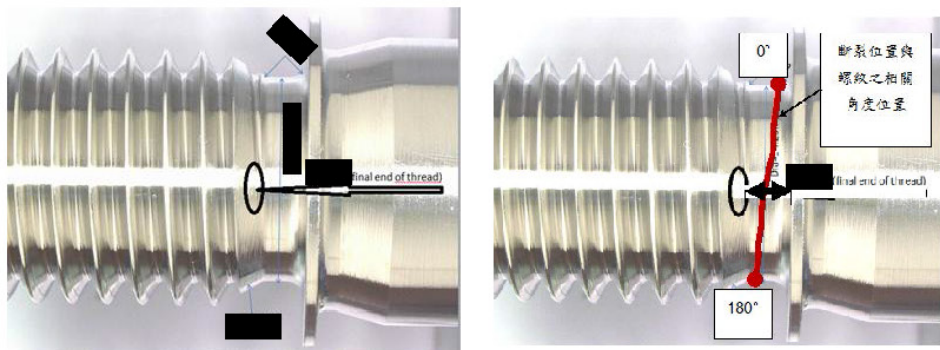
圖14、連接桿螺紋根部細部照片

- 經檢視後發現，裂痕的出現位置是在無螺牙部分的半徑過渡區(Transition Radius)而不是在無螺牙部分的最小半徑處。
- 如圖14所示，出牙處根部之曲率半徑約為 [REDACTED]，角度為 [REDACTED]，並不是在無螺牙部分的半徑過渡區域。

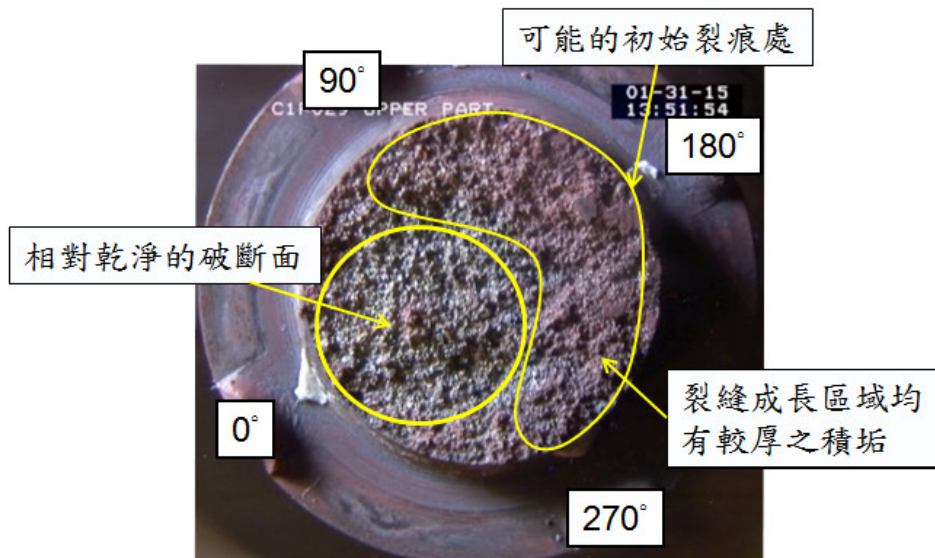
圖19、上半截連接桿破斷面(破斷面1)

整個破斷面為晶粒感的，在巨觀上並無顯示有塑性變形的跡象。破斷面的平面有輕微的傾斜，在180°的位置最高，0°的位置最低。約有三分之一的破斷表面被大量的橘紅色沉積物覆蓋(約從90°到270°的外圍部分)，在180°位置附近有一處較為平坦的區域，可能是這束燃料在最後吊運時發生斷裂後所造成的機械損傷。其餘的破斷表面則為金屬色。

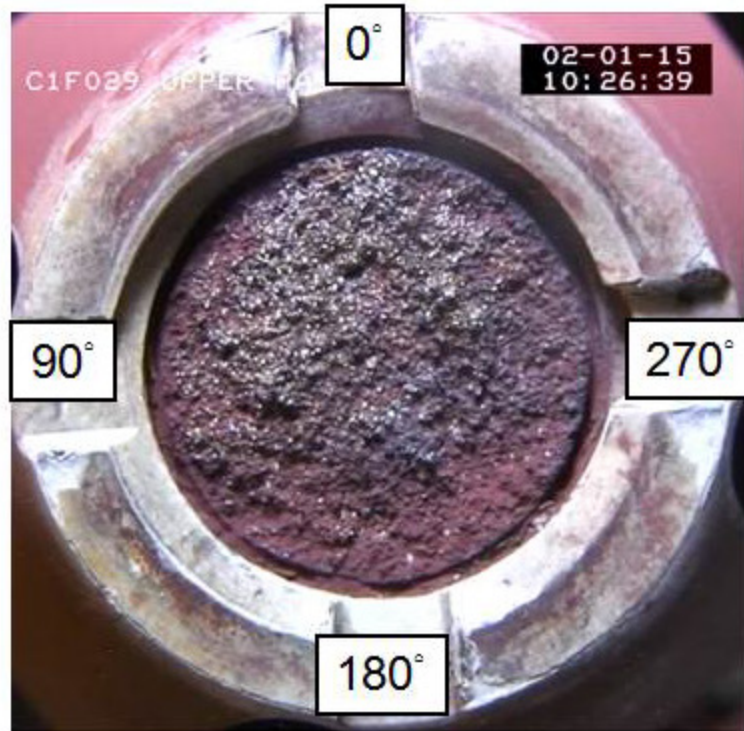
圖22、連接桿承接處(破斷面2)的上視照片

連接桿承接處的破斷面定義為破斷面2。破斷面2的分析方法和破斷面1相同。在180°位置的破斷面約和第一個螺牙處的底部接近。連接桿承接處和連接桿凸緣接觸的位置為金屬色澤，如圖22。

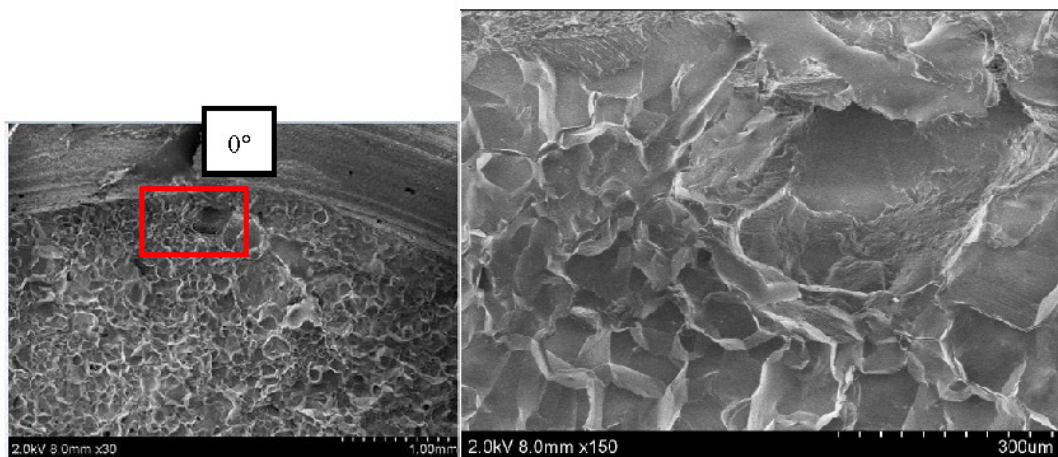
圖27、複製膜R1.1：0°位置的照片，局部發生穿晶破裂的區域

在靠近 0°位置的破斷面上觀察到最後斷裂時的裂痕。
在圖 26 的上方黑灰色區域並不是真實破斷面的表面特徵，是複製膜製備時產生的人工缺陷。

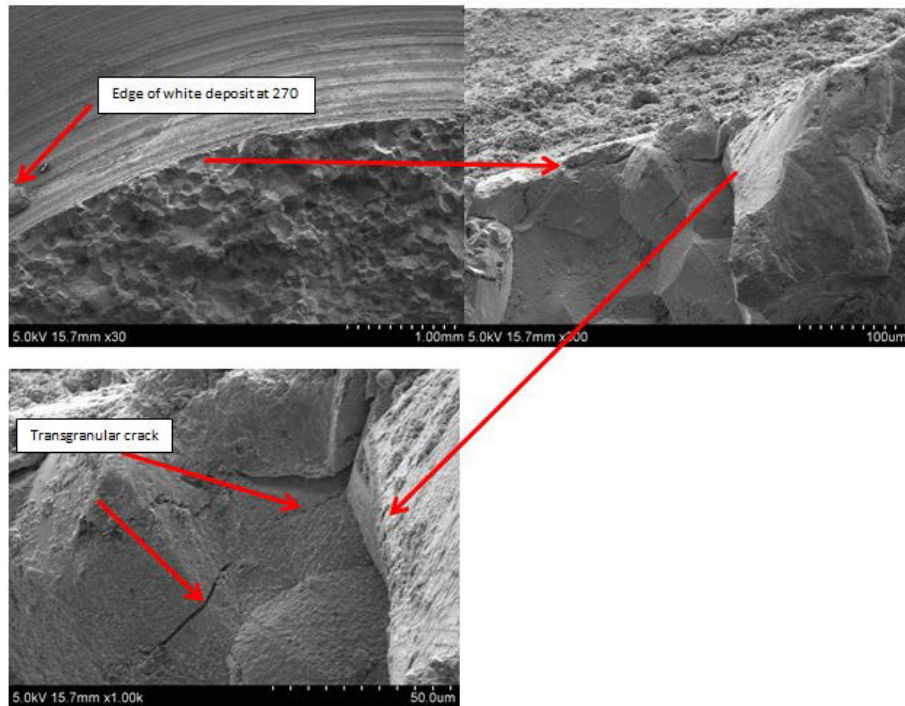
圖35、破斷面1、試片I上靠近270°的位置，觀察到有穿晶裂紋

在破斷面1的試片I上，發現有沿晶破裂的特徵，且金屬晶粒的表面上有大量的氧化物，如圖32、圖33和圖34。在靠近270°的區域的破斷面上雖發現有穿晶裂紋(裂紋方向朝下)，如圖35，但沒有明顯的塑性變形特徵。

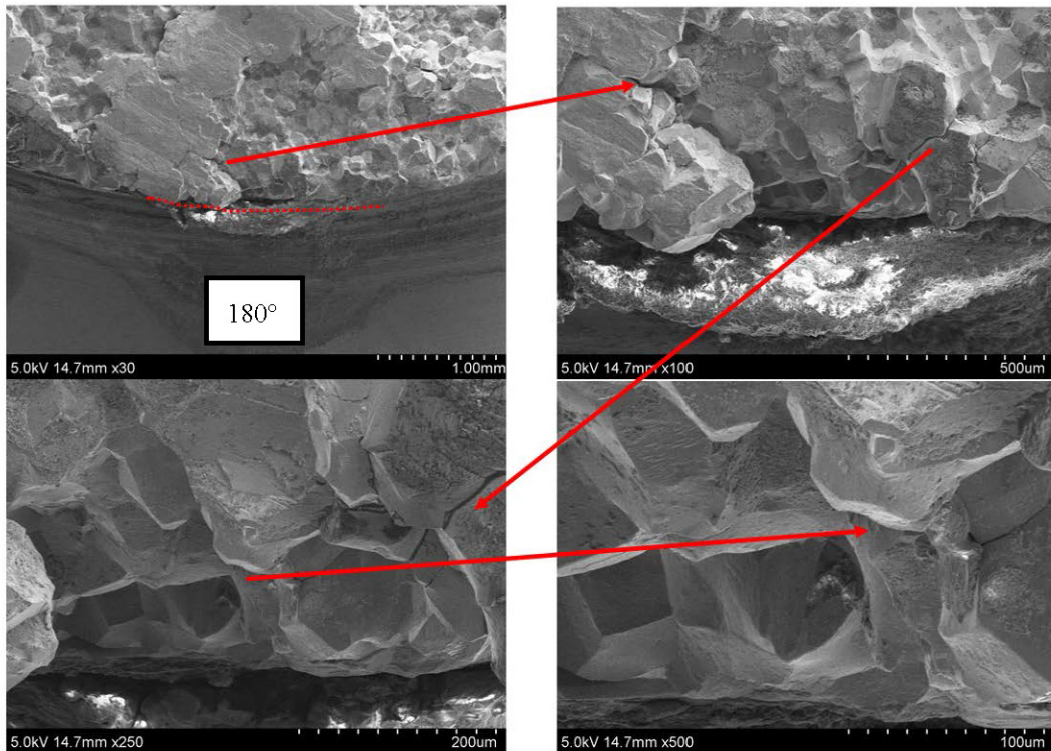
圖36、破斷面1、試片II上靠近180°的位置之沿晶破裂特徵

在破斷面1上靠近180°位置進行較大倍率的SEM分析，顯示沿晶破裂為主要的特徵。發現有數個不同的裂紋，但仍無法確認是否為初始裂紋。而連接桿外側邊緣有表面瑕疵，與原始設計之邊緣不同(如圖36紅色虛線處)。此表面瑕疵處的材料缺損可能是由腐蝕機制或是在製造過程中機械加工交互作用(夾雜物)的結果，如圖36。

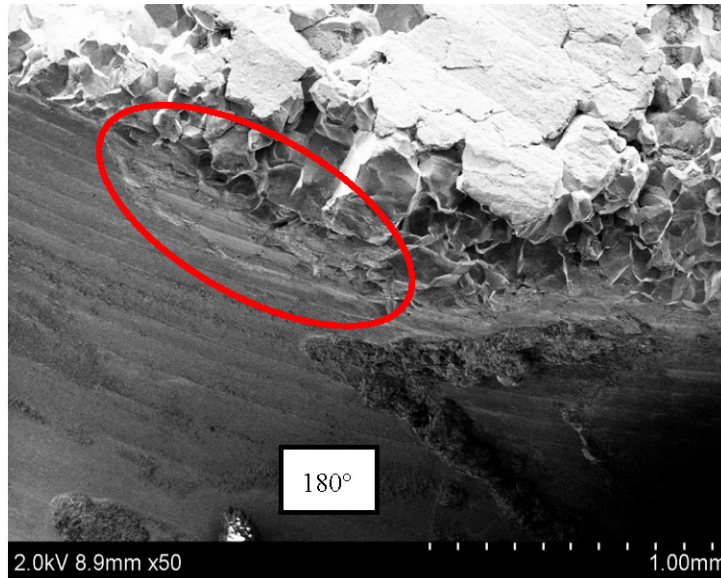
圖 39、破斷面 1、試片 II 上靠近 180° 的位置的側面 50 倍放大照片(經檸檬酸清洗後)

圖40上的紅色箭頭所指)。圖39紅圈處的右半邊已發生明顯的孔蝕為較早期的失效區域，為可能的主要裂紋起始區域。

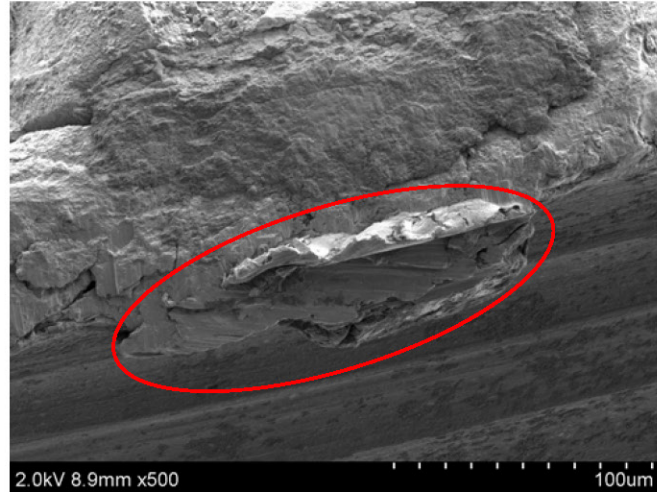
圖 41、破斷面 1、試片 II 上靠近 180° 的位置的側面 500 倍放大照片(經檸檬酸清洗後)

在 180° 位置的另一張照片顯示為另一個可能的夾雜物，如圖 41。這種尺寸大小的夾雜物為非預期中的，且在相同產品的歷史紀錄上也不曾出現過。因此，若此確實是夾雜物，則不預期在其他的連接桿表面上會看到類似的狀況。

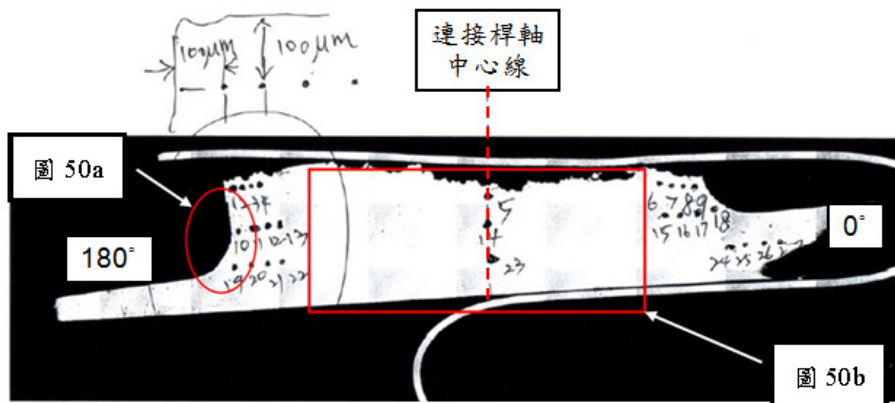
圖 46、在破斷面 1、試片 I 上不同位置量測維氏微硬度

為了進行金相分析和微硬度量測，已對破斷面1的試片I進行了橫切、鑲埋、研磨和拋光。圖45為試片I從連接桿上取樣的位置和微硬度的量測位置。在試片做蝕刻(金相分析樣品製備的最後一道手續)之前已先完成了微硬度的量測。表5為試片I上不同位置的微硬度量測結果，相關量測位置對應如圖46，結果顯示其硬度較同一批次的庫存材料(未受輻射照射)高。

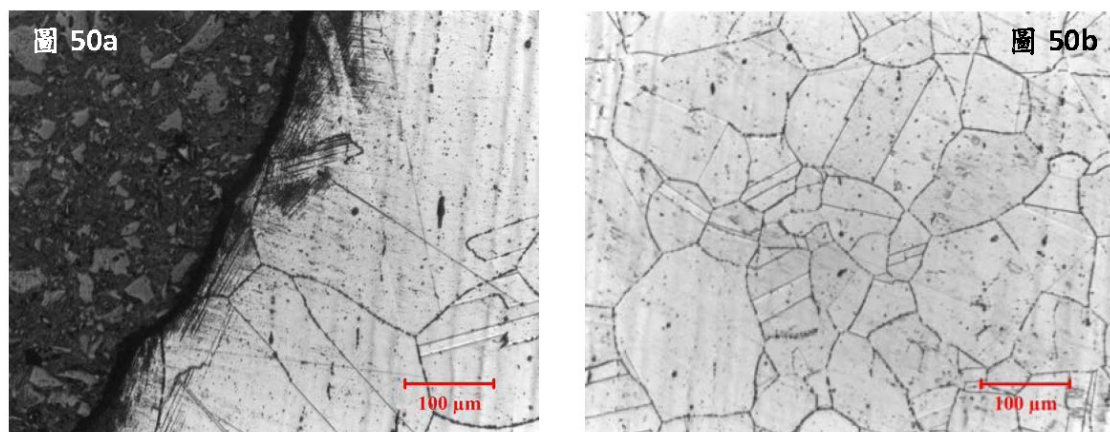
圖 50、破斷面 1、試片 I 經拋光與蝕刻後的金相照片，顯示詳細的晶粒分布

試片 I 的橫截面經過拋光和蝕刻後進行金相分析，如七、10.2 中討論的，同樣可清楚觀察到晶界輪廓，如圖 50。此外在表面可明顯觀察到因機械加工造成的冷作效應，如圖 50a；在基材則沒有冷作效應的痕跡，如圖 50b。此現象符合庫存材料的殘留應力分析結果，如七、10.3。試片 IIb 同樣也經過鑲埋、拋光和蝕刻後，可清楚觀察到晶界輪廓，如圖 51。

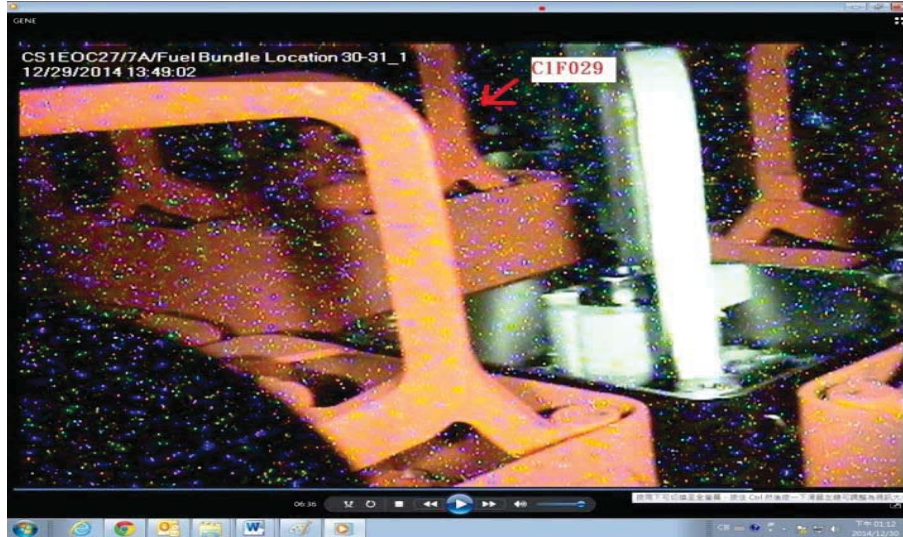
Figure 2. Raised fuel channel (in the background) in comparison to a fresh fuel assembly.

On December 28, 2014 during fuel outage at end of cycle 27, Chinshan's fuel handlers attempted to lift C1F029 fuel assembly to move it to a new location in the core for a fourth cycle of operation. During the lift, the load cell on the fuel handling crane indicated an immediate drop in mass below the load cell trip point. This indication meant that the entire weight of the fuel assembly was not registering on the load cell. In order to confirm the function of load cell is normal, the crew stopped and reversed the crane. The fuel handlers then moved the crane to the next fuel assembly location and proceeded to lift the fuel assembly as normal. This movement confirmed that the crane was working as designed.

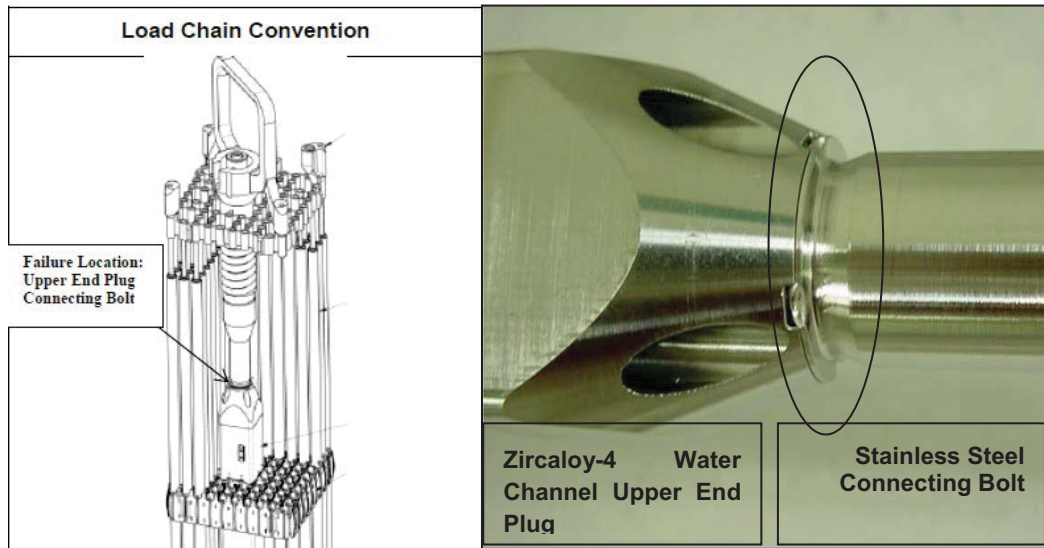
Figure 3. Location of threaded joint of broken Connecting Bolt.

Following removal of the fuel assembly from the core, the fuel services team proceeded to remove the fuel rods. Visual examination of the central load chain identified the broken Connecting Bolt (Figure 3).

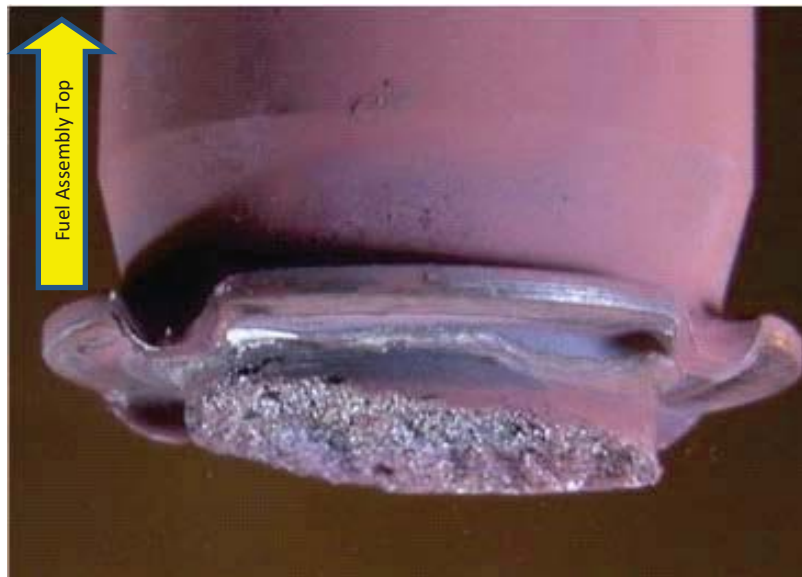
Figure 4. Upper part of stainless steel Connecting Bolt.

The fuel assembly cage was disassembled, and the Connecting Bolt upper piece was sent to the Institute of Nuclear Energy Research (INER) hot cell for examination. Later, the upper part of the central water channel was removed from the bundle and also sent to INER. The separation appears to be a fracture with environment assisted cracking around the edges. Figure 4 and Figure 5 show the broken bolt and the receiving connection. Figure 5 also shows reddish crud deposits on the fracture surface.

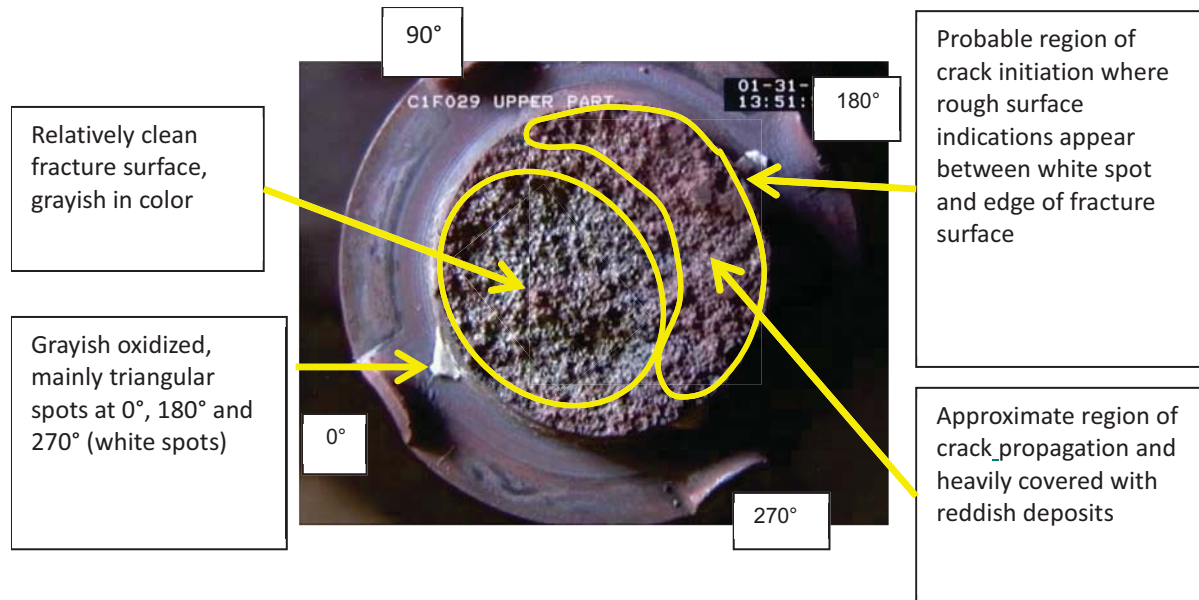
Figure 19. Close-up image of FF1.

- Referring to Figure 19, the general appearance of FF1 is grainy with no indication of macroscopic plastic deformation. The fracture surface is slightly tilted to the axis of the bolt having its highest elevation at 180° and its lowest at 0°. About 1/3 of the surface extending from approximately 90° to approximately 270° is covered by reddish deposits (close to the outer surface) and a flat surface close to the 180° position (most probably post-fracture mechanical deformation introduced during the handling of the fuel assembly) can be observed. The remaining part of the fracture surface appears grayish in color.

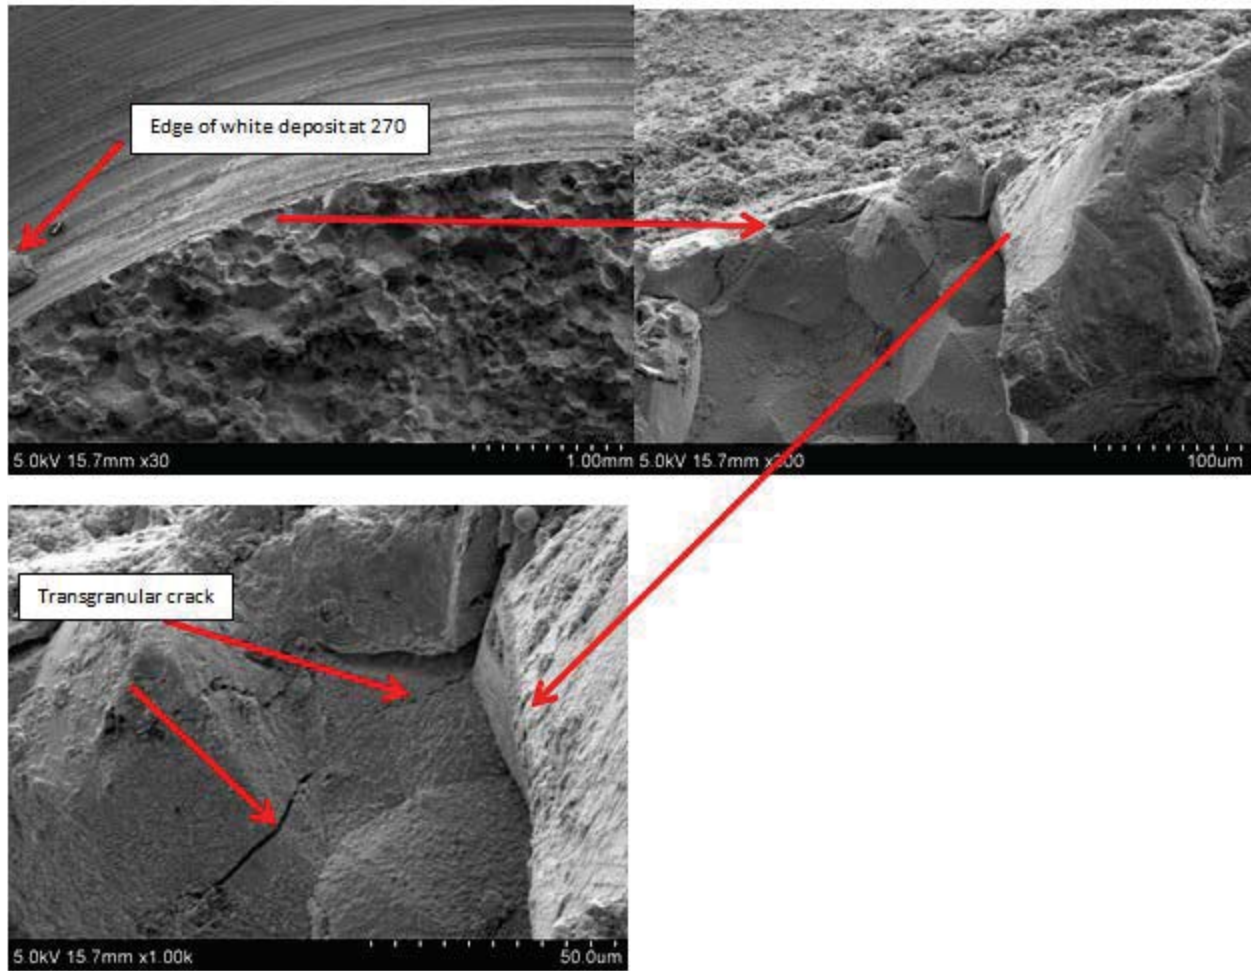
Figure 35. FF1, 270° Position - Images of cracking, including evidence of transgranular cracks.

Most of the surfaces of all three Specimens of FF1 shown in Figure 32, Figure 33, and Figure 34 exhibit intergranular cracking. Grain faces appear covered with heavy oxides. In areas from the 270° Position around to the 0° Position and continuing to the 90° Position transgranular cracks are observed (see Figure 35). The transgranular cracks represent a much smaller proportion of the fracture surface than the intergranular cracks. There is no apparent plastic deformation in the material at the 180° Position determined to be most likely site of crack initiation.

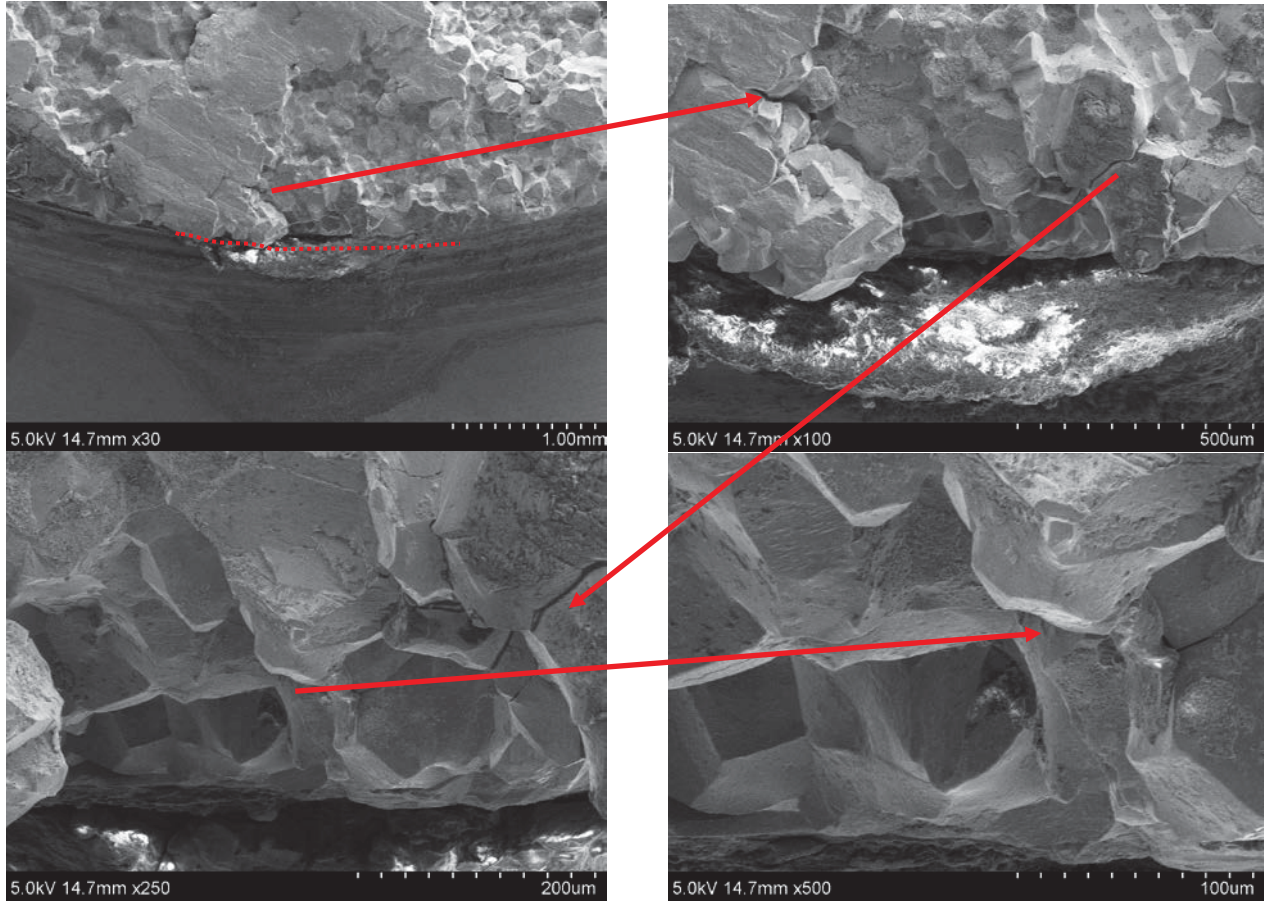
Figure 36. FF1, Specimen II, 180° Position shows intergranular cracking.

A close examination of the fracture surface at 180° confirms the primarily intergranular nature of the fracture. Several distinct cracks are visible, but none can yet be clearly defined as the initiating crack. It is evident that the outer surface of the bolt at this location does not demonstrate the designed edge of the bolt (see dashed red line in Figure 36). Rather, material has been removed either by a corrosion mechanism or a mechanical interaction during manufacturing. This region is shown in Figure 36.
