# BWR Control Rods Performance

Department of Nuclear Regulation  
Atomic Energy Council, R.O.C

AEC/NRC Bilateral Technical Meeting  
May 31 to June 2, 2005

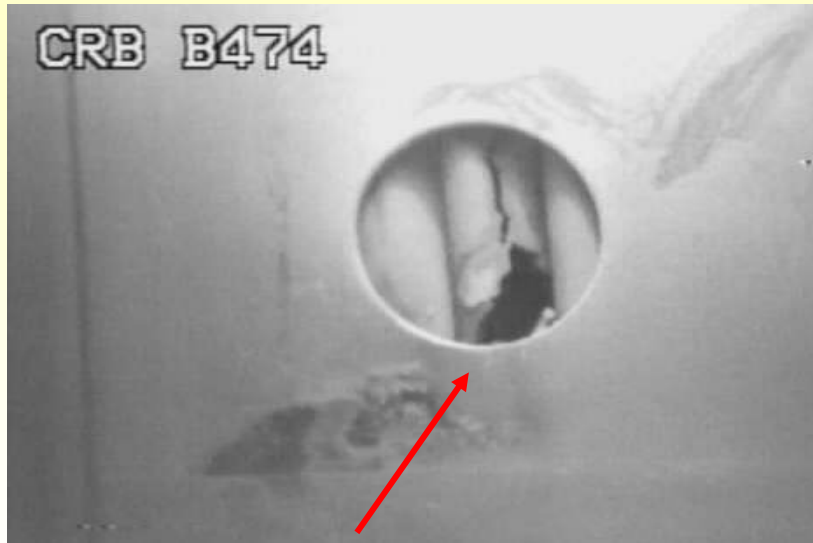
B4 C absorber rod crack

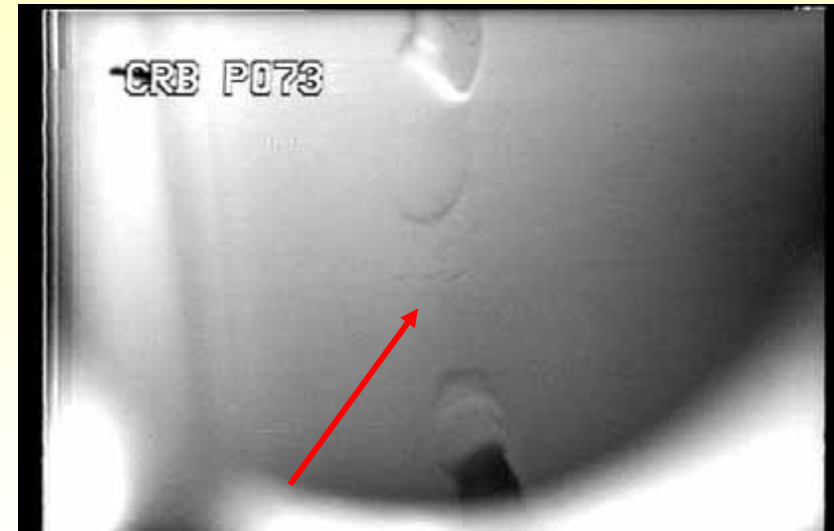
Sheath to tie rod crack

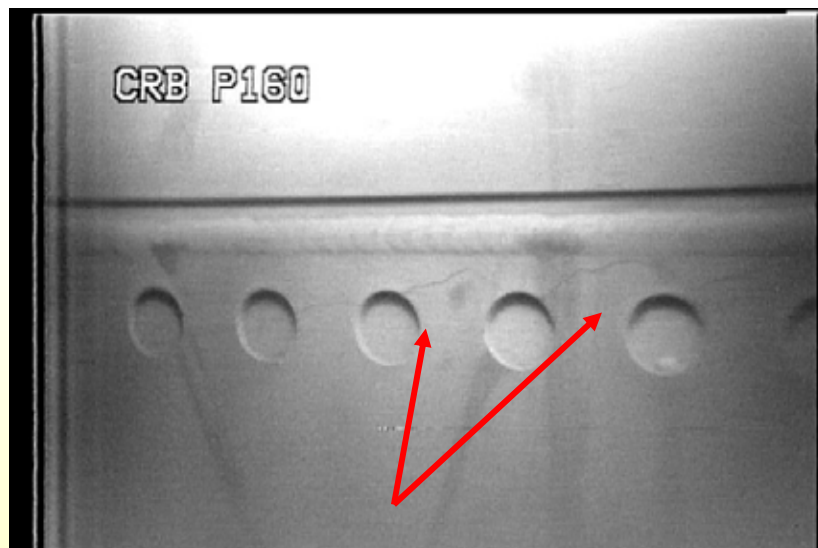
Handle to Sheath crack

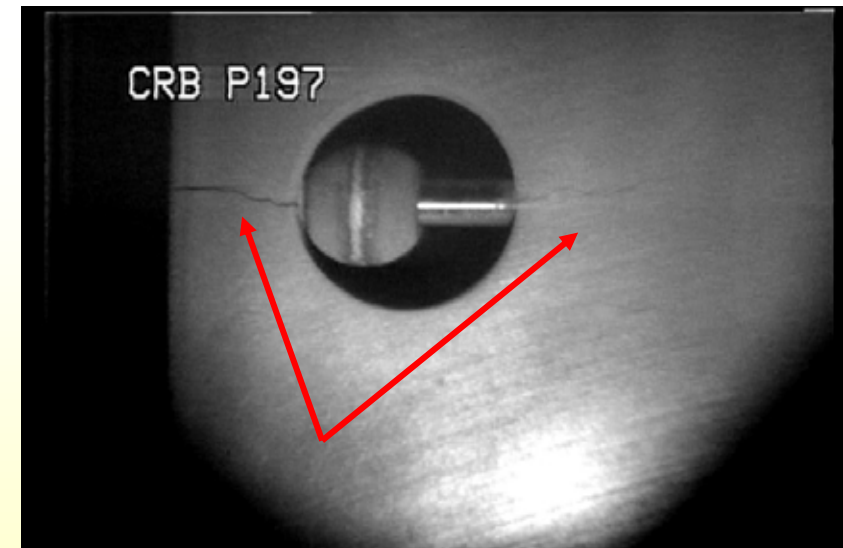
Handle roller pinhole outboard  
and inboard crack

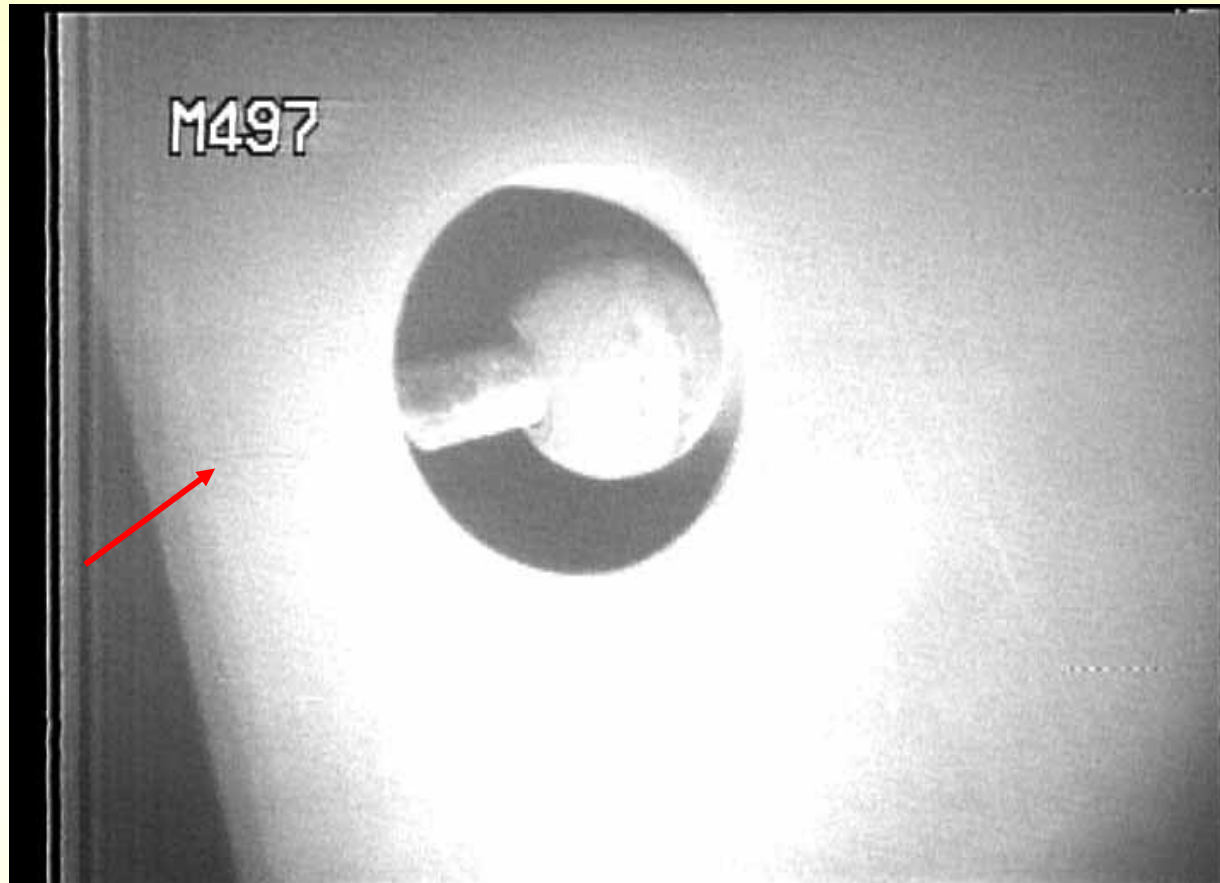
- During the Chinshan unit 2 EOC-19 outage inspection (September 2003), 15 out of 17 original Marathon type control rods used in the unit for only one cycle has also shown crack indications on handle roller pinhole outboard locations.

**Handle Roller Pin Outboard Indication of original  
Marathon Control Rod**

- Additional regulatory requirements are enforced which are the reconfirmation of the control rod quality documentation, and the one-cycle time limit for the root cause identification.
- According to GE and Taipower's root cause study ,there are three contributory factors to the original Marathon CRB cracking namely:
  - (1)Sulfur and Chlorine contamination of the roller pin-hole,
  - (2)Significant cold work hardening,
  - (3)Manufacturing residual stress.

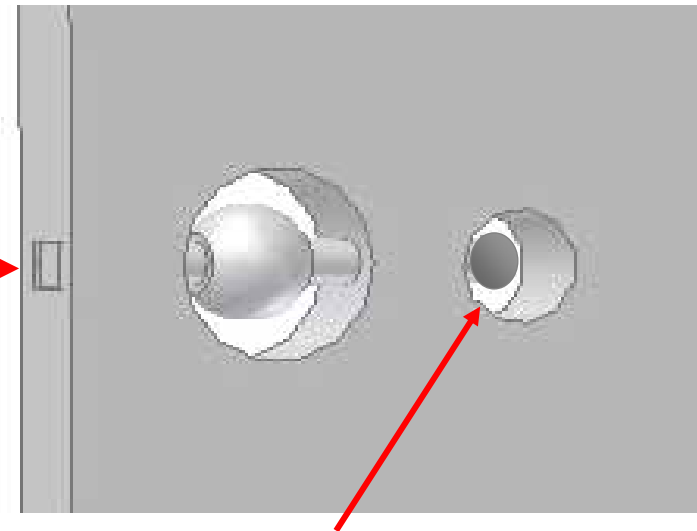
Small weld deposit
