Nuclear Fuel Performance

Department of Nuclear Regulation
Atomic Energy Council, R.O.C

AEC/NRC Bilateral Technical Meeting
May 31 to June 2, 2005

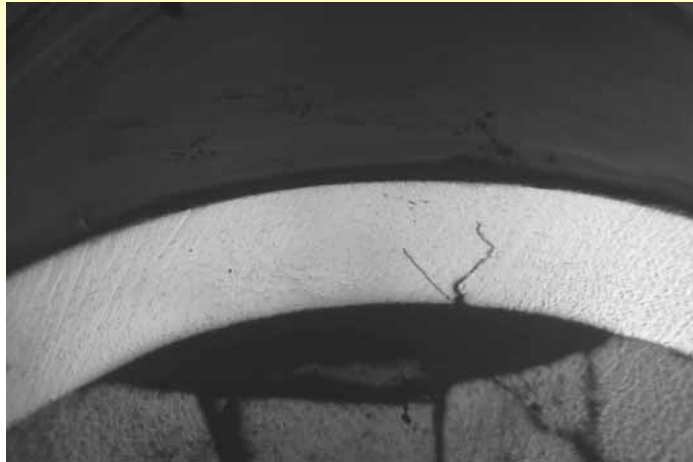
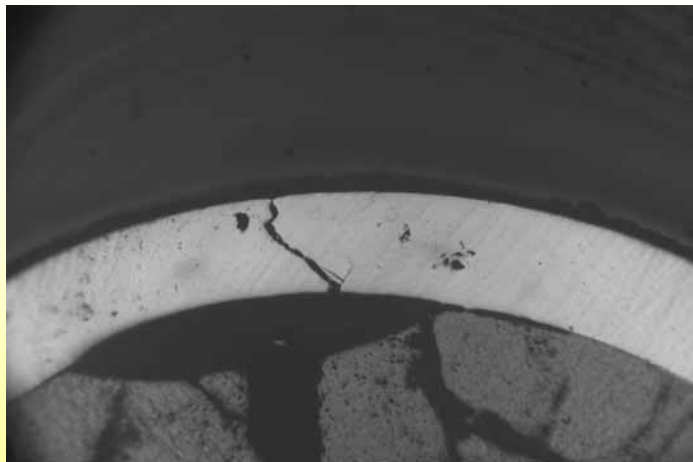
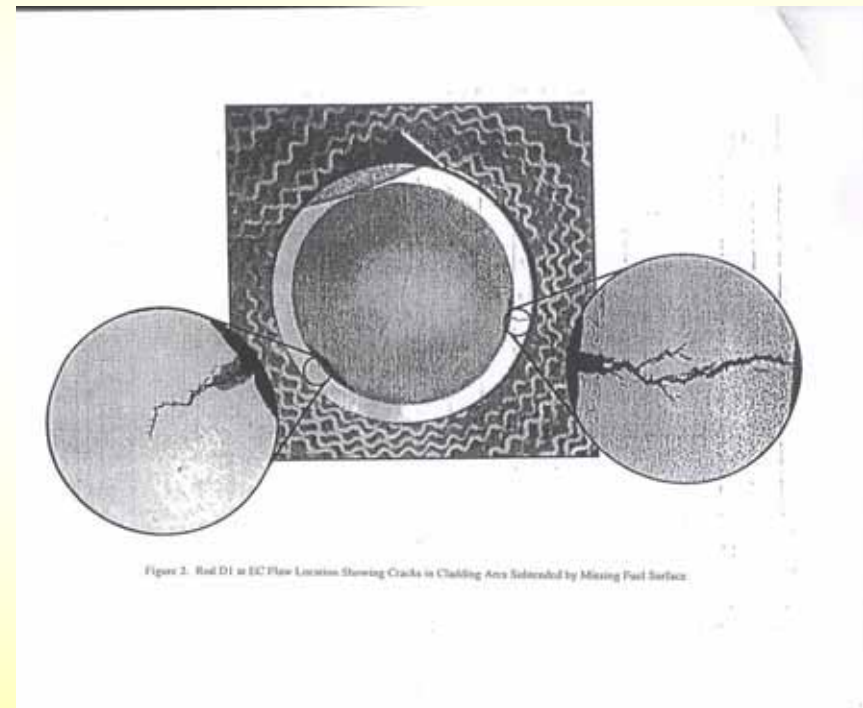
- Kuosheng Unit 2 fuel failure investigation:
 - In 2000, two failed fuel rods in one assembly was found in Cycle 14. (KAD122, ATRIUM-9B, two-cycle fuel, burnup: 25.4 GWD/MTU, failed fuel rods A6 & E1)
 - The failure cause was initially determined to be fuel shuffling criteria violation induced PCI by FANP.
 - Failed fuel rods were transported to INER's hot lab for Post-Irradiation Examination (PIE).
 - The PIE results indicated that pellet missing cylindrical surface enhanced PCI failure for A6, and hydrogen contamination induced hydriding cracking for E1.

PIE results for the cross sections of failed fuel rod A6

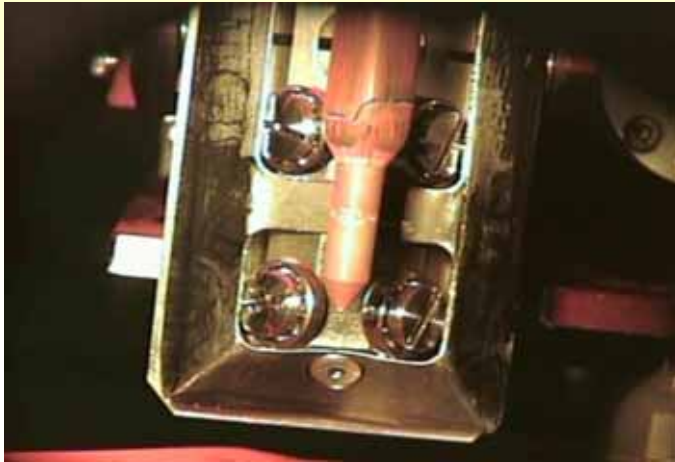
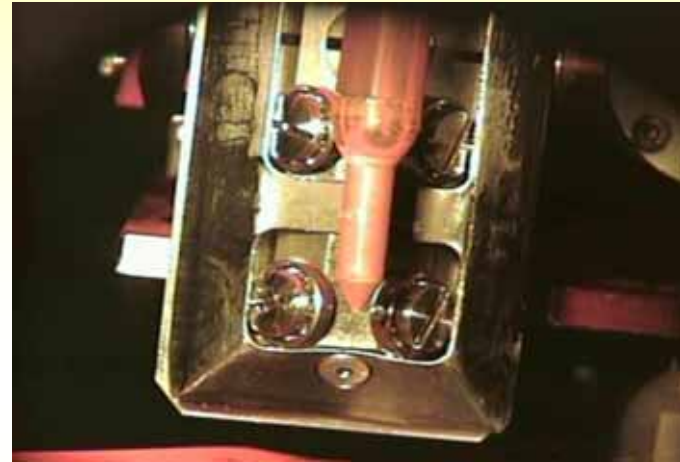
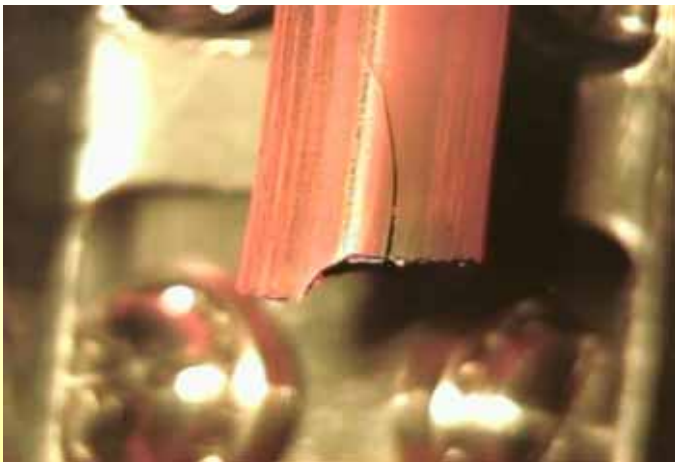
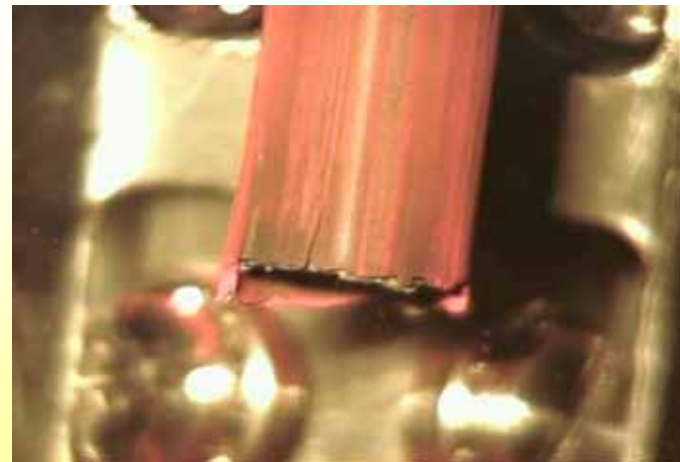
- In 2003, two failed fuel rods in two fuel assemblies were found at Unit 2 Cycle 16.
- ATRIUM-9B, non-barrier two-cycle fuel, burnup: 28.9 & 28.6 GWD/MTU.
- KAG115, core location: 28-49, failed fuel rod F2.
- KBH069, core location: 44-33, failed fuel rod F2.
- The root cause is still under investigation.

KAG115 failed fuel rod F2: Circumferential crack just above weld area of lower end cap

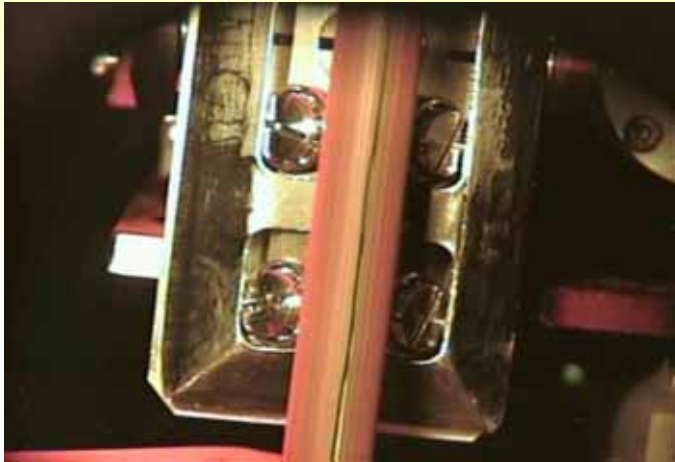
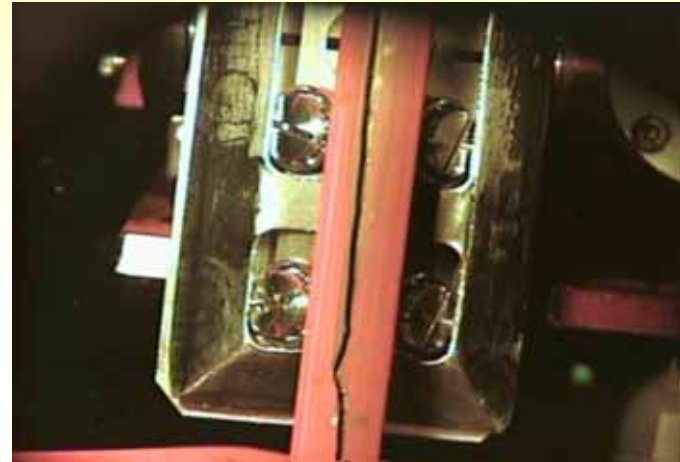
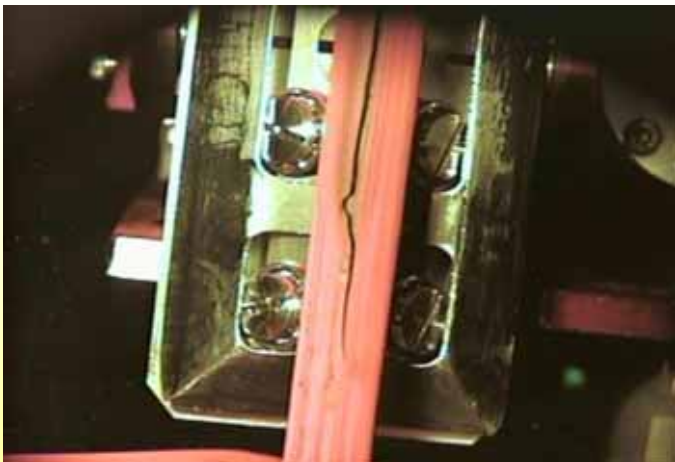
KAG115 failed fuel rod F2: 35 to 40 cm axial split on span 5

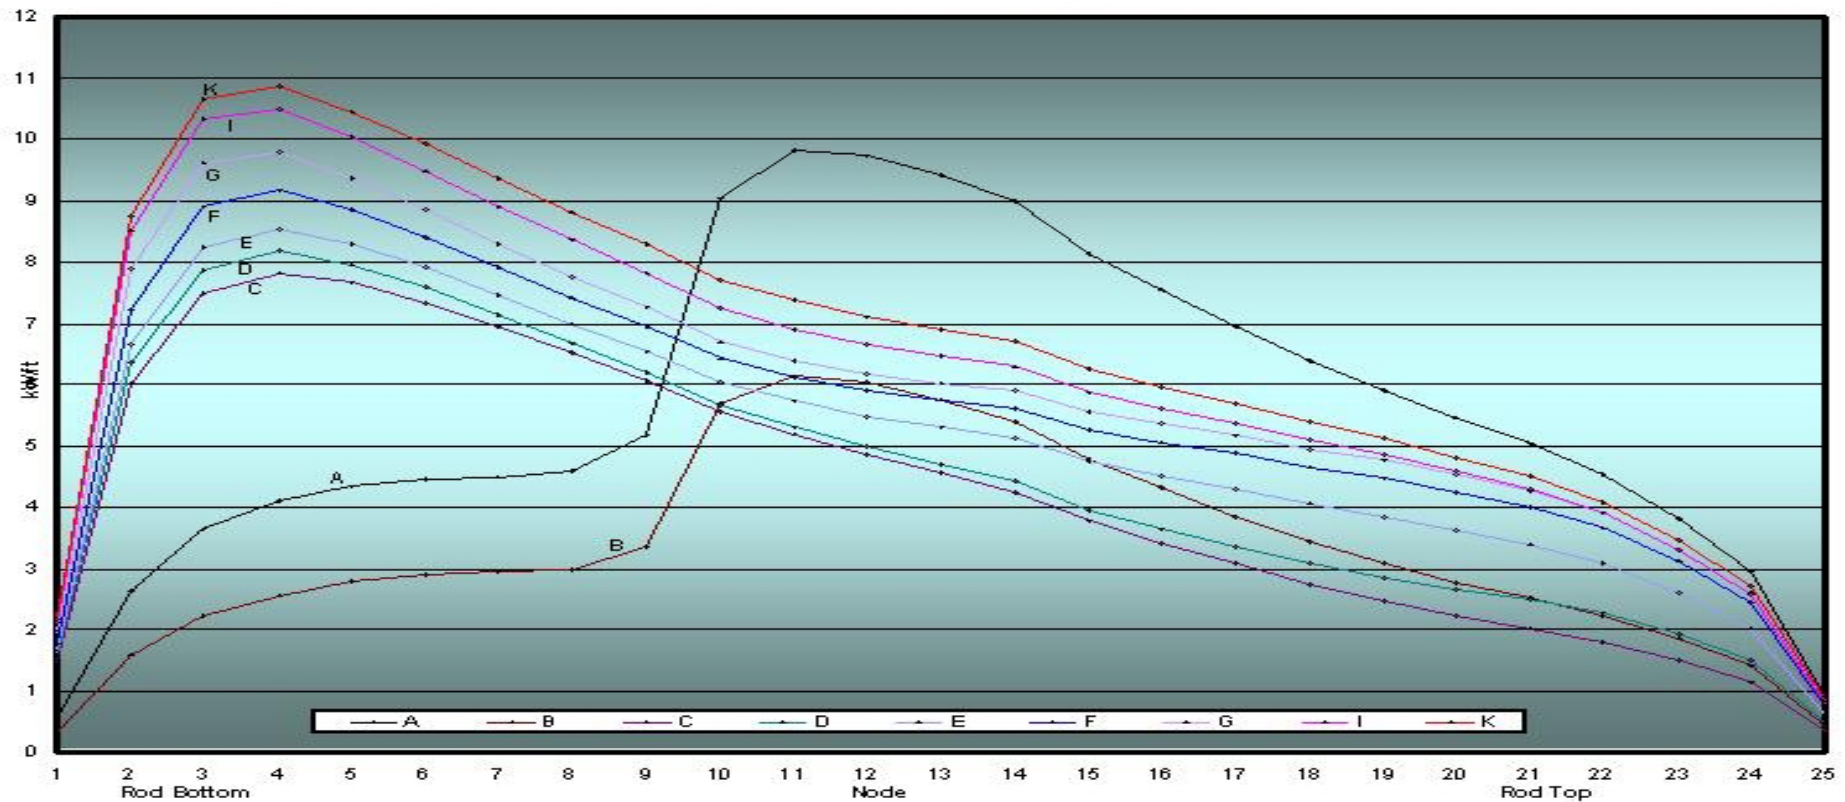
Fig 1. Kuosheng Unit 2 Cycle 16 LHGR (kW/ft) of KAG115 Rod F-02 During the April 13, 2003 Control Rod Sequence Exchange

A - 99.5%CTP Prior to the sequence exchange. Adjacent control rod was at 30.	F - 84.9%CTP Power ascension to rated. Adjacent control rod was fully withdrawn.
B - 99.5%CTP Prior to fully withdrawn the adjacent control rod.	G - 90.6%CTP Power ascension to rated. Adjacent control rod was fully withdrawn.
C - 90.4%CTP After the adjacent control rod was fully withdrawn (from 30 to 48).	I - 94.9%CTP Power ascension to rated. Adjacent control rod was fully withdrawn.
D - 65.2%CTP Power ascension to rated. Adjacent control rod was fully withdrawn.	K - 99.7%CTP Rated power reached. Adjacent control rod was fully withdrawn.
E - 75.3%CTP Power ascension to rated. Adjacent control rod was fully withdrawn.

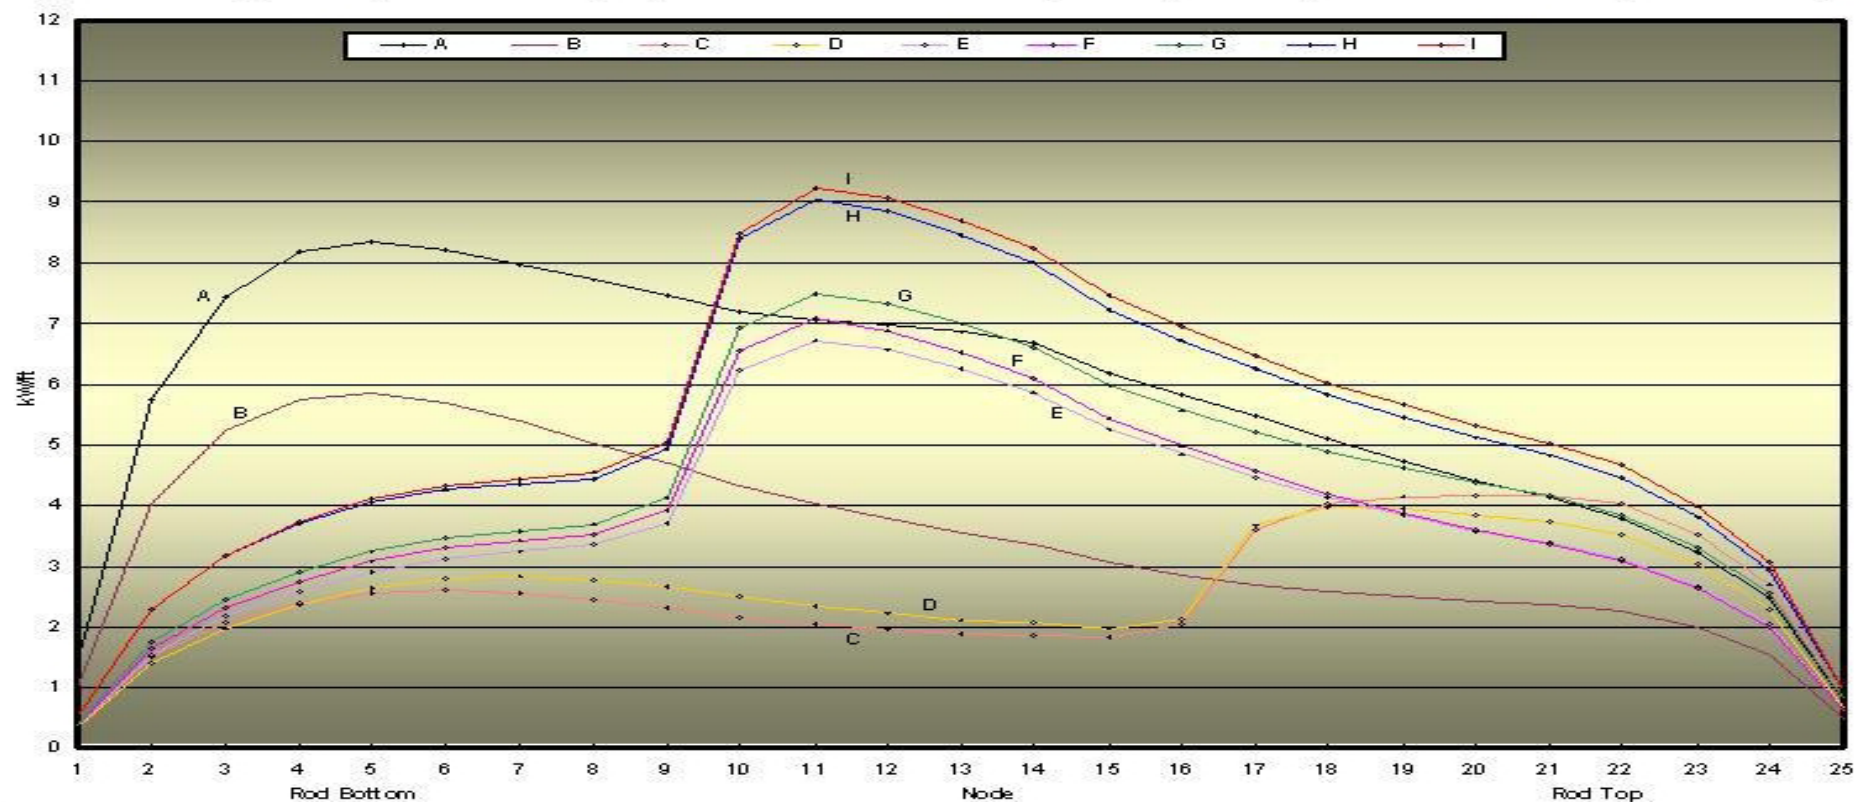
Fig 2. Kuosheng Unit 2 Cycle 16 LHGR (KW/ft) of KAG115 Rod F-02 During the September 7, 2003 Control Rod Sequence Exchange

A - 99.8% CTP Prior to the sequence exchange. Adjacent control rod was fully withdrawn.

B - 58.2% CTP Prior to inserting adjacent control rod.

C - 61.0% CTP After the adjacent control rod was inserted from 48 to 16.

D - 58.5% CTP Prior to adjusting the adjacent control rod.

E - 66.4% CTP After adjusting the adjacent control rod from 16 to 30

F - 72.5% CTP Power ascension to rated. Adjacent control rod was at 30.

G - 79.8% CTP Power ascension to rated. Adjacent control rod was at 30.

H - 97.6% CTP Power ascension to rated. Adjacent control rod was at 30.

I - 99.9% CTP Rated power. Adjacent control rod was at 30.

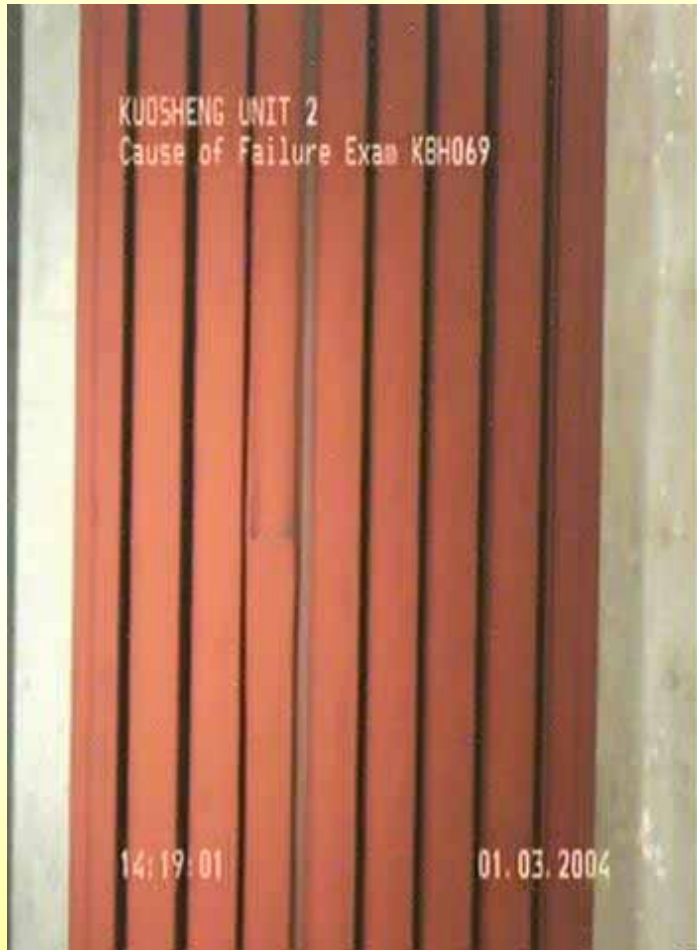
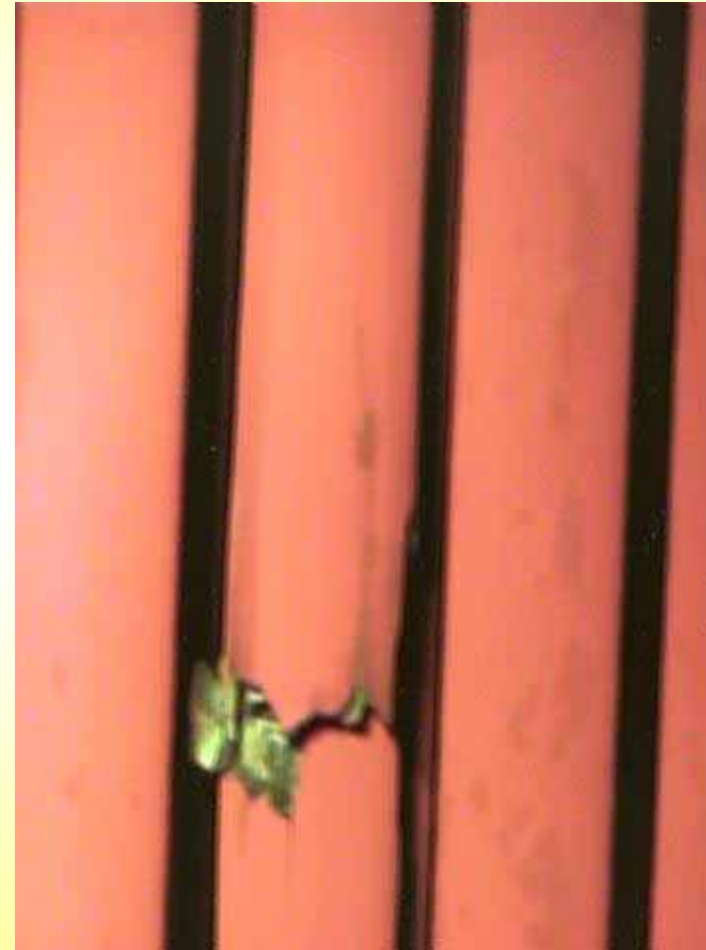
KBH069 failed fuel rod F2: Circumferential crack on span 2

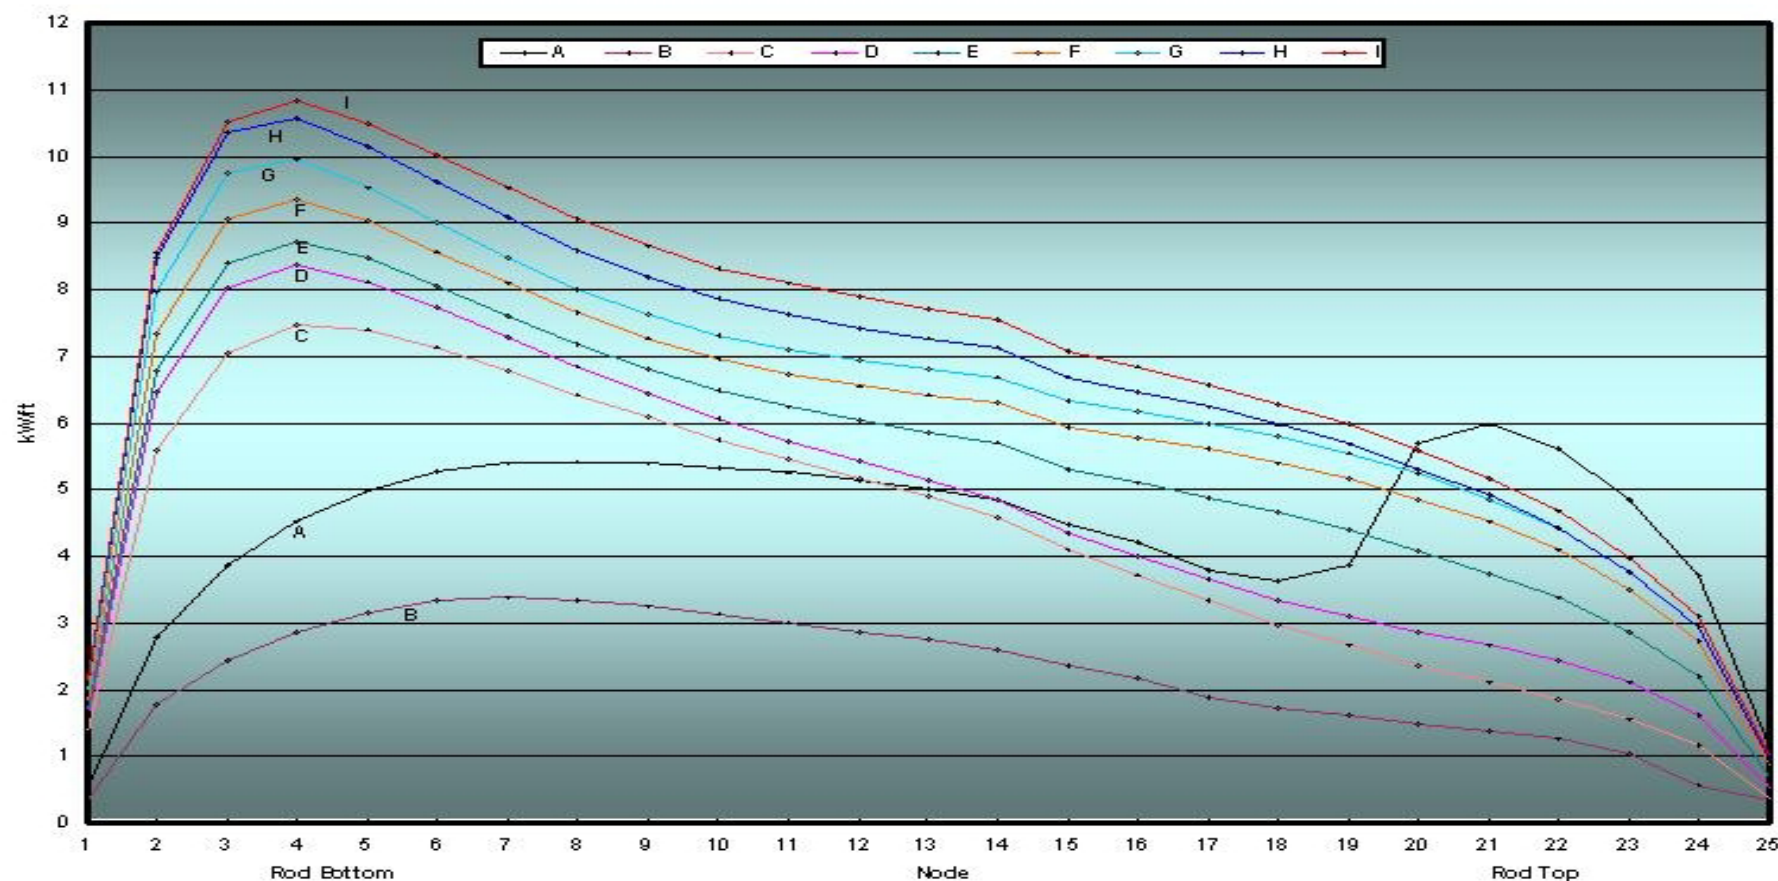
Fig 3. Kuosheng Unit 2 Cycle 16 LHGR (kW/ft) of KBH069 Rod F-02 During the April 13, 2003 Control Rod Sequence Exchange

A - 99.9 % CTP. Adjacent control rod was at 10. Rated power prior to sequence exchange.	F - 84.9 % CTP. Adjacent control rod was at 48 (Fully withdrawn). Power Ascension.
B - 56.9 % CTP. Adjacent control rod was at 00. Rod adjusted during sequence exchange.	G - 90.6 % CTP. Adjacent control rod was at 48 (Fully withdrawn). Power Ascension.
C - 59.1 % CTP. Adjacent control rod was at 48 (Fully withdrawn). Rod in new pattern.	H - 94.9 % CTP. Adjacent control rod was at 48 (Fully withdrawn). Power Ascension.
D - 65.2 % CTP. Adjacent control rod was at 48 (Fully withdrawn). Power Ascension.	I - 99.9 % CTP. Adjacent control rod was at 48 (Fully withdrawn). Rated power reached.
E - 75.3 % CTP. Adjacent control rod was at 48 (Fully withdrawn). Power Ascension.

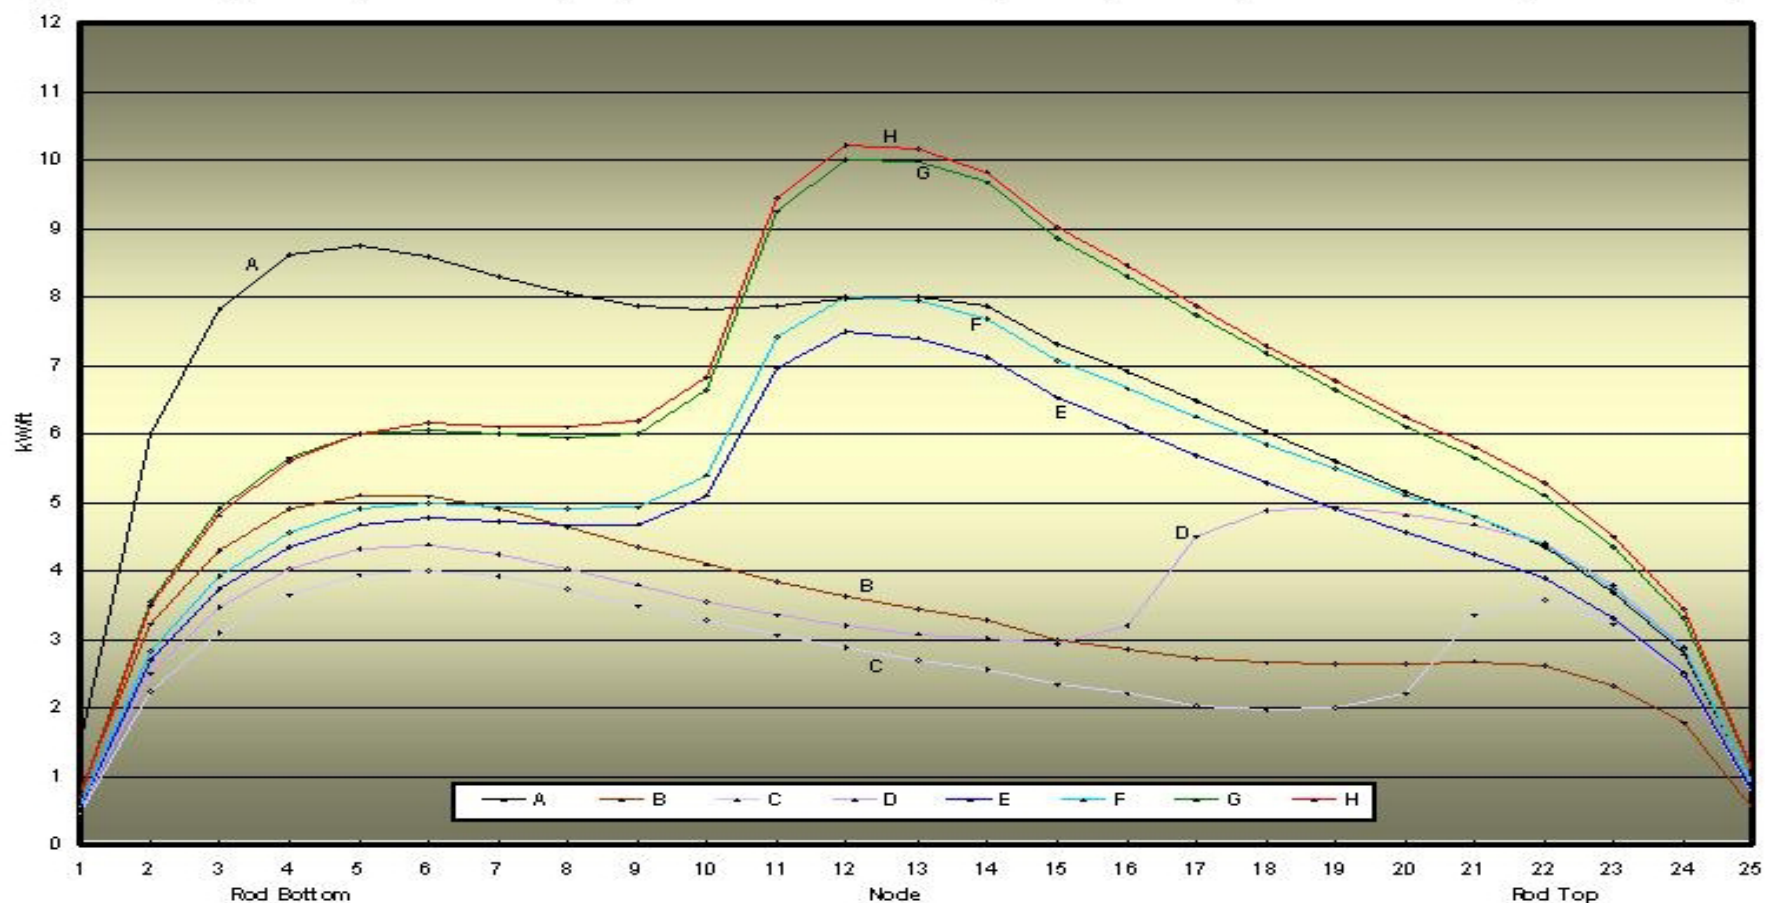
Fig 4. Kuosheng Unit 2 Cycle 16 LHGR (kW/ft) of KBH069 Rod F-02 During the September 7, 2003 Control Rod Sequence Exchange

A - 99.8% CTP. Adjacent control rod was at 48 (Fully withdrawn) prior to sequence exchange.	E - 72.5% CTP. Adjacent control rod was at 28. Rod adjusted & Power Ascension.
B - 50.9% CTP. Adjacent control rod was at 48 (Fully withdrawn) prior to sequence exchange.	F - 79.8% CTP. Adjacent control rod was at 28. Power Ascension.
C - 57.5% CTP. Adjacent control rod was at 8. Rod in new pattern.	G - 97.6% CTP. Adjacent control rod was at 28. Power Ascension.
D - 66.4% CTP. Adjacent control rod was at 16. Rod adjusted & Power Ascension.	H - 99.8% CTP. Adjacent control rod was at 28. Rated power reached.

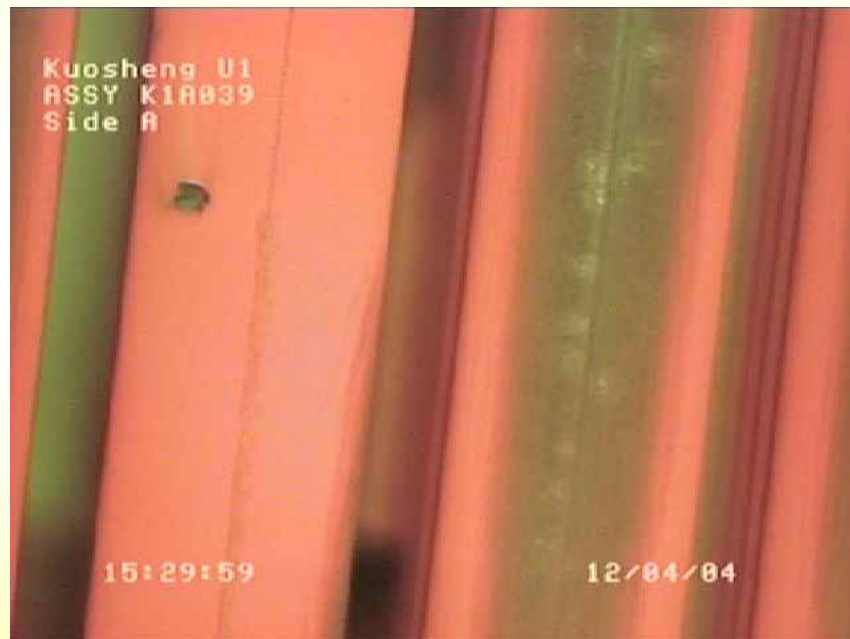
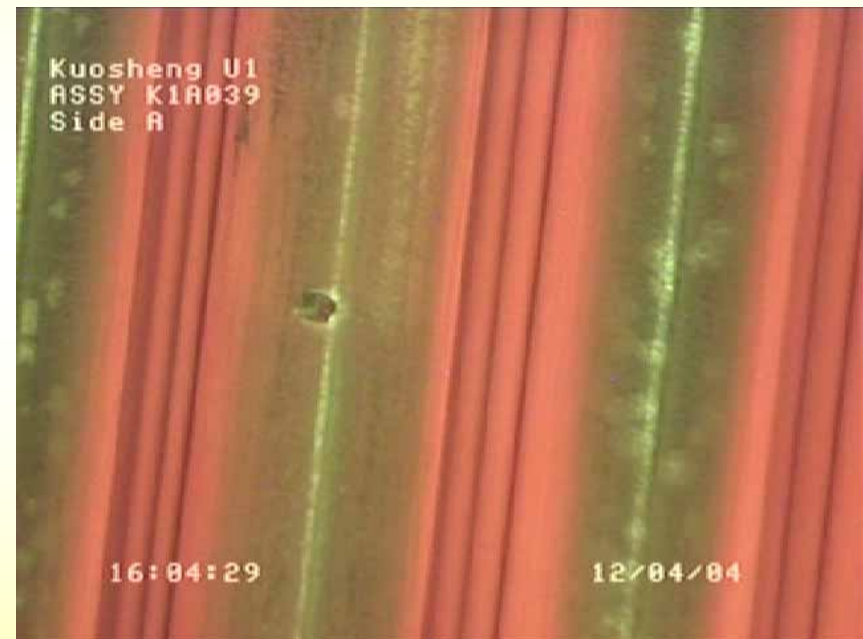
- In 2004, one failed fuel rod was found at Unit 1 Cycle 17.
- ATRIUM-10, non-barrier with small hole lower tie plate two-cycle fuel, burnup: 31.2 GWD/MTU.
- K1A039, core location: 25-22, failed fuel rod H1.
- The root cause is debris-induced fretting.

K1A039 failed fuel rod H1:Debris fret hole on span 3

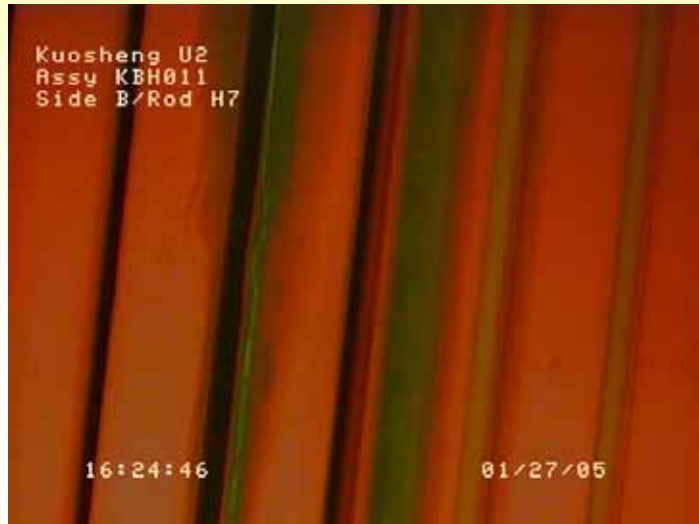
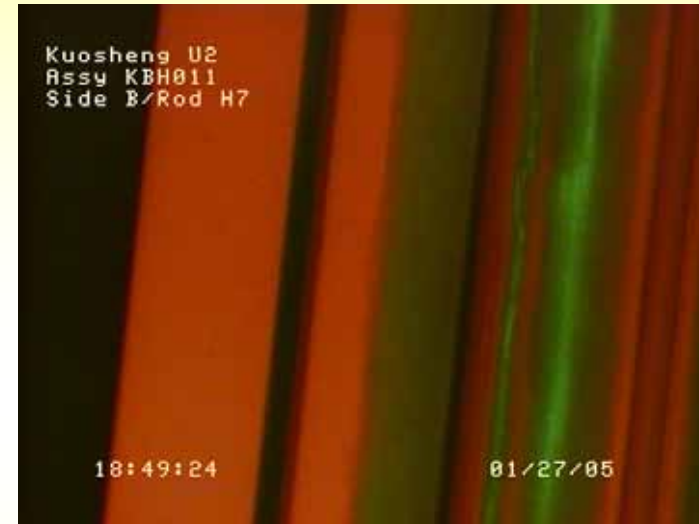
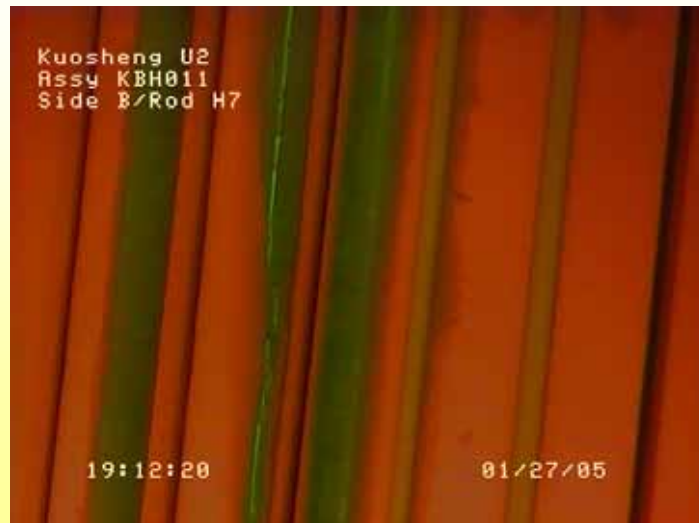
KBH011 failed fuel rod H7: Axial split on span 1, axial crack on span 3 & 7

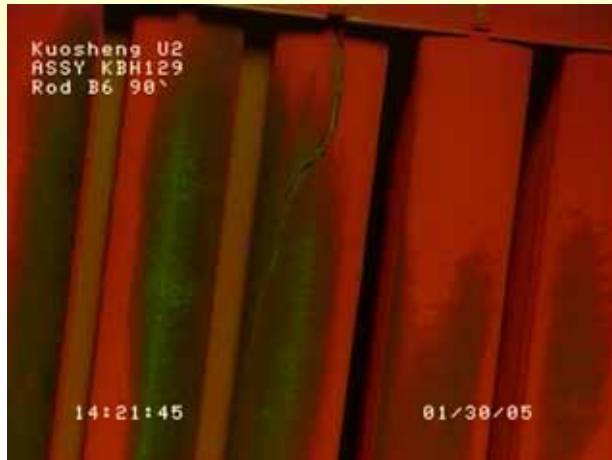
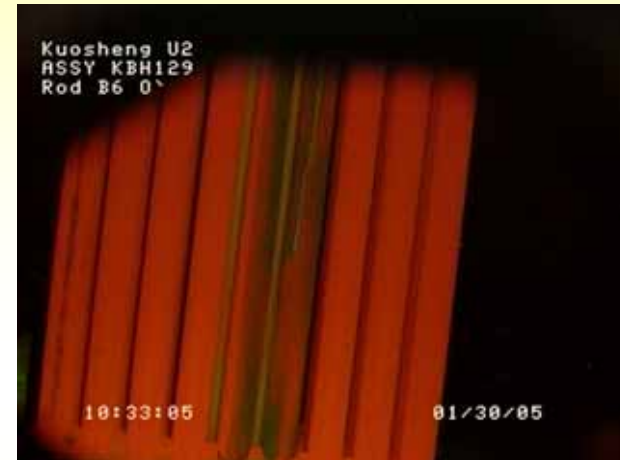
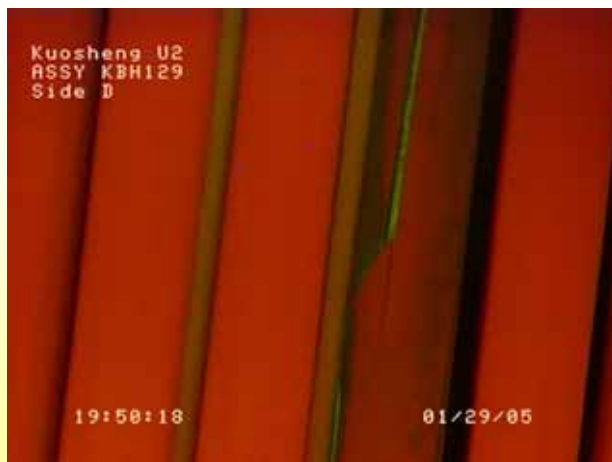
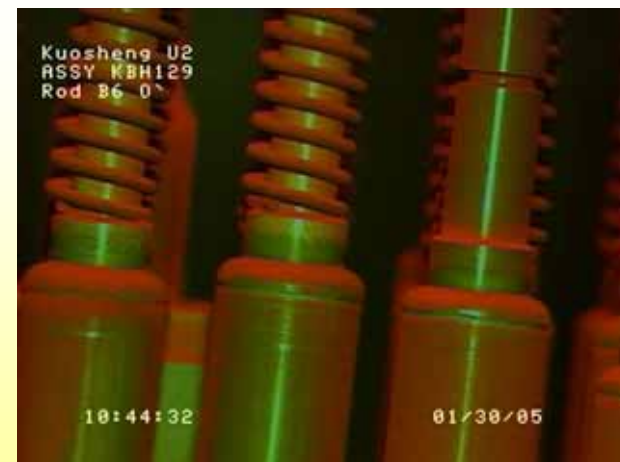
KBH129 failed fuel rod B6: Axial split on span 1 & 2, axial crack on span 4, circumferential crack below weld area of upper end cap

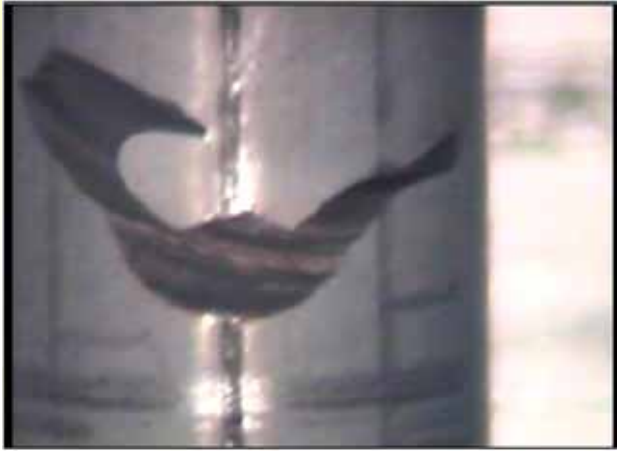
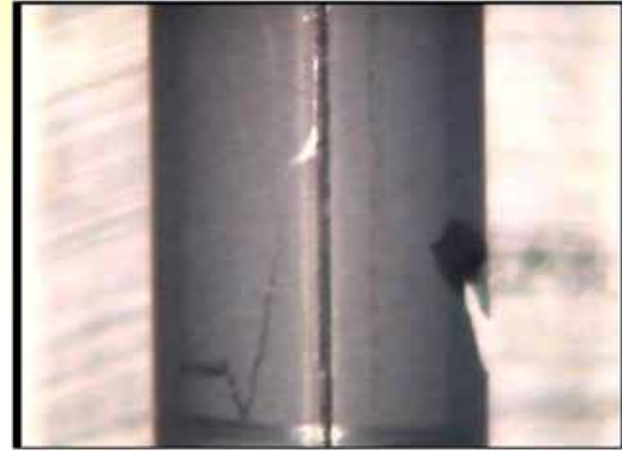
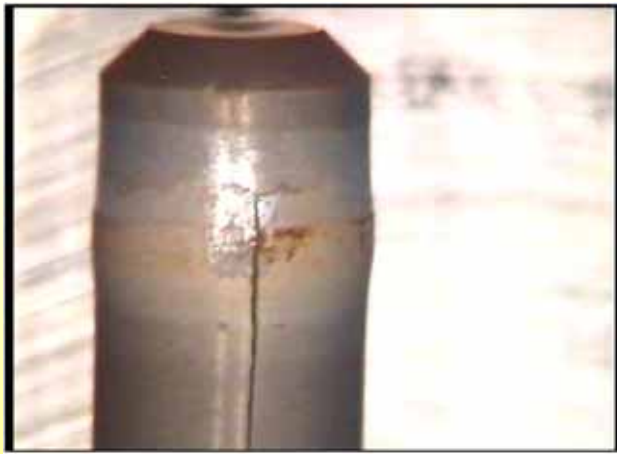
- In 2003, one failed fuel rod was found at Unit 2 Cycle 14.
- OFA, third-cycle fuel, burnup: 46.2 GWD/MTU.
- D166, core location: A-9, failed fuel rod L1.
- The root cause is debris-induced fretting.

D166 failed fuel rod L1: Wear scar below bottom grid, horizontal & vertical crack on top end plug

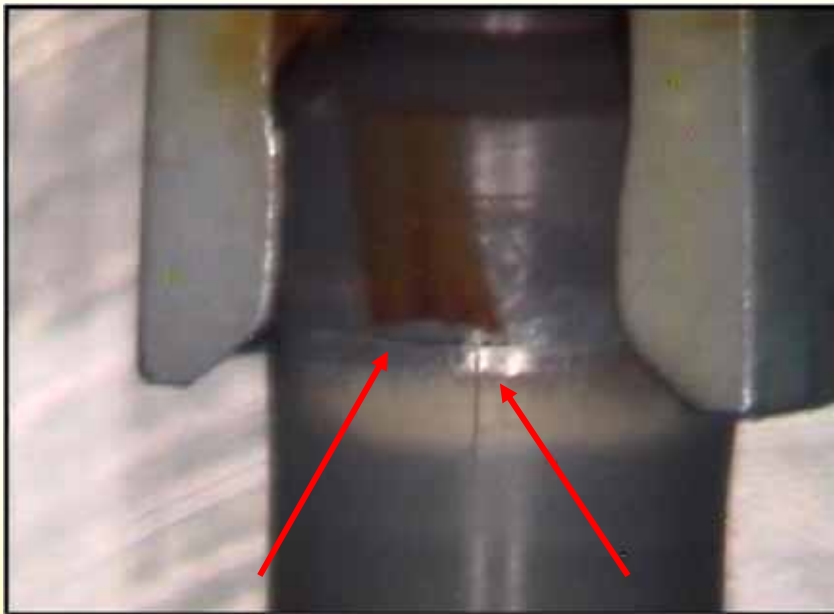
G121 failed fuel rod O7: Crack between clad & top end plug, small vertical crack on clad, small hole above bottom grid

Crack between clad
& top end plug

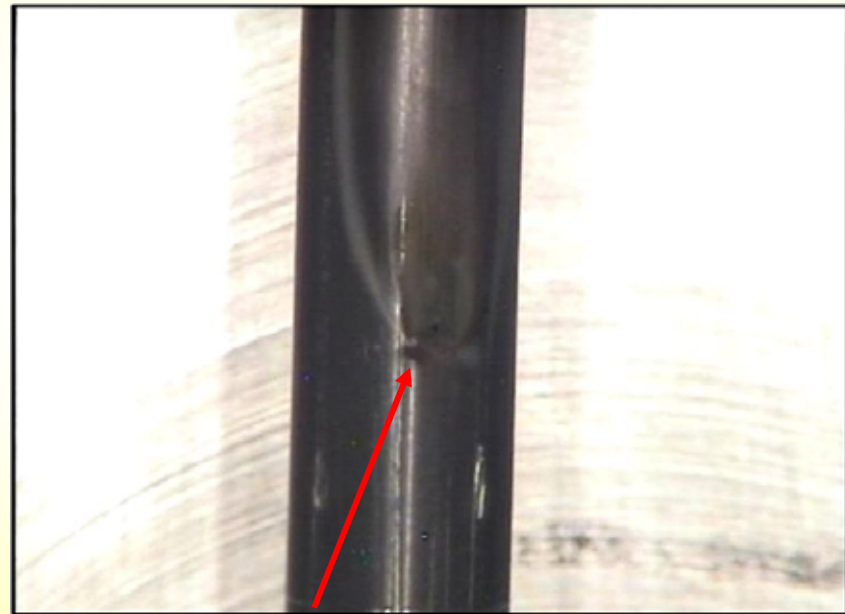
small vertical
crack on clad

Small Hole (0.008" dia)
