2010 AEC-NRC Bilateral Technical Meeting

*345kV Startup Transformer Failure
(June 12 2009 Mannshan NPP)*

Taiwan Power Company

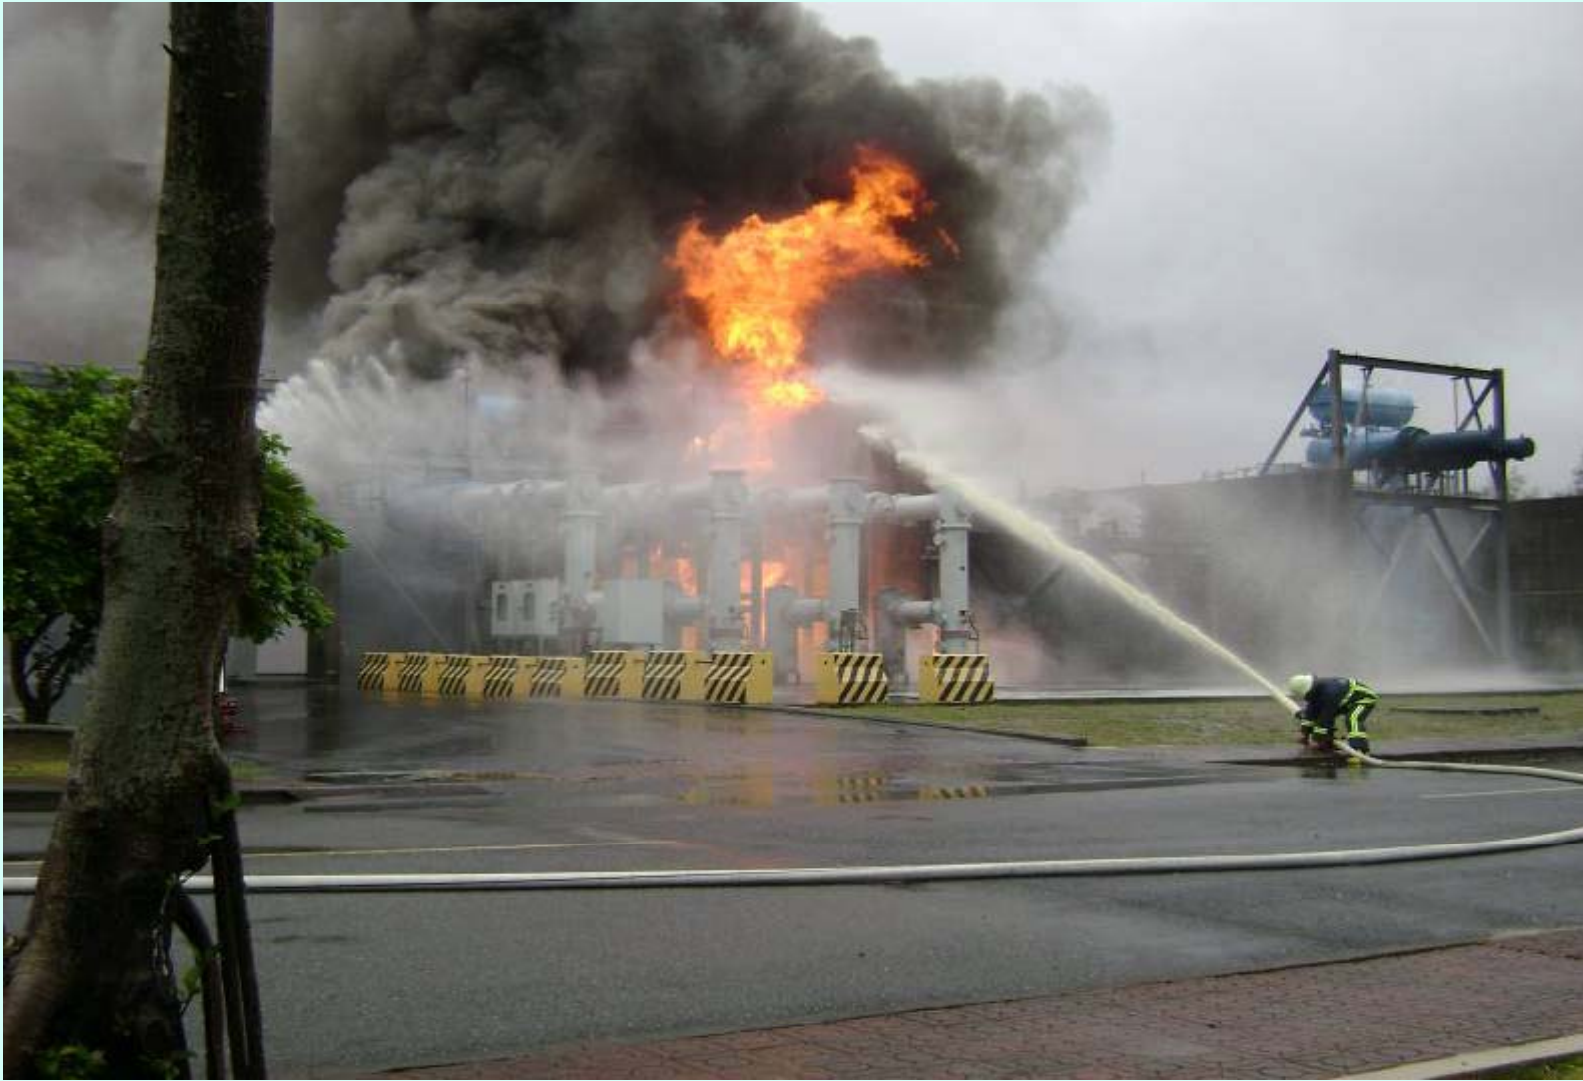
The 345kV startup transformer on fire

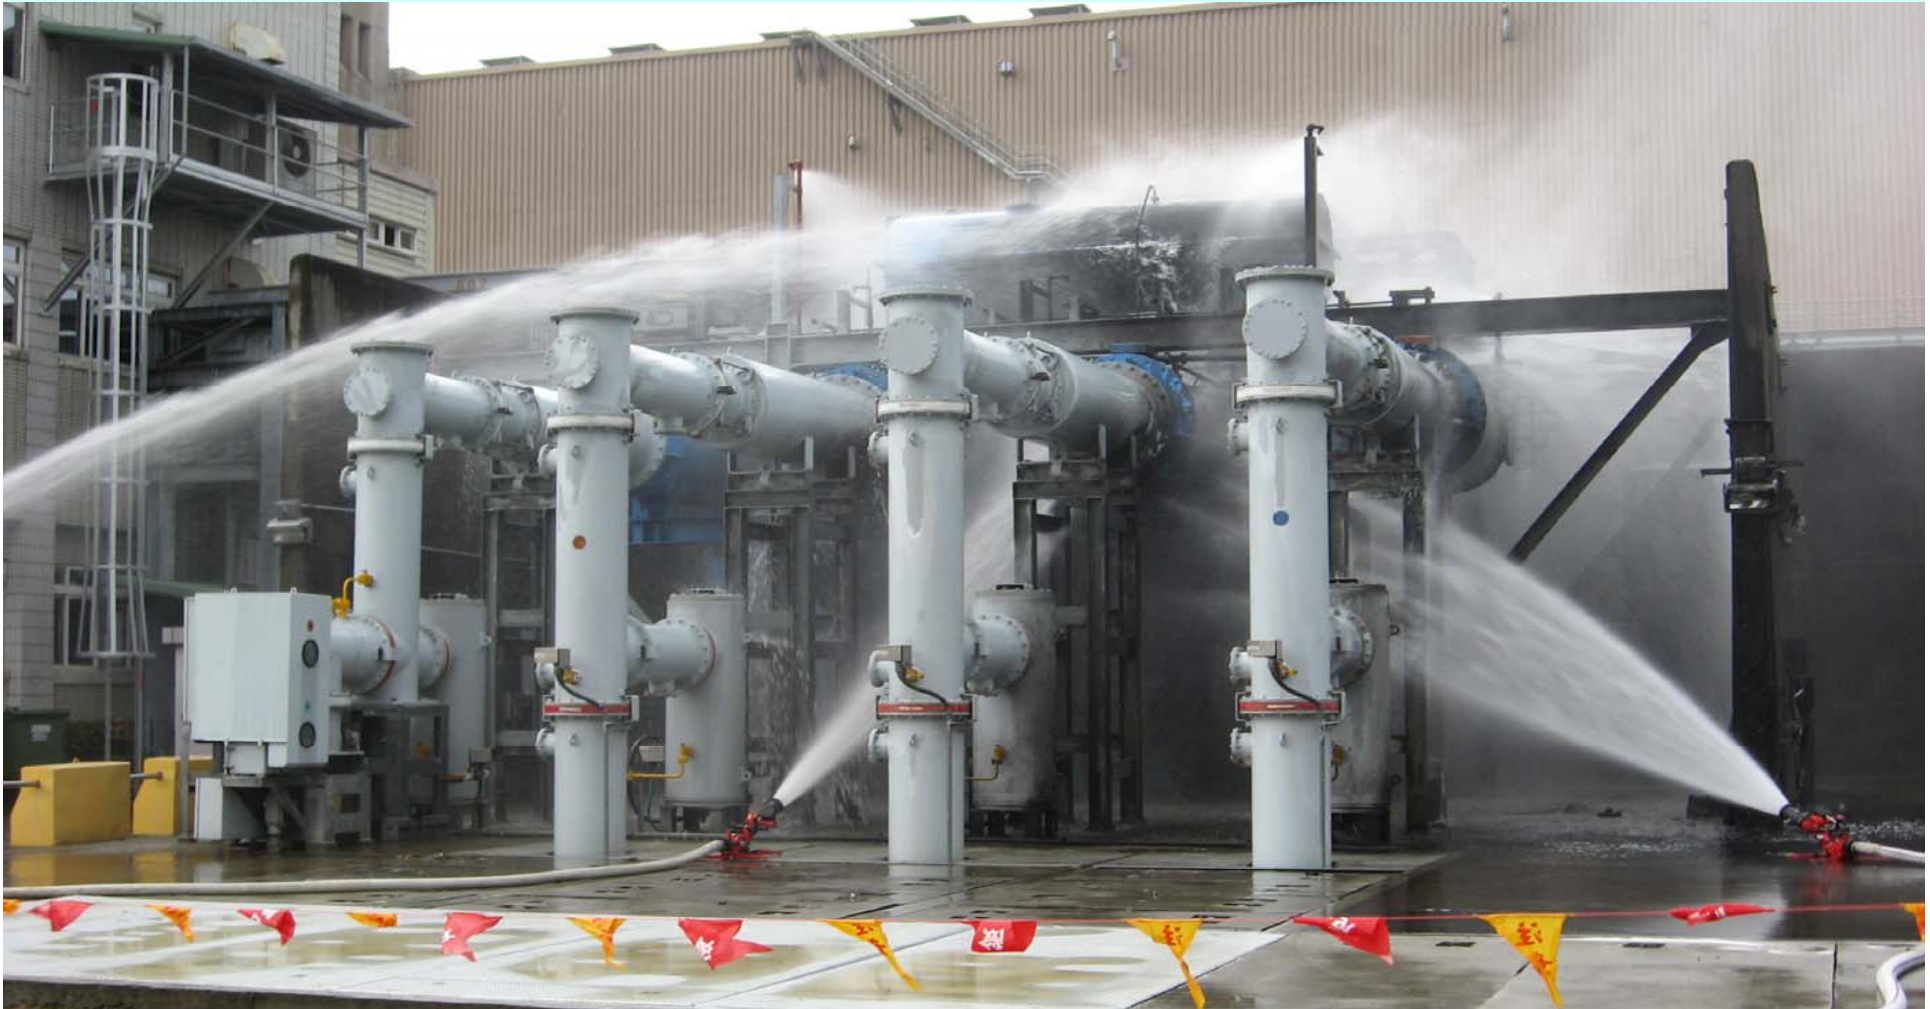
The 345kV startup transformer on fire

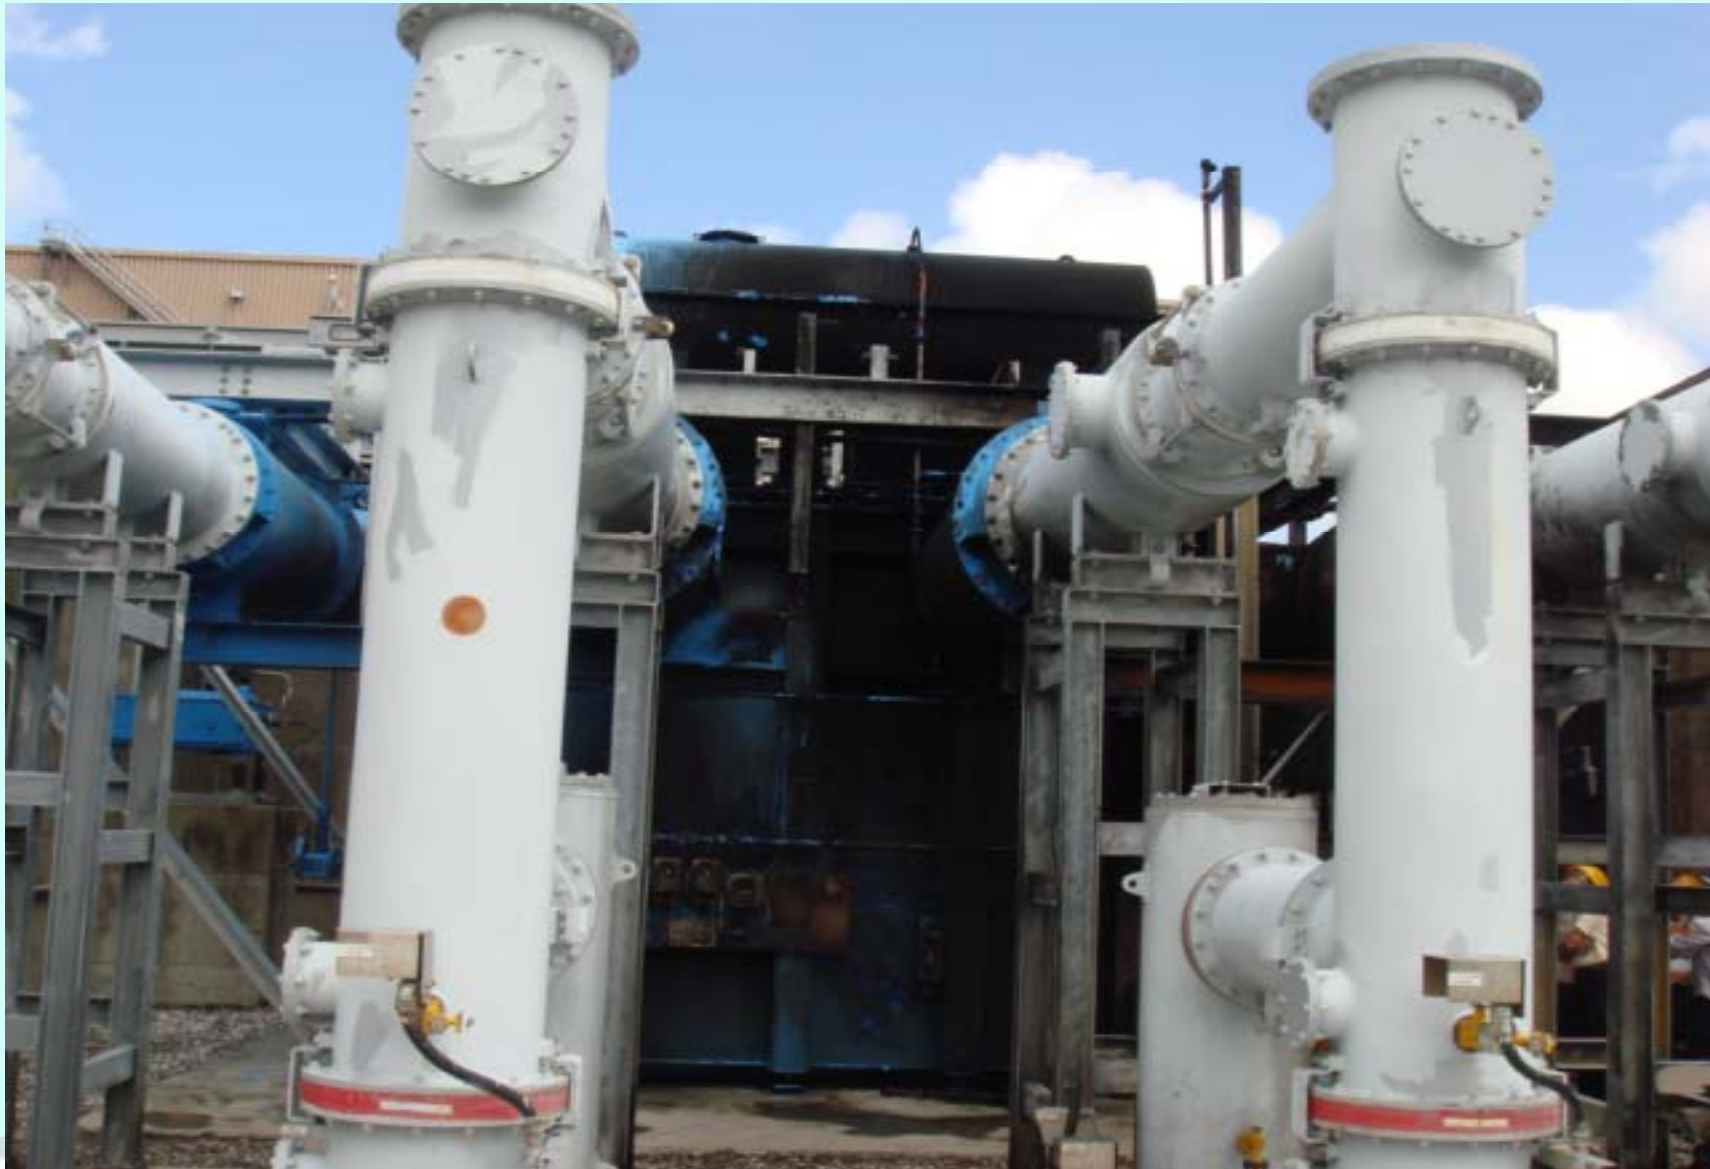
External of the damage 345kV startup transformer after the fire

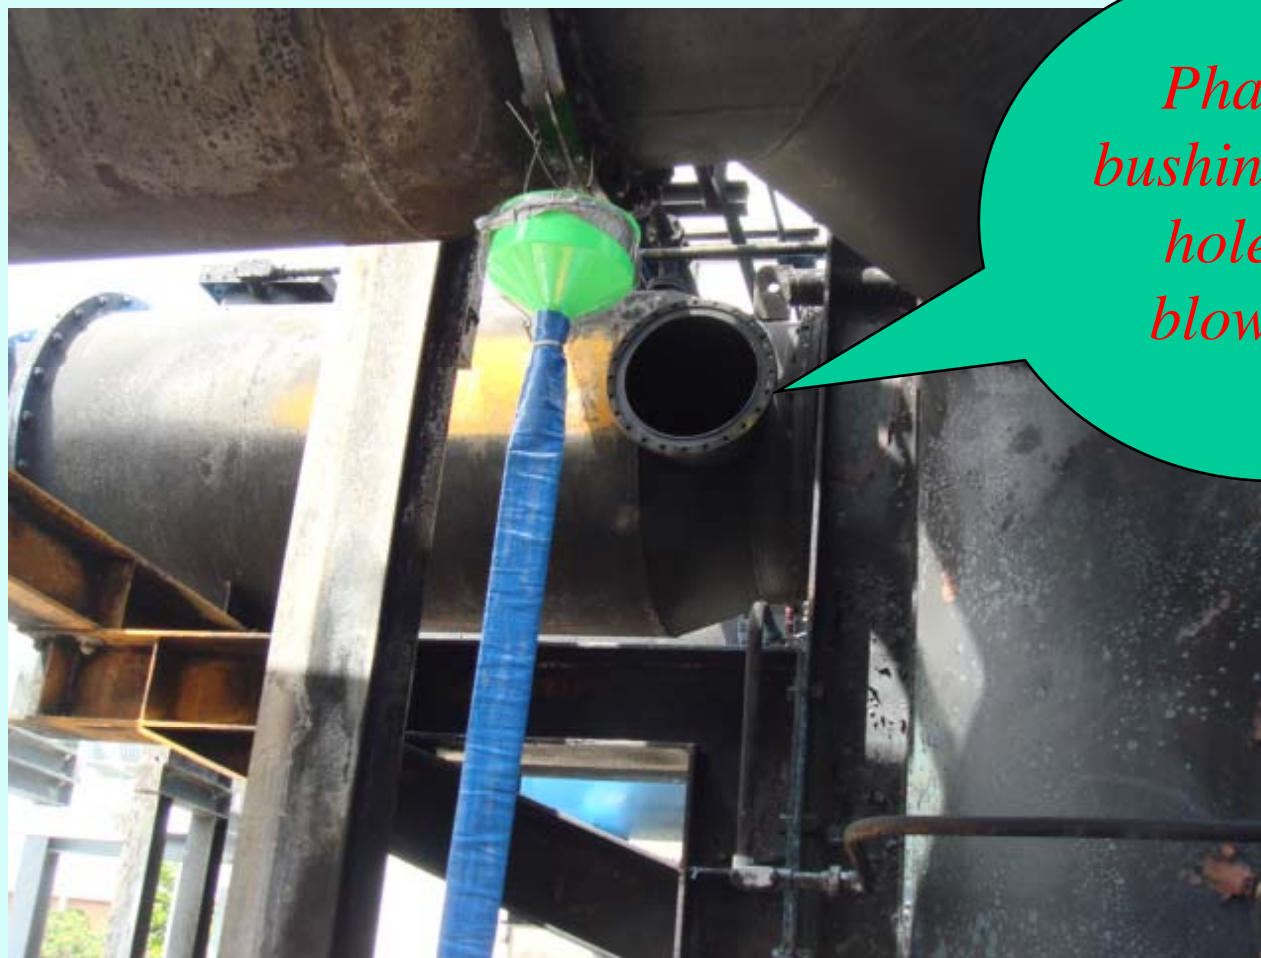
- After inspection on the startup transformer ,a small corroded perforation was found on its phase B bushing.*
- Water intruded into the bushing body via the small corroded perforation caused the bushing faulted .*
- The bushing fault was initiated by internal corona phenomenon.*
- Sudden instantaneous high oil pressure actuated pressure relief device and blew out the bushing hand hole ,High temperature oil gas got ignited upon its contact with oxygen in the air.*

Phase B bushing hand-hole was blown out

*Phase B
bushing hand-
hole was
blown out*

- 1. Inspecting all the HV bushings of similar design to check if rusty corrossions existed.*
- 2. Improving the drain path on the HV bushing expansion chamber structure to avoid accumulating rainwater .*
- 3. A revised procedure has been worked out and V&V tested for measuring the power factor of the HV bushing properly.*
- 4. Evaluating the feasibility to install Partial Discharge(PD) monitor or on-line power factor monitoring equipment.*

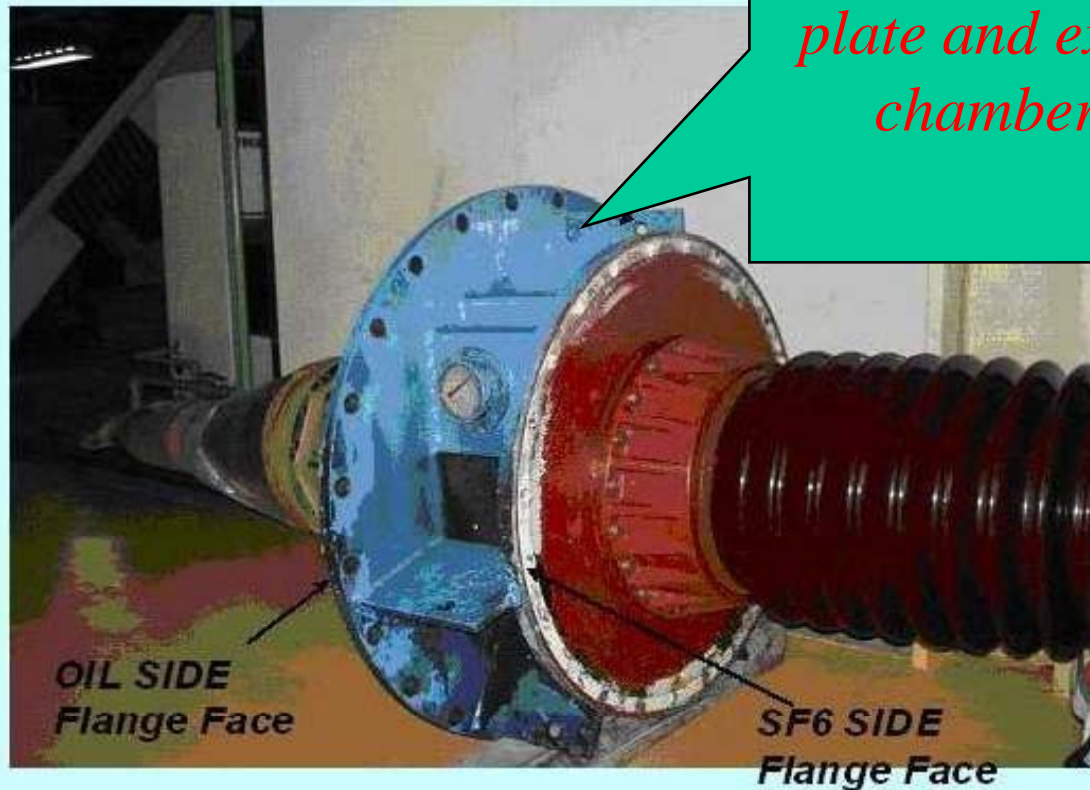
BUSHING

*Corroded perforation
close to the welding
joint of lifting lug
plate and expansion
chamber body*

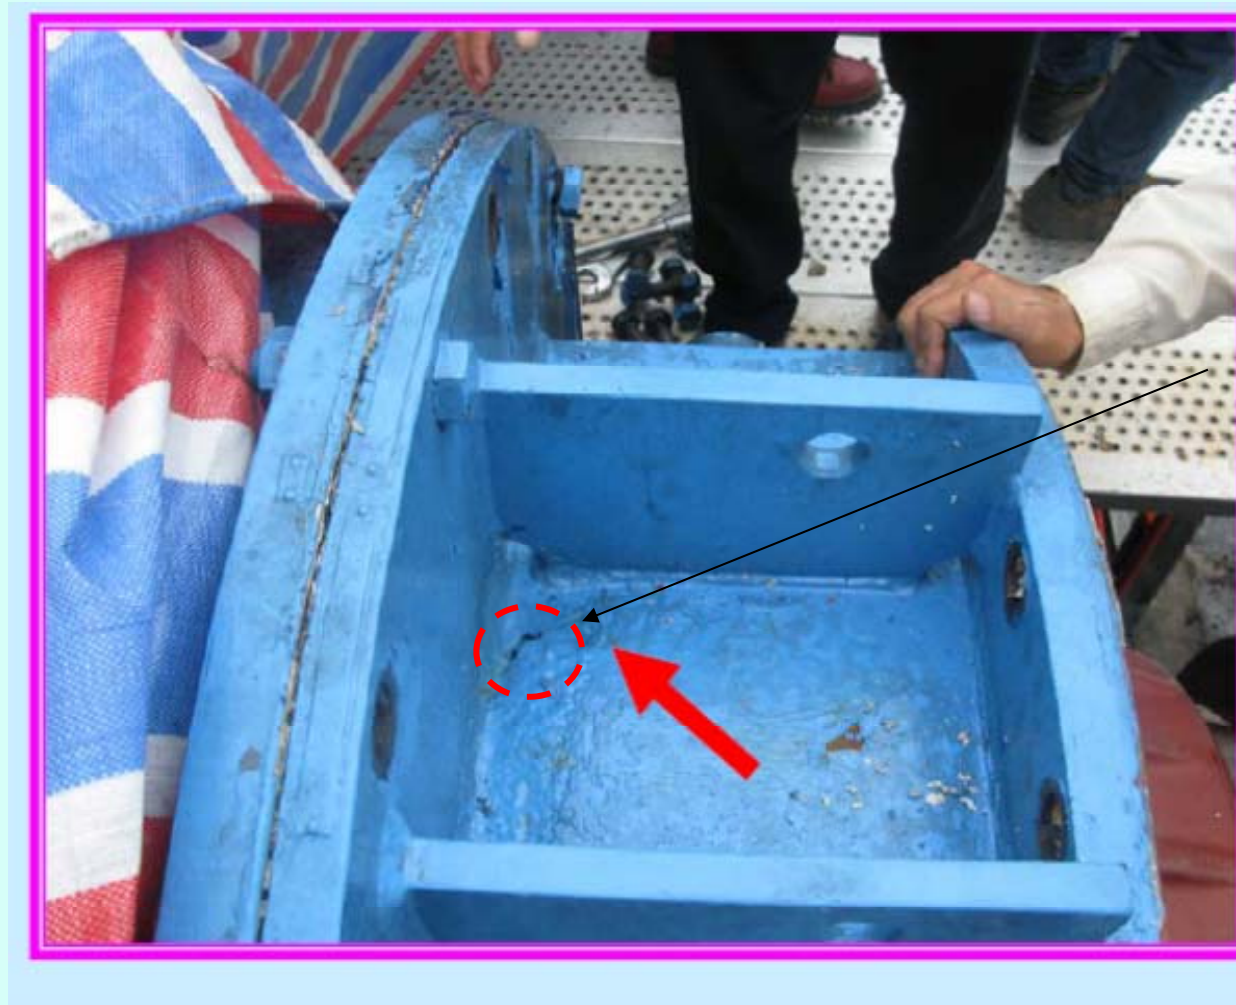
Location of corroded perforation

*corroded
perforation
location*

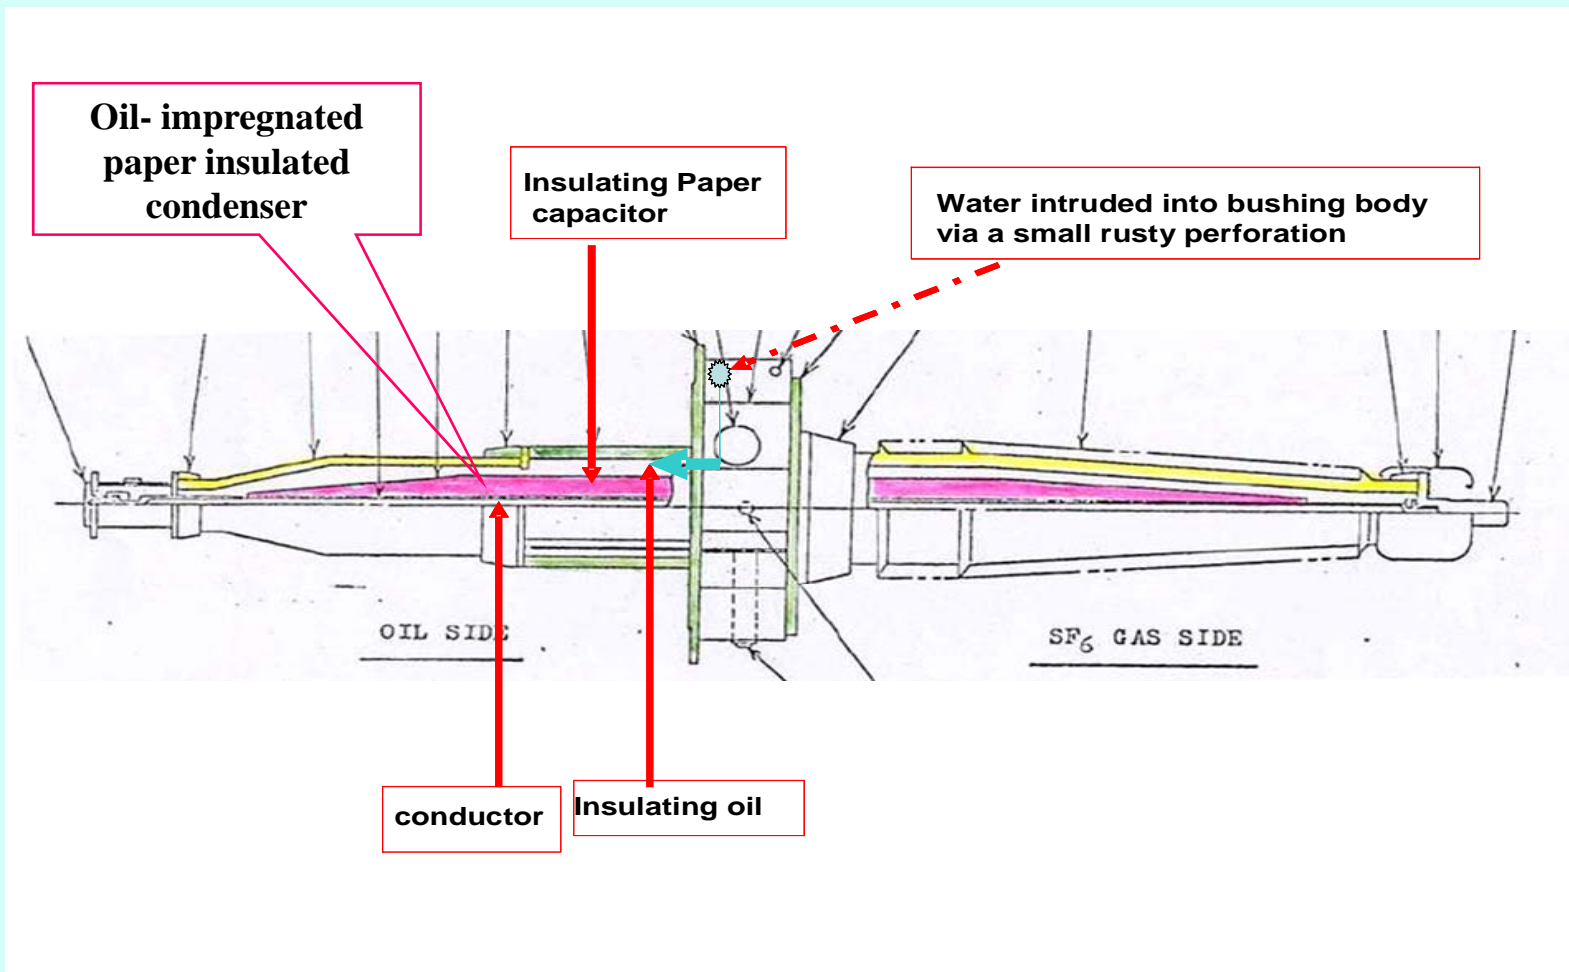
Flashover Spot (Bushing oil)

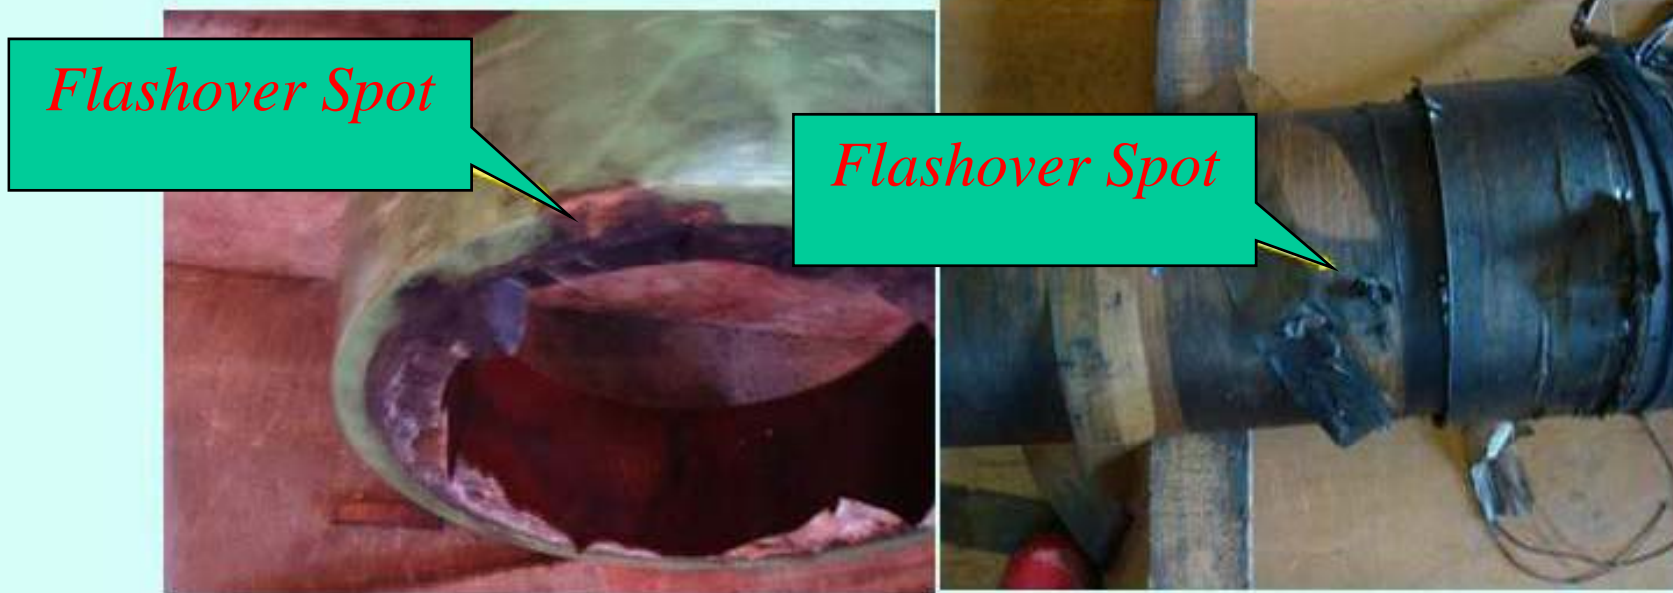
**Flashover spot on
capacitor paper layers**

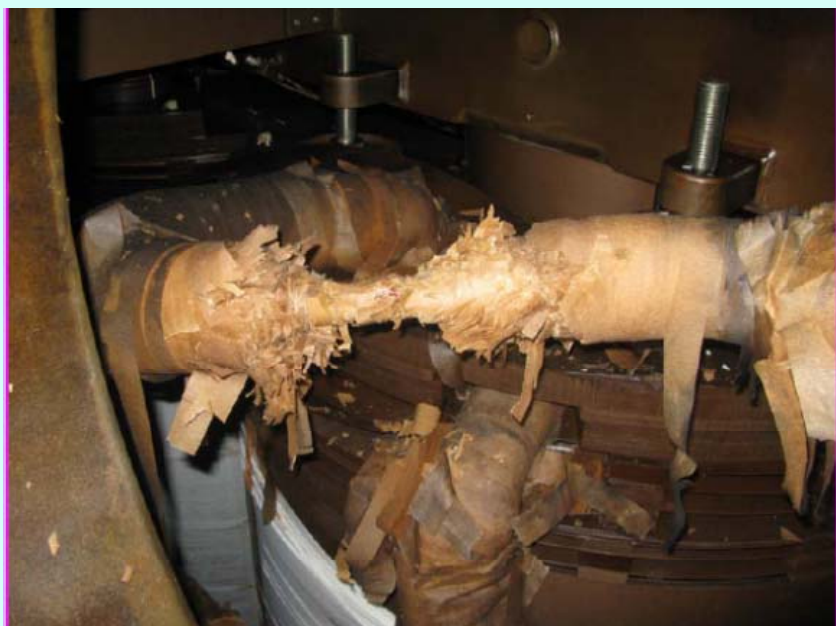
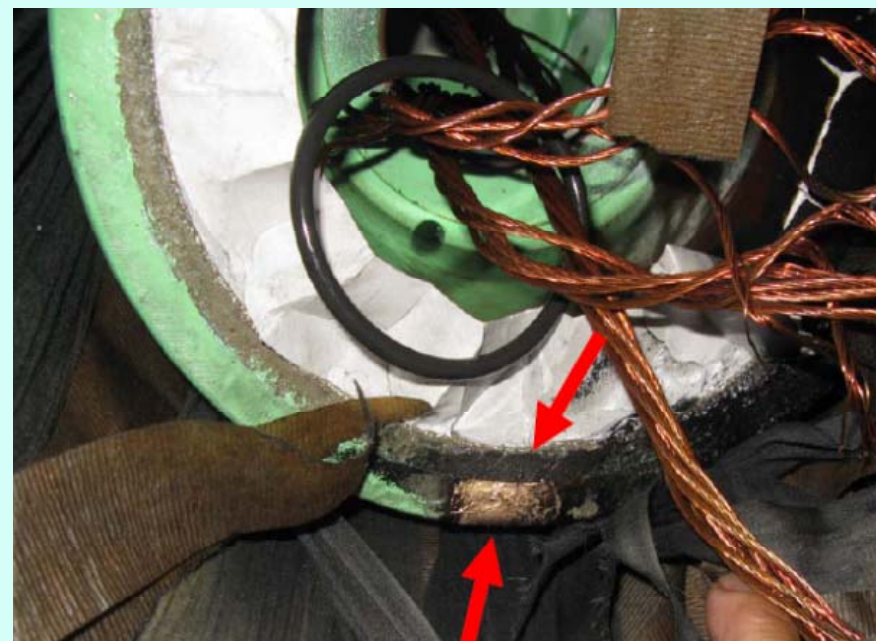
flashover spot (phase B bushing connection)

Flashover point
