The Effect of Maanshan NPS Due to the Earthquake Occurred on December 26, 2006

M. T. Hsu Deputy Director

Department of Nuclear Regulation Atomic Energy Council

The Fifth USNRC-TAEC Bilateral Technical Meeting Washington D.C. June 21-22, 2007

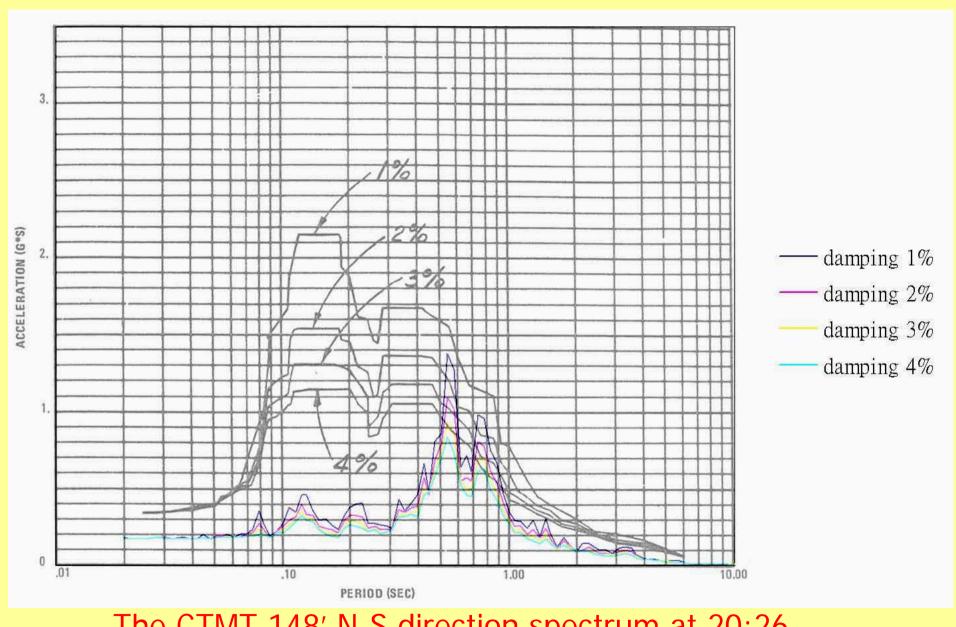
- Compares the ground acceleration spectrum measuring from each floor of MNPS with the OBE design spectrum, there is only one data (0.7 Hz at 20:34) exceed the OBE design spectrum (but not exceed 10%). All the other datas are under OBE design spectrum envelope.
- According to ANS 2.10 criteria, we concluded that OBE has not exceeded during earthquakes occurred on December 26, 2006.

The CTMT 148' N-S direction spectrum at 20:26 compare with OBE design basis spectrum

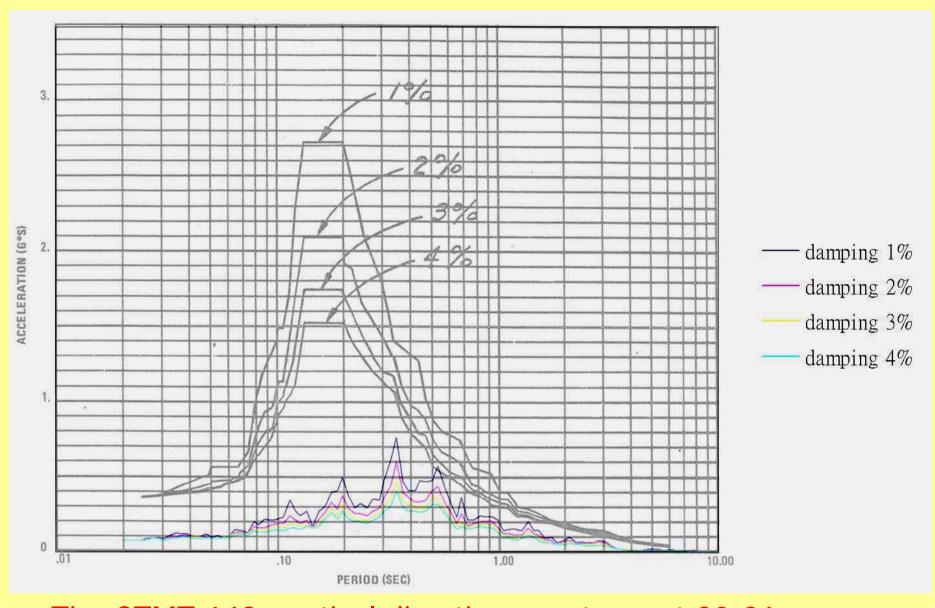
The CTMT 148' vertical direction spectrum at 20:26 compare with OBE design basis spectrum

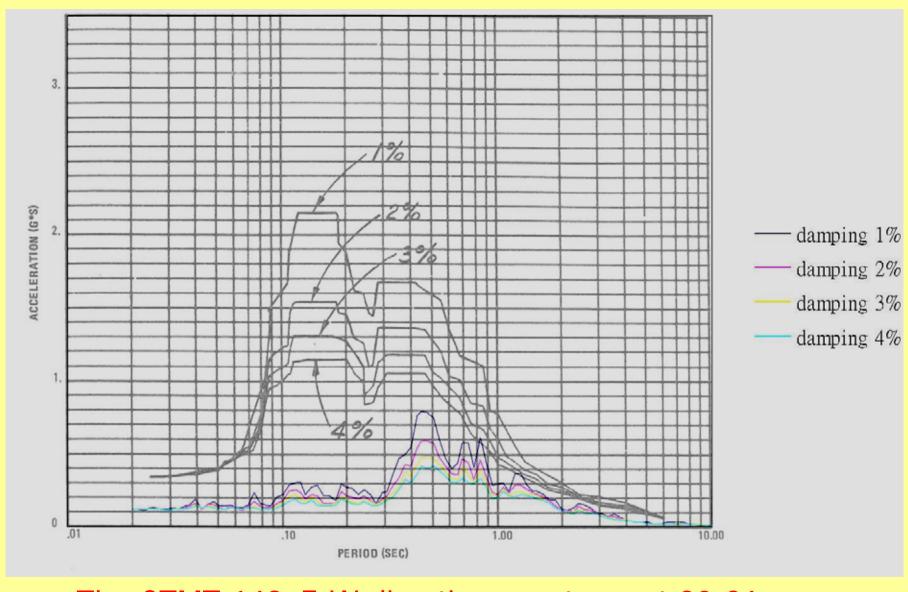
The CTMT 148' E-W direction spectrum at 20:26 compare with OBE design basis spectrum

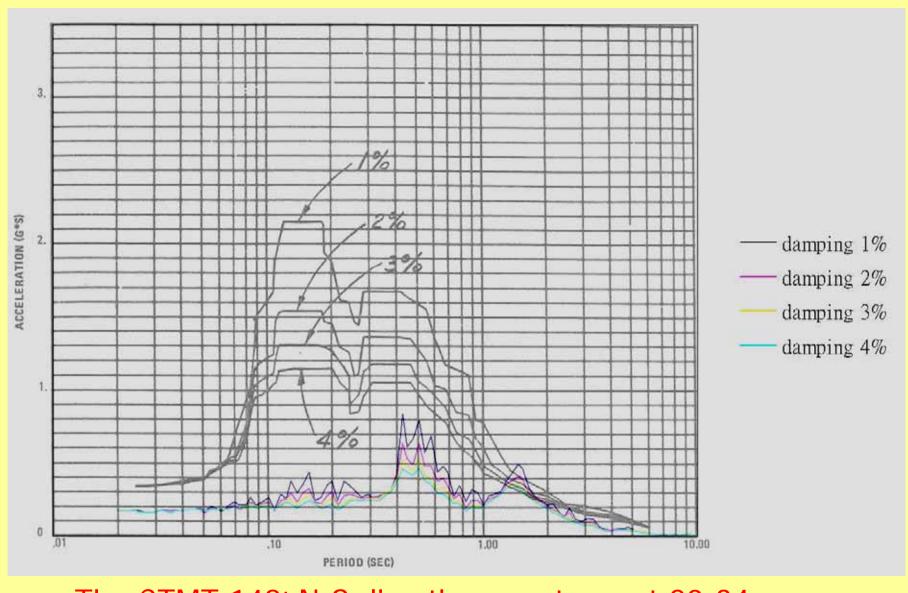
The CTMT 148' N-S direction spectrum at 20:34 compare with OBE design basis spectrum

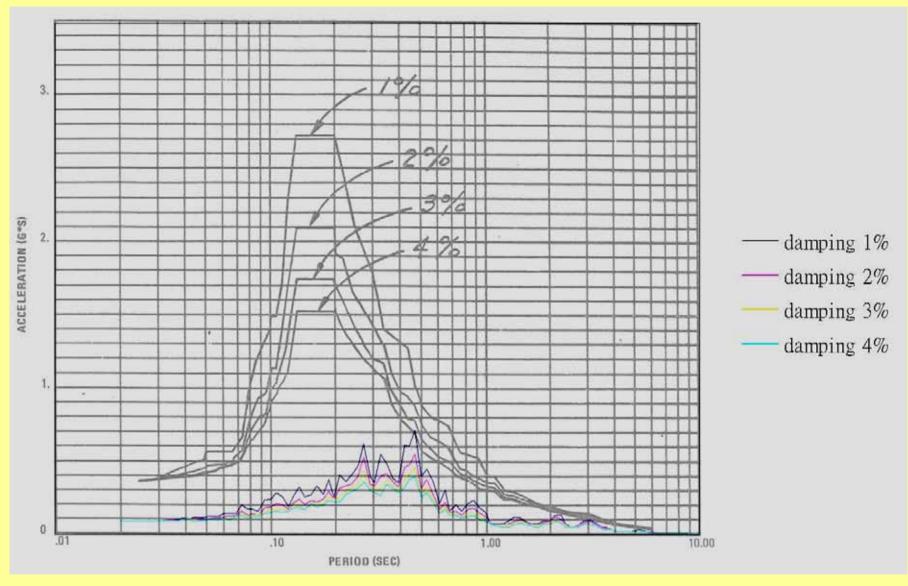
The CTMT 148' vertical direction spectrum at 20:34 compare with OBE design basis spectrum

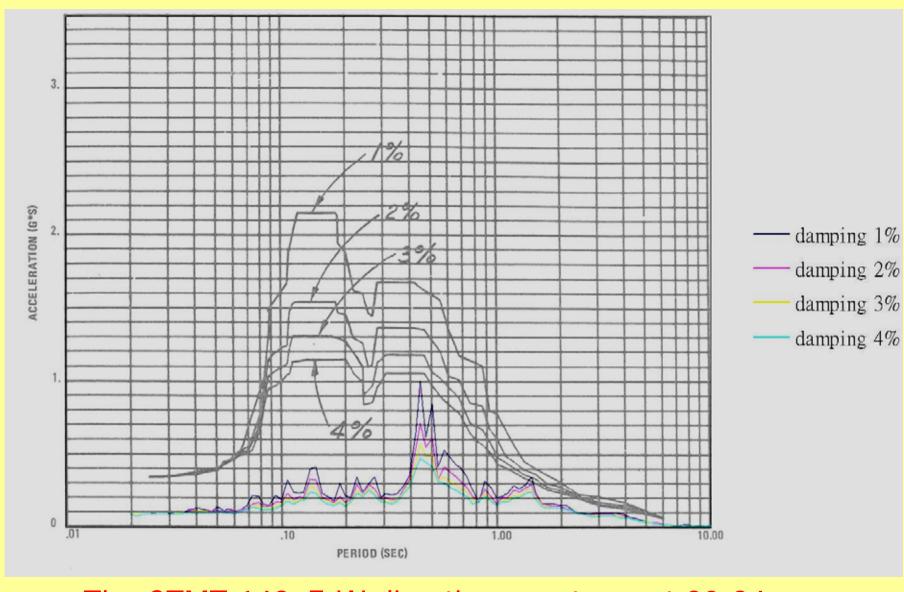
The CTMT 148' E-W direction spectrum at 20:34 compare with OBE design basis spectrum

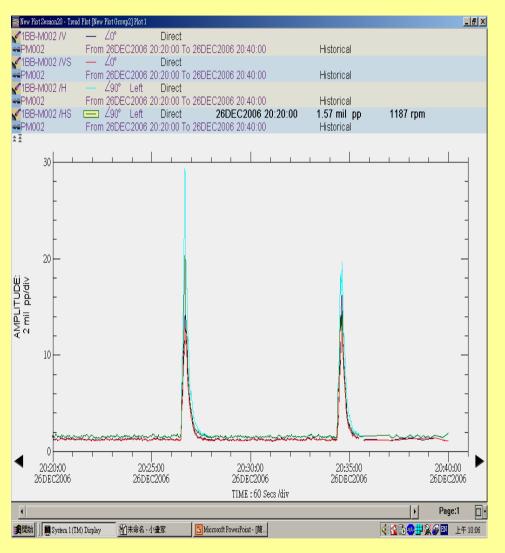
Unit 1 RCP B Motor

During the earthquake, operators in both units had experienced of violent shock, and also noticed the RCP and main turbine high vibration alarms appeared. The unit #2 operators trip Rx manually. However, when unit #1 operators decided to took the same action, the earthquake had been slowed down and the alarms of high vibration could be reset, so they terminated action and the unit #1 keep in operating.

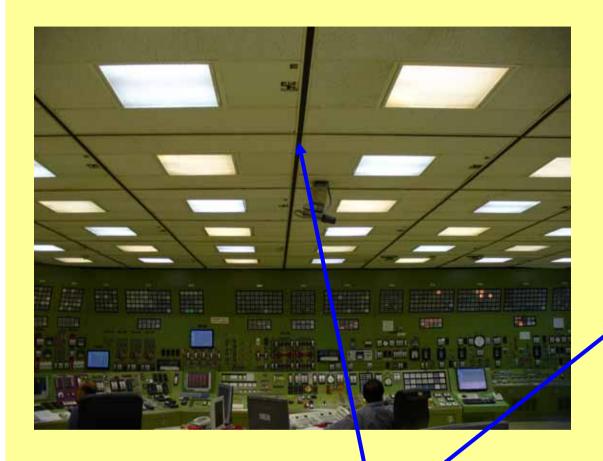
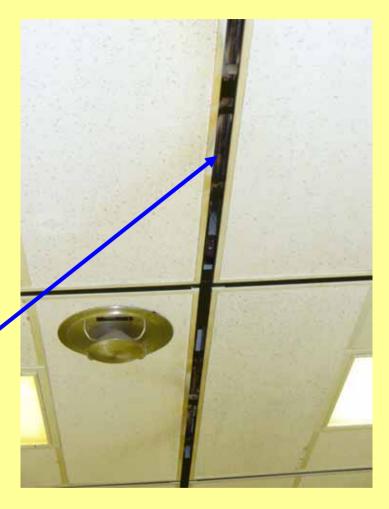
Ventilation outlet

- After the earthquake, plant staffs followed the procedure 582.1 "checklist of significant equipment after shutdown due to strong earthquake" to examine the integrity of SSCs of both units (except inaccessible areas of unit #1).
- The result showed that there is no major damage on all SSCs of two units .Minor damages are as following items:
 - 1. some RCP C/T cable ducts connection are loose(unit #2)
 - 2. some water and oil spilt from Spent fuel pool and EDG fuel oil storage tank.
- Lots of dust accumulated inside ventilation pipe floated down from top ceiling of main control room during & after the earthquake.

- Re-review & standardize the procedures dealing with earthquake for all operating NPPs.
- Routine inspection records and digital images of major SSCs are essential information for checking activities after earthquake. it is important to gather & update those information during routine inspection tours by plant staffs periodically.
- Organize a plan to clean the dust accumulated inside ventilation pipe of main control room periodically.
- Study the possibility to incoroperate a seismic shaking table experience course into the operator on-job training.
- Study the ways (radiation level, humidity, temperature, etc.) to monitor the status of inaccessible areas after earthquakes.
