RPV Support Skirt Anchor Bolt Fracture Event at Kuosheng Unit 1

**Taiwan Power
Company**

2012/6/20

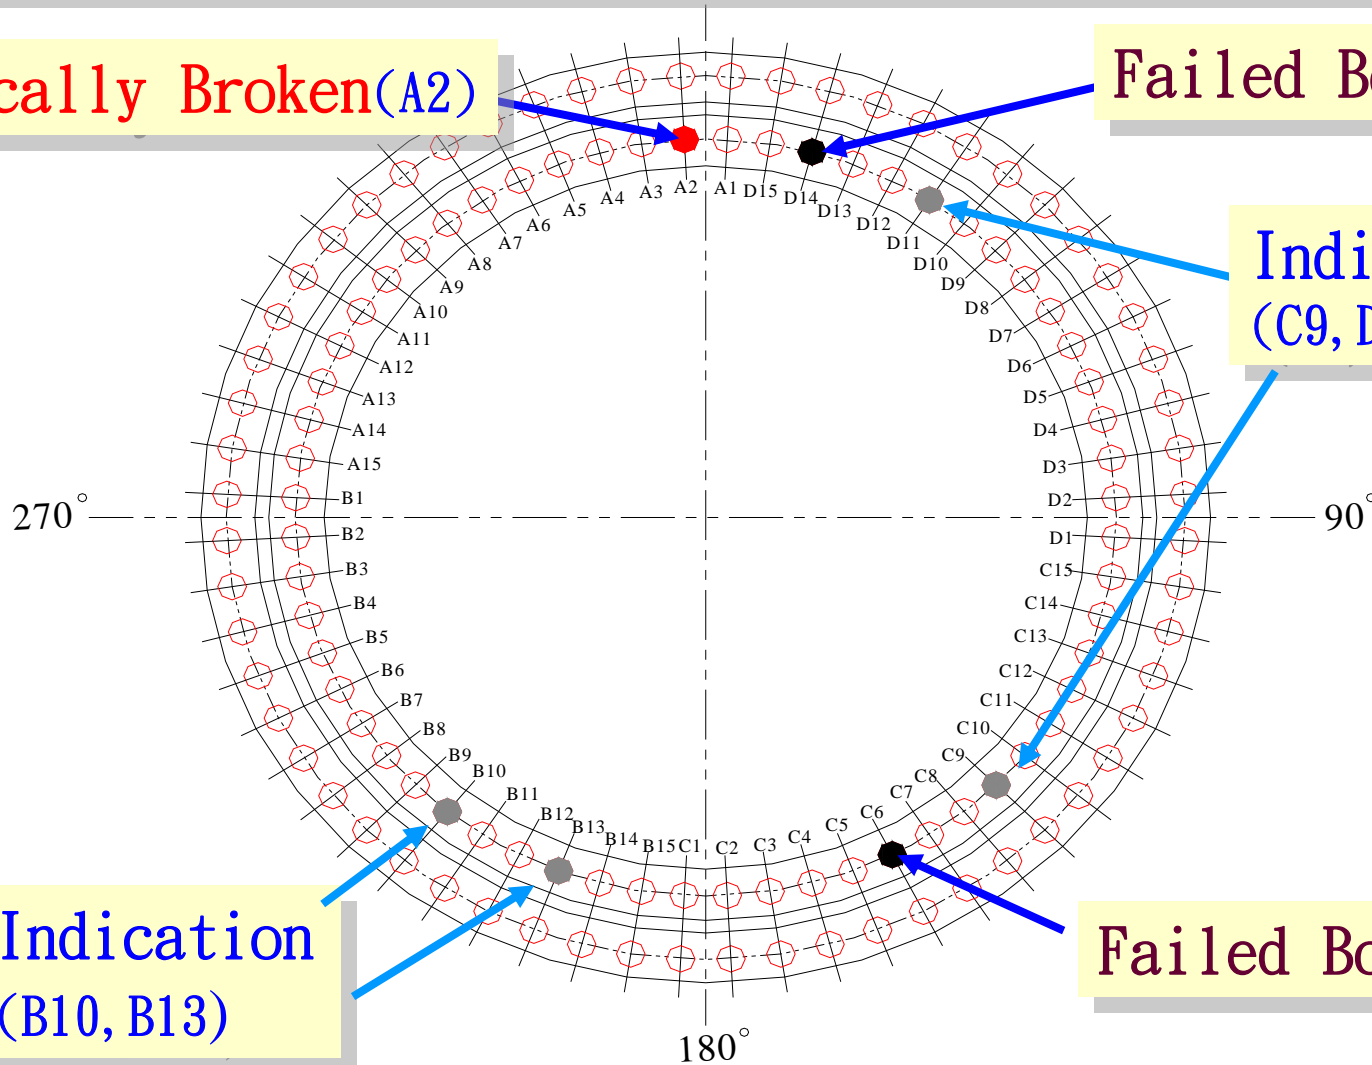
Physically Broken(A2)

Failed Bolt(D14)

Indication
(C9, D11)

Indication
(B10, B13)

Failed Bolt(C6)

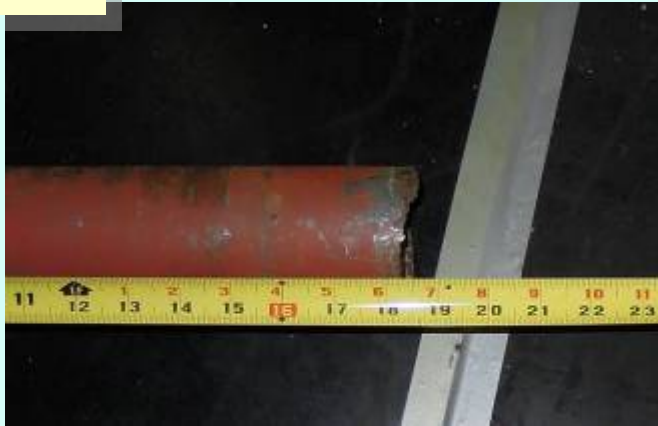
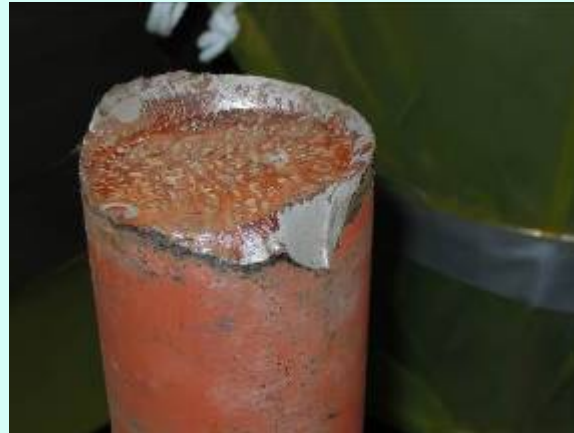
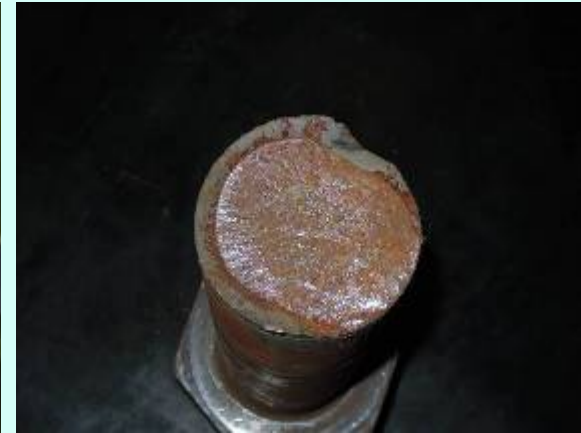
- **During Kuosheng Unit 1 EOC-22 refueling outage in 2012, RPV inner skirt bolt A2 was found to be physically broken.**
- **Following UT on the remaining RPV skirt bolts, additional two failures were found on inner skirt bolts C6 & D14, and indications were found on four inner skirt bolts B10, B13, C9, & D11.**
- **The UT results of the remaining 113 anchor bolts are all “Accept”.**

Broken Bolts

- Preparation of a JCO for 1 cycle of operation with 7 failed bolts was successful with no safety concerns or operational problems.
- For conservative considerations, TPC replaced all the 7 damaged bolts.

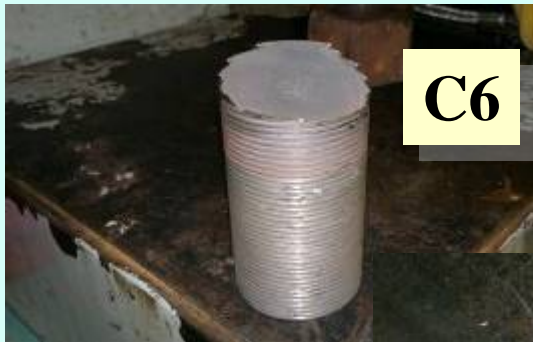
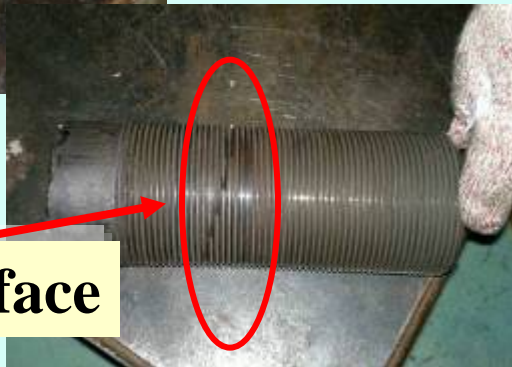
C6

fracture surface

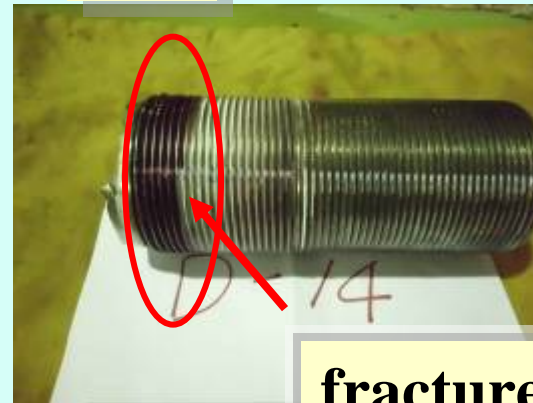
D14

fracture surface

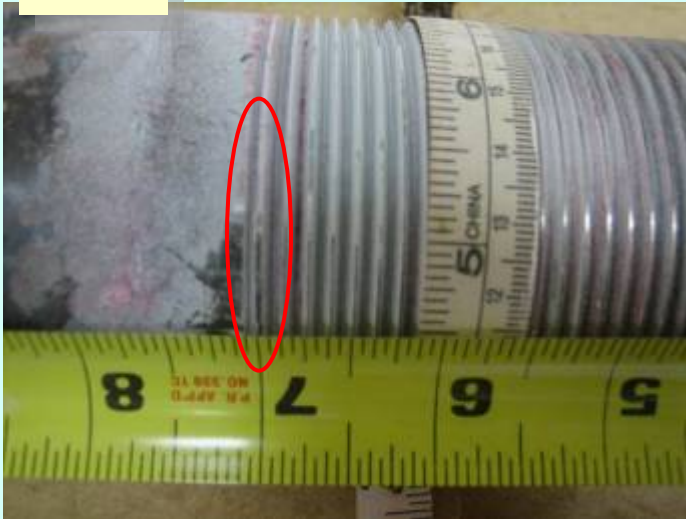
D11

Bolts with indication
