Recent Material Aging Degradation Related Issues

Department of Nuclear Regulation
Atomic Energy Council, Taiwan

The Fifth USNRC/TAEC Bilateral Technical Meeting
Washington D.C. June 21-22, 2007

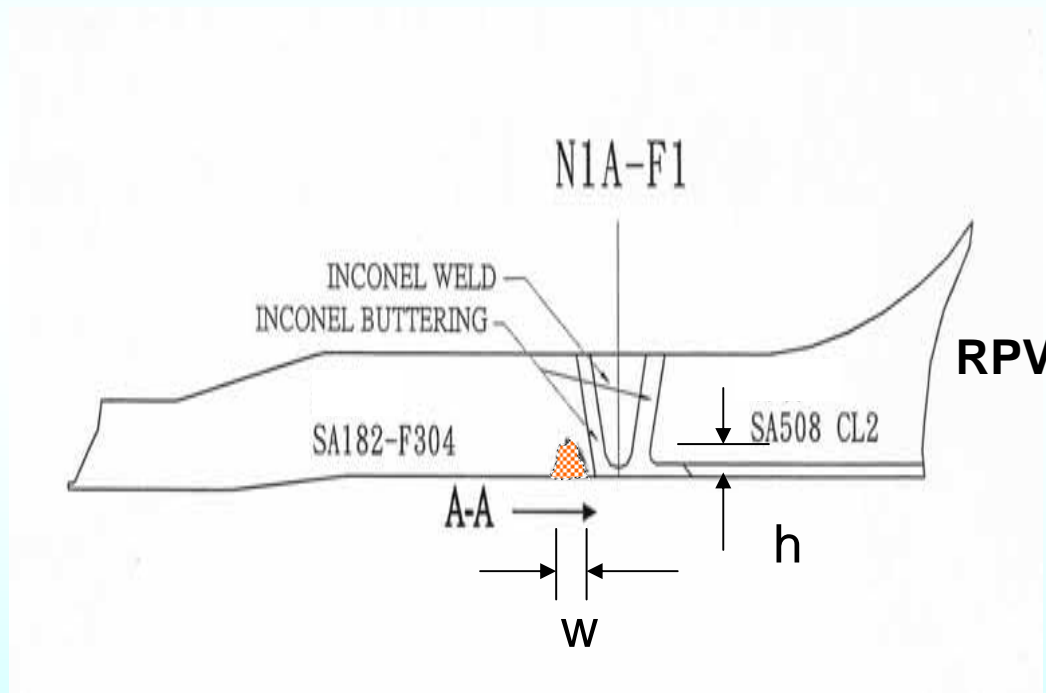
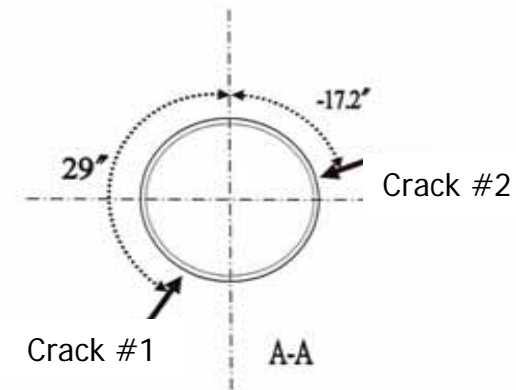
Finding during CS1 EOC-21 outage

Flaw No	w	h
1	0.82"	0.54"
2	0.4"	0.36"

Two axial cracks at the N1A-F1 dissimilar metal weld

- TPC repaired it by weld overlay reinforcement

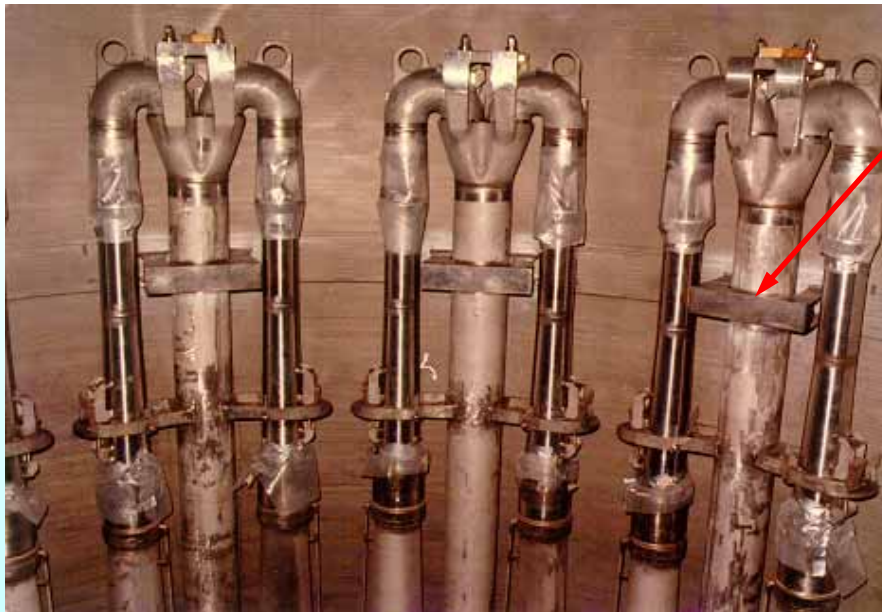
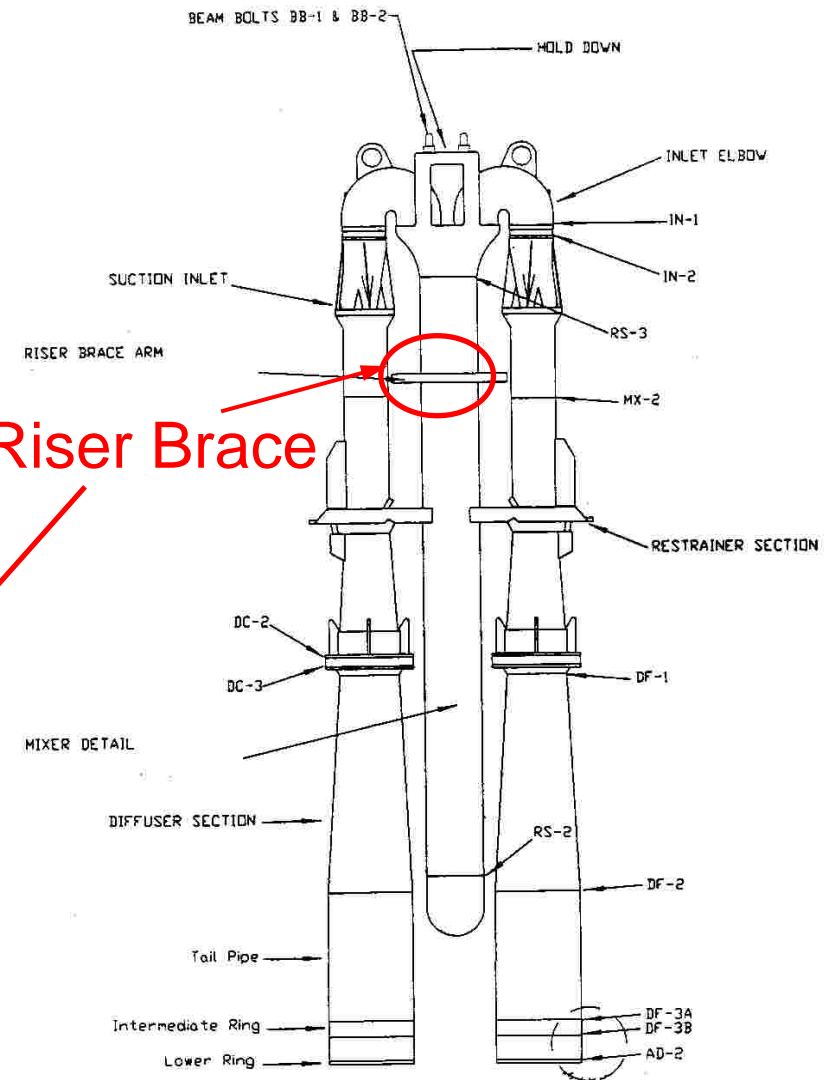
Riser Brace

- The RS-9 weld on the riser brace of jet pumps No.15/16 contained a 6.6 inches crack indication (21% around the circumference of this riser pipe)

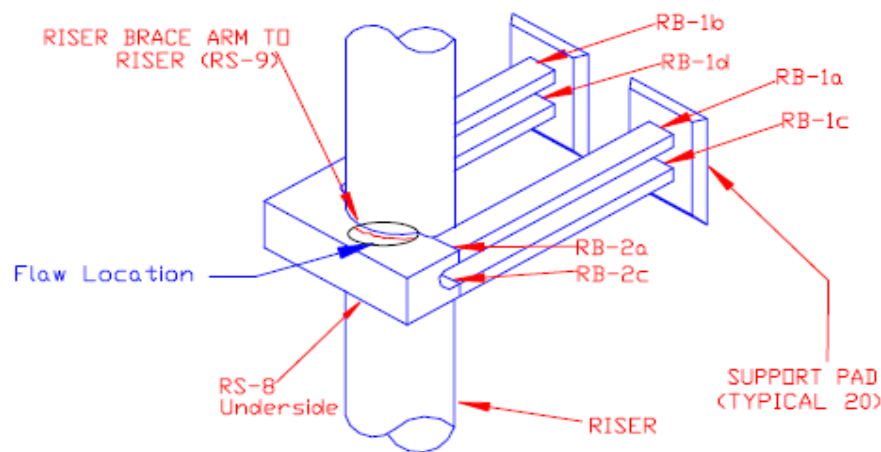
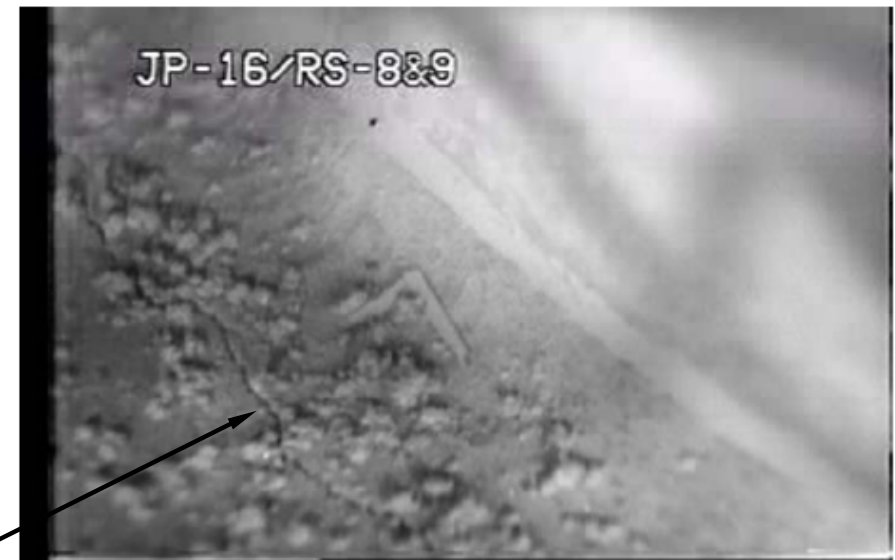
Jet Pump 16 (RS-9)

- The crack indication appeared to be caused by IGSCC.

Crack Indication

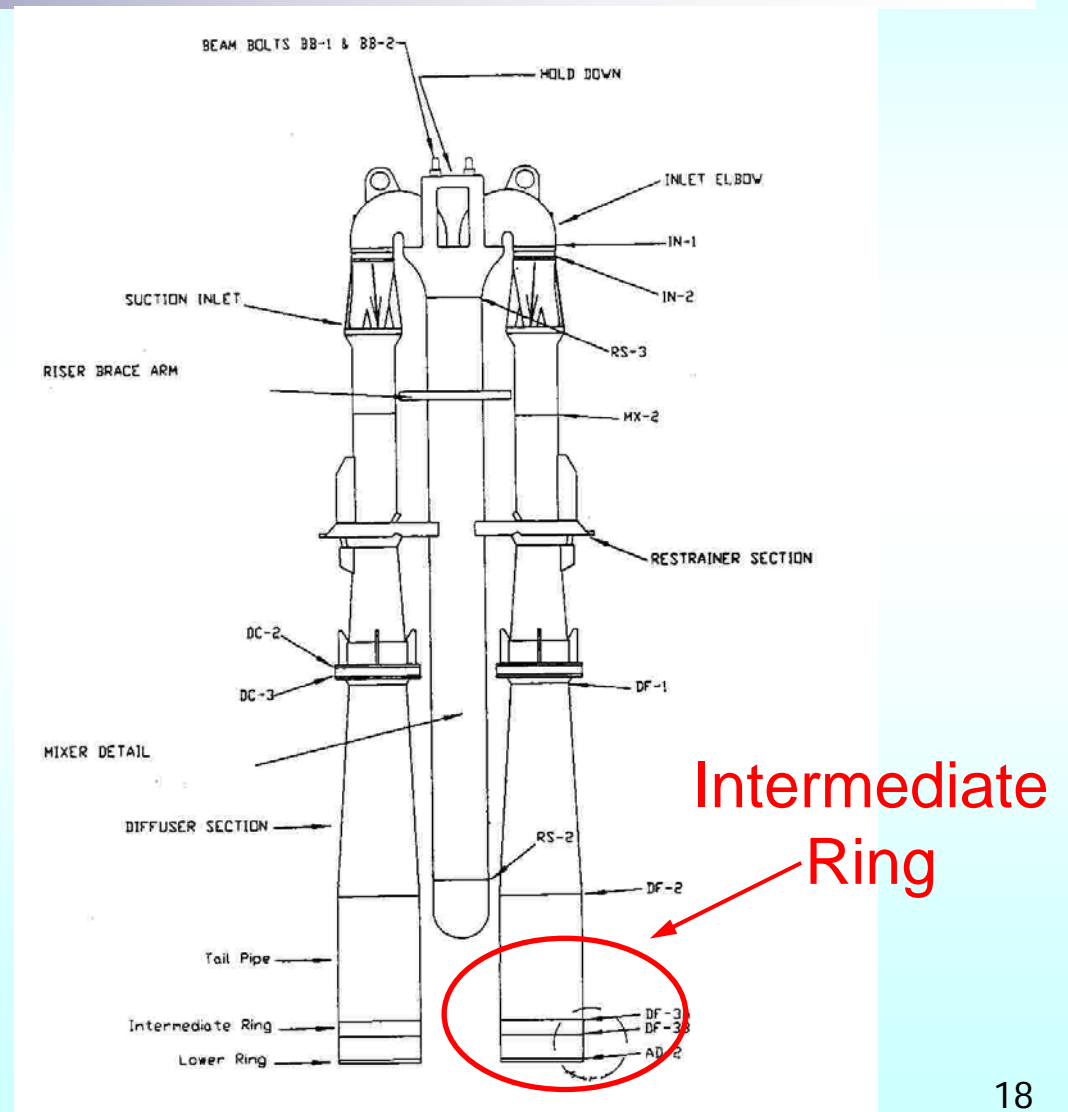
- The diffuser weld DF-3B on jet pump No.12 had a 12.06" crack indication. (26% around the circumference of this diffuser, not a through- wall crack)

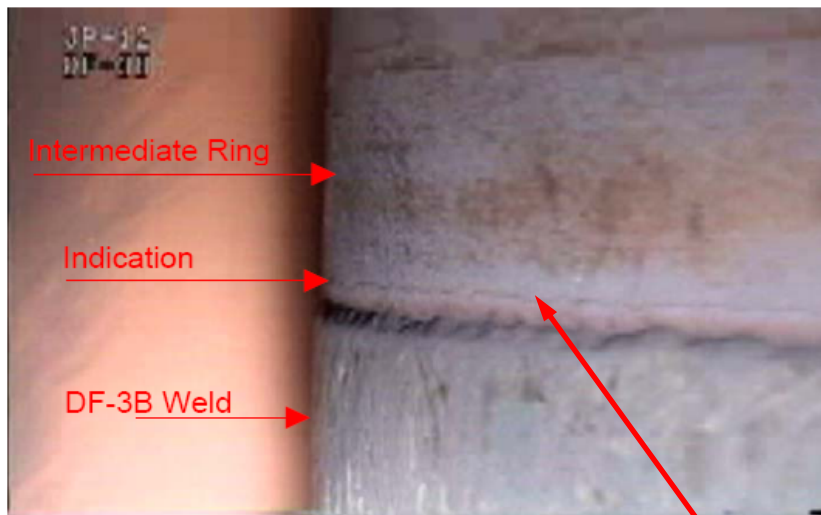
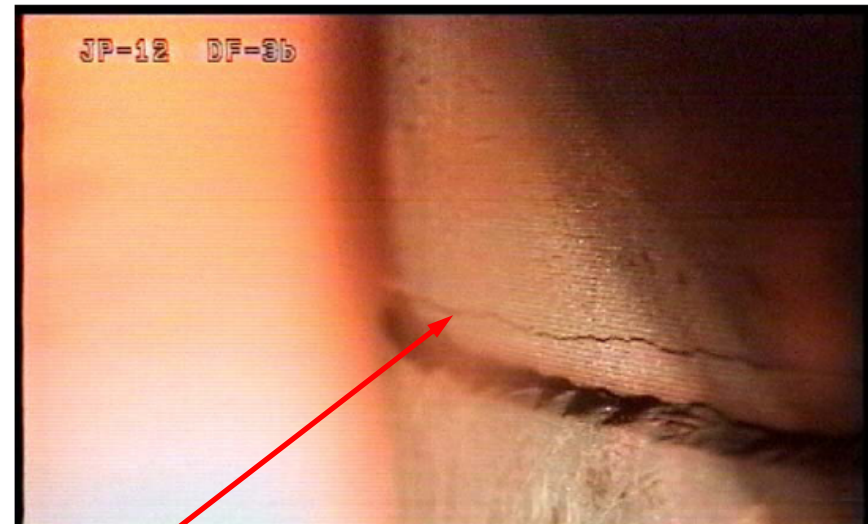
- The crack indication appeared to be caused by IGSCC.

DF-3B Crack

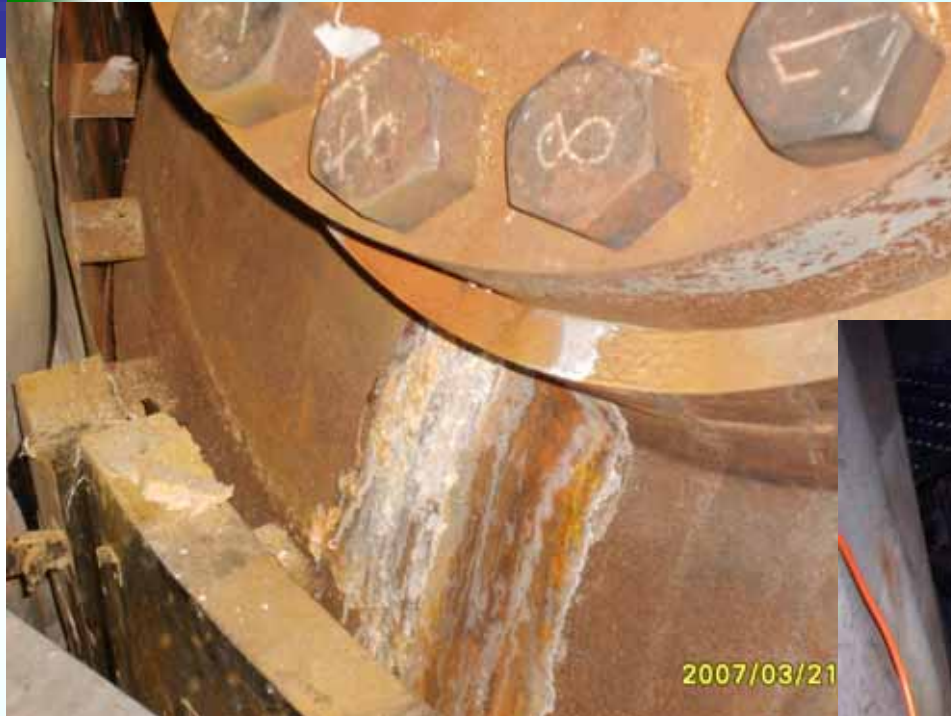
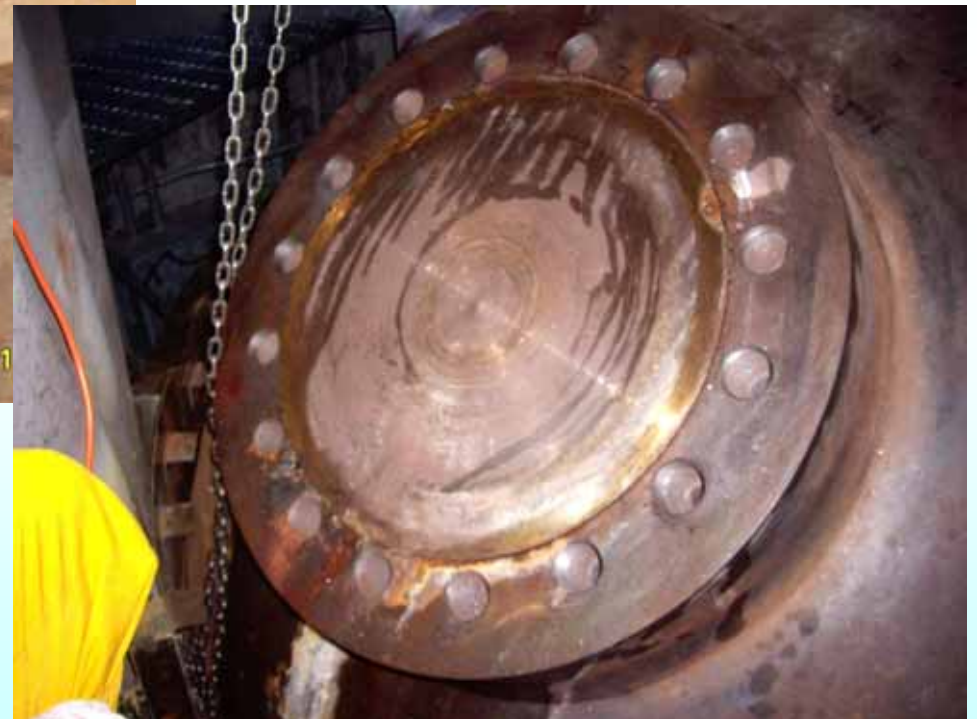
3/21/2007 after RCS
cooldown and PZR solid,
water leakage from man-
hole is clear.

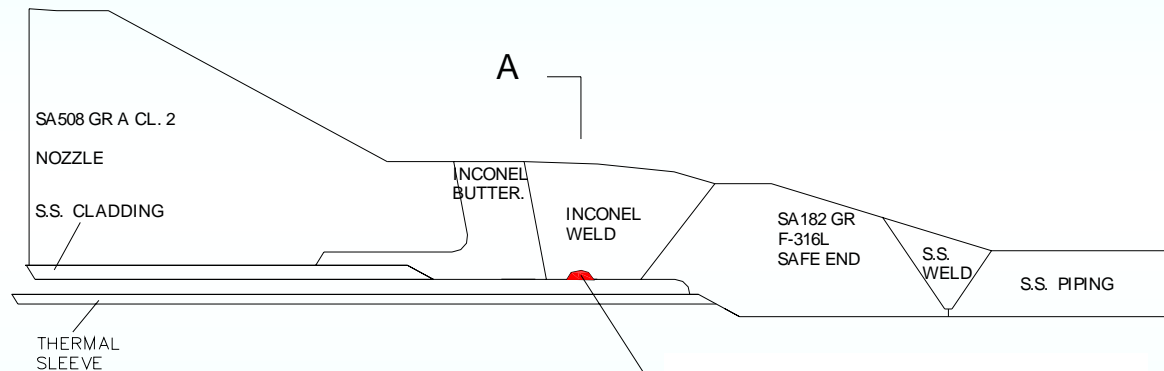
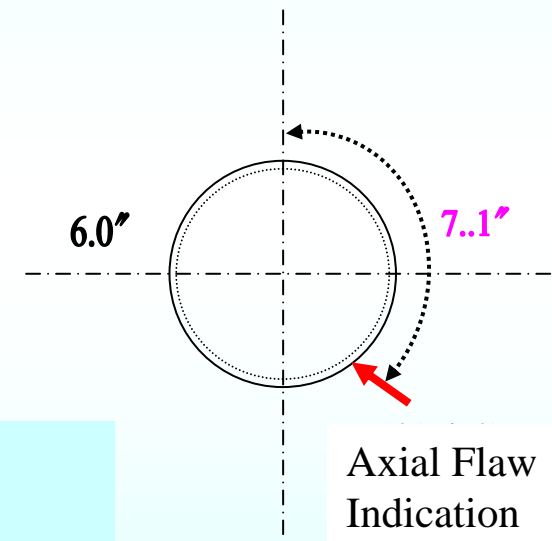
MAANSHAN Unit 2 PZR Spray Nozzle

Axial Flaw Indication

thickness:1.0"

length:0.25"

depth:0.1"

Meet ASME CODE SEC.XI TableIWB-3514-2
"ALLOWABLE PLANAR FLAWS"Criteria
