2008 AEC-NRC Bilateral Technical Meeting

AEC's Regulatory Action after Earthquake on Japanese Kashiwazaki-Kariwa NPP

May 13, 2008
Wen-Chun Teng
Section Chief
Department of Nuclear Regulation
AEC

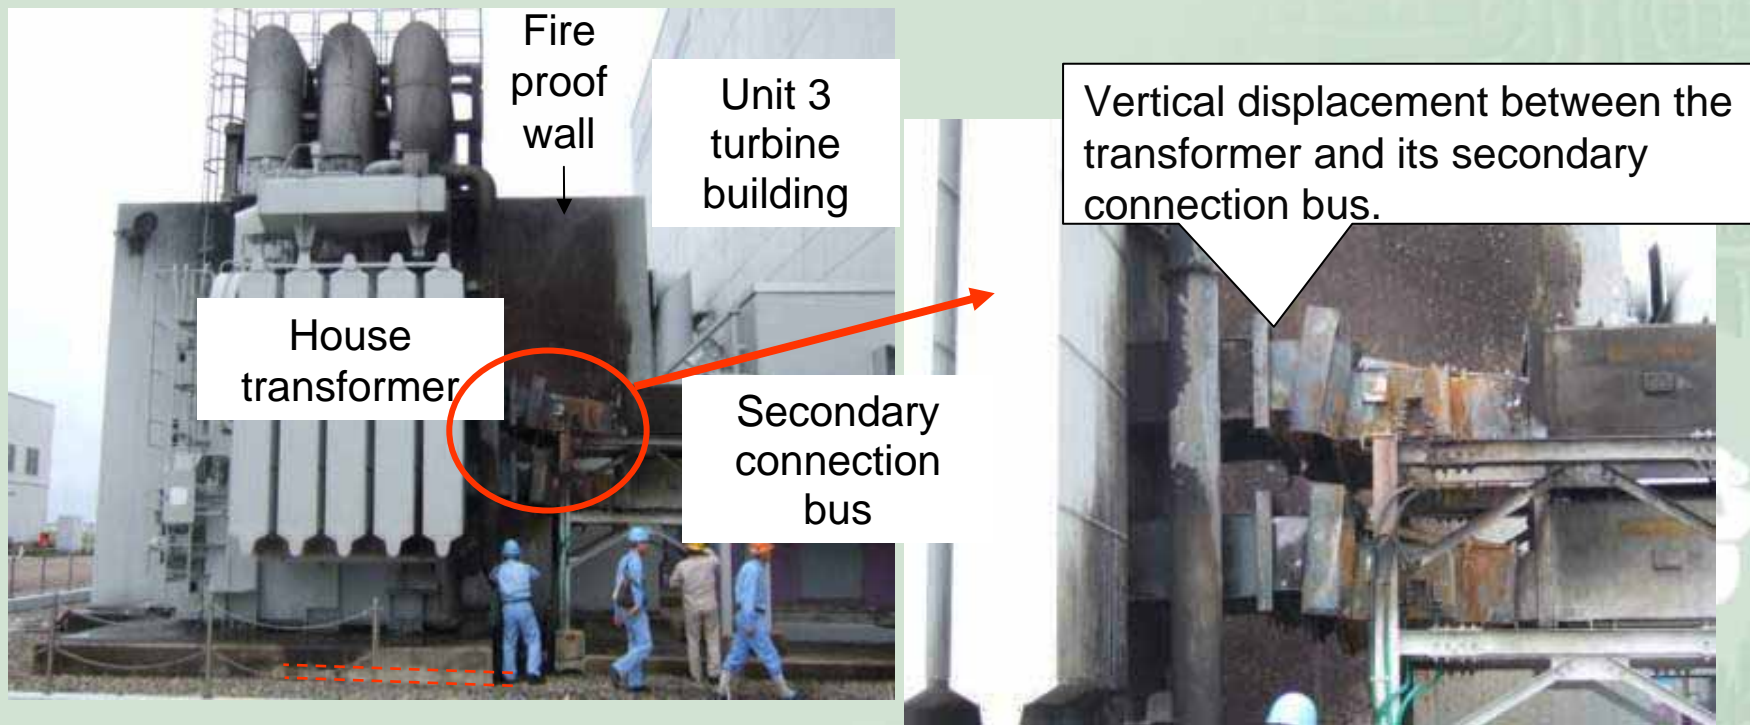
Quake-induced Event #1: Unit 3 House Transformer Fire

- The house transformer was on sound base but the base of secondary connection bus was not and vertically sank, which caused a short circuit.
- Sparks from the short circuit ignited insulating oil that leaked from the transformer.
- The fireproof wall prevented the fire from spreading to other important facilities.
- This transformer is for house power demand while generator is running, which means it does not have any safety functions after the reactor trip.

Improvements for resolving the issue (Transformer fire)

- Reinforcement of the in-house fire fighting corps.
 - Forming a fire-fighting corps on round-the-clock standby.
 - Deployment of chemical fire engine and fire engine with a water tank.
 - Setting up a hotline with the Main Control Room.

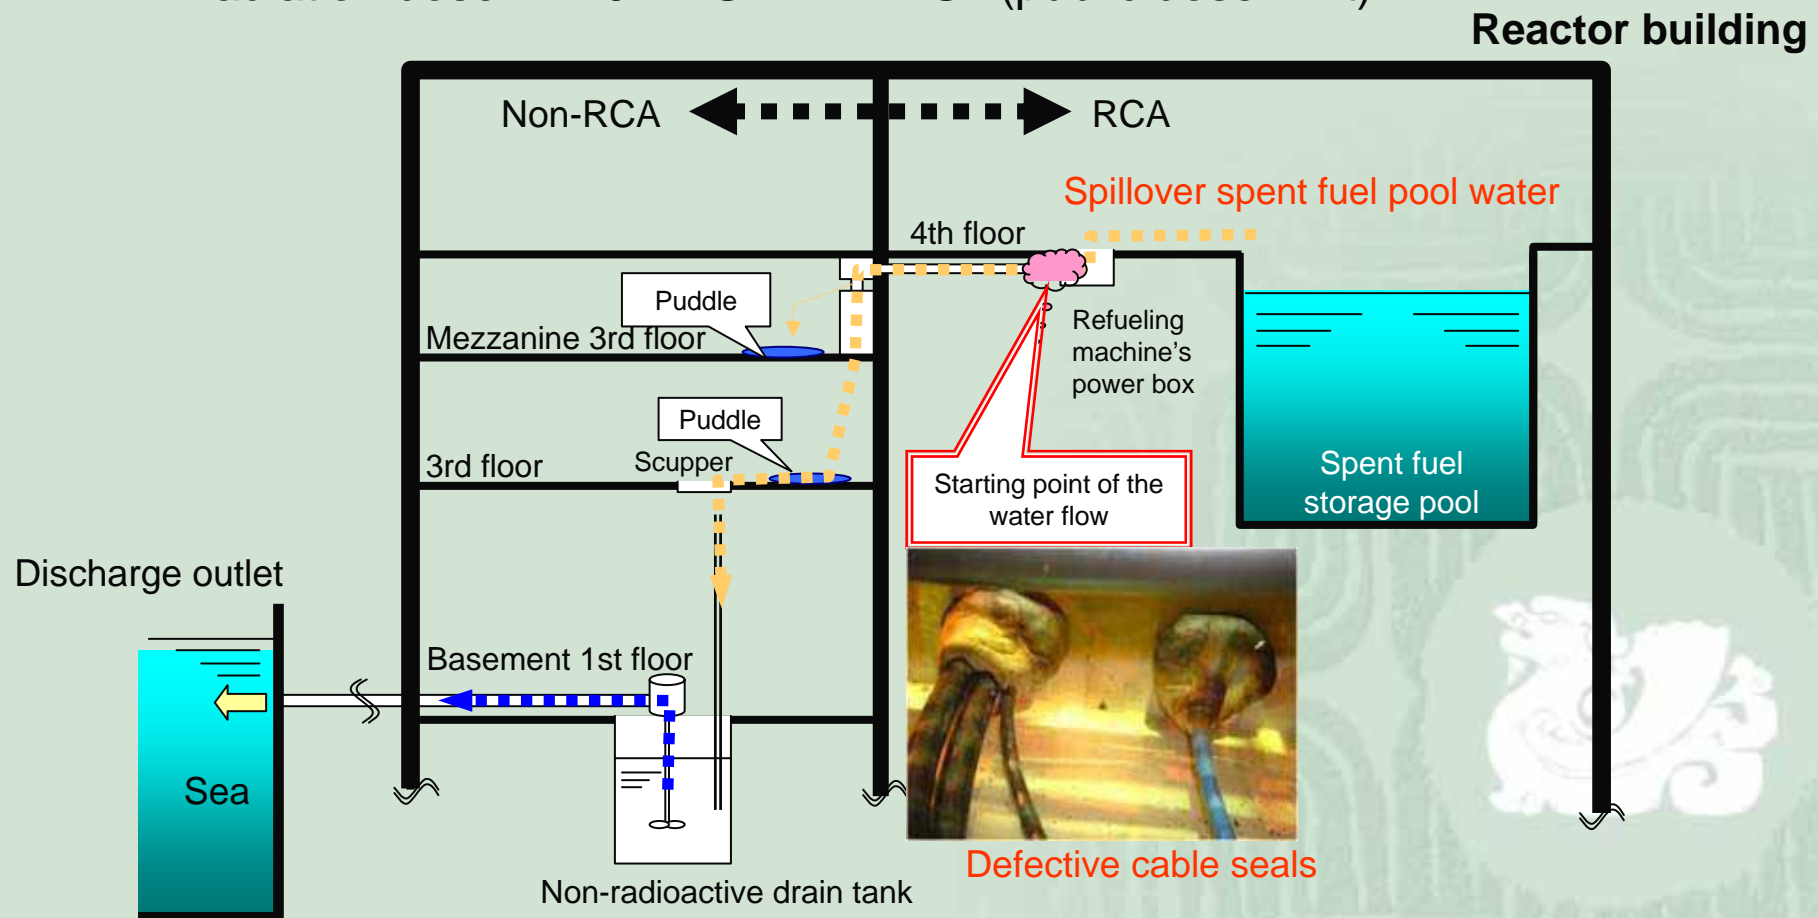
Quake-induced Event #2: Minuscule Amount of Radioactivity Leaked into the Sea from Unit 6

- Water leakage and subsequent release of radioactive substances into the sea.
- Amount of water discharged: 1.2 m³.
- Radiation dose: 2×10^{-9} mSv \ll 1 mSv (public dose limit).

Improvements for resolving the issue (Radioactive leakage)

- Development of a swift and strict reporting process.
- TEPCO's management was blamed for delayed radioactive sampling and slow reporting
- Developing a round-the-clock process that enables accurate and swift sample collection and radiation measurement in the event of leakage of radioactive substances. Radiation technicians on round-the-clock standby has been introduced at all stations
- Ensuring the isolation of leakage routes and circulation of information upon the discovery of leakage in non-RCA areas and possibility of contamination with radioactive substances.

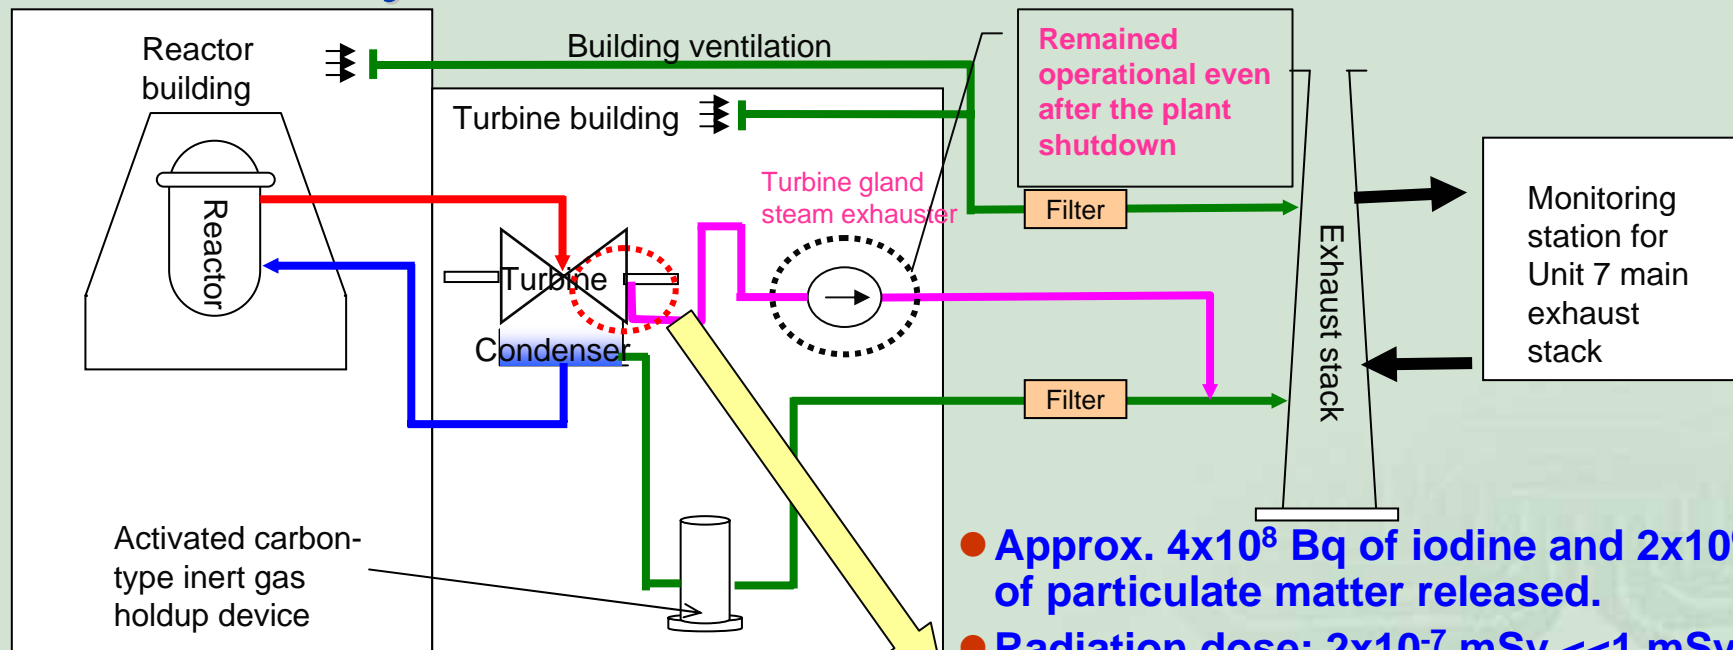
Quake-induced Event #3: Minuscule Amount of Airborne Radioactivity Released into the Air from Unit 7

- **Approx. 4×10^8 Bq of iodine and 2×10^6 Bq of particulate matter released.**
- **Radiation dose: 2×10^{-7} mSv \ll 1 mSv (public dose limit).**
