# Degradation of Boral in Spent Fuel Pools at Chinshan and Kuosheng Plants

Department of Nuclear Regulation  
Atomic Energy Council, Taiwan

10th TAEC-USNRC Bilateral Technical Meeting  
May 03-05, 2011

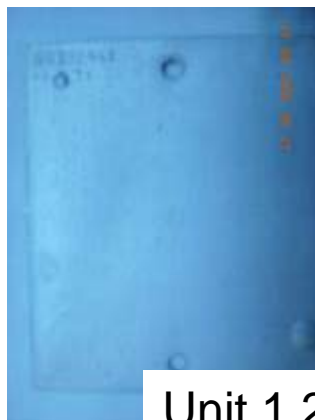
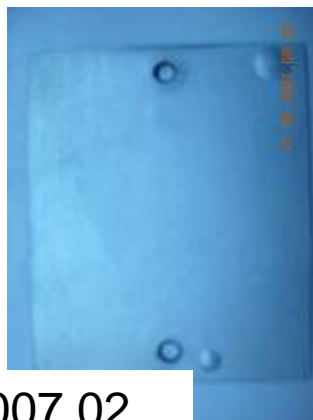
Unit 1 2007.02

- In each SFP, there were 10 coupons mounted on the “coupon tree” and are positioned axially within the central 8 feet of the fuel zone, and the “coupon tree” is surrounded by freshly discharged fuel assemblies at each of the first five refueling outages following installation of the racks. From the fifth cycle on, the fuel assemblies surrounding the “coupon tree” remain in place for the remaining lifetime of the racks.
- Up to 2011, totally 9 boron test coupons have been examined. Two of the latest examined coupons showed blisters near the edge of the coupons.

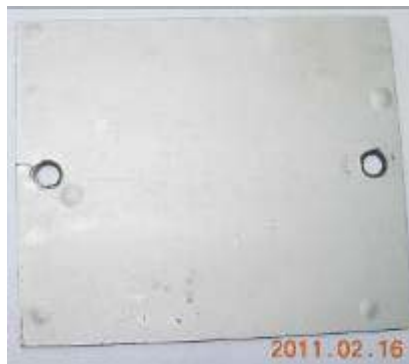
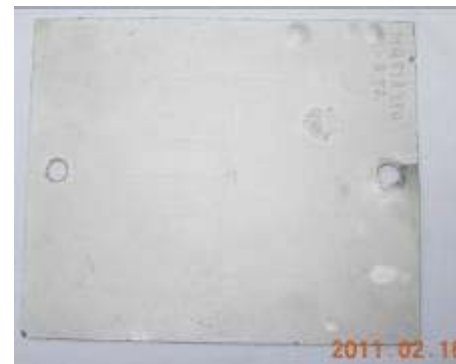
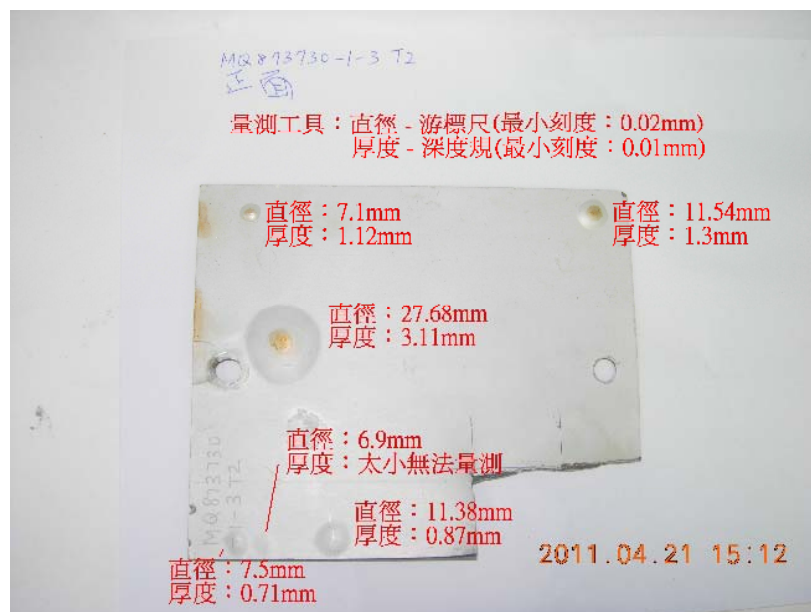
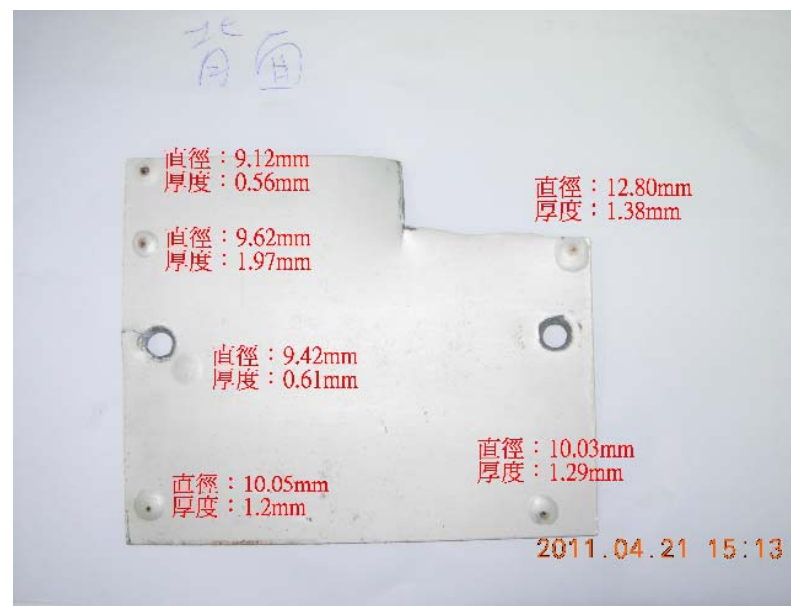
- Surveillance results of coupon taken out from Unit 2 in Feb. 2011.

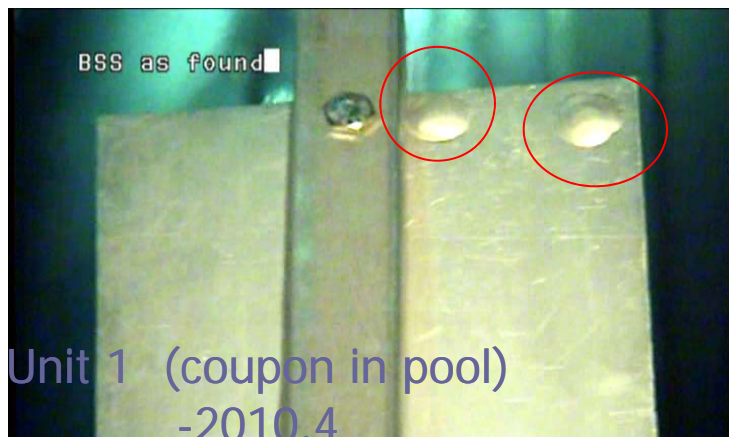
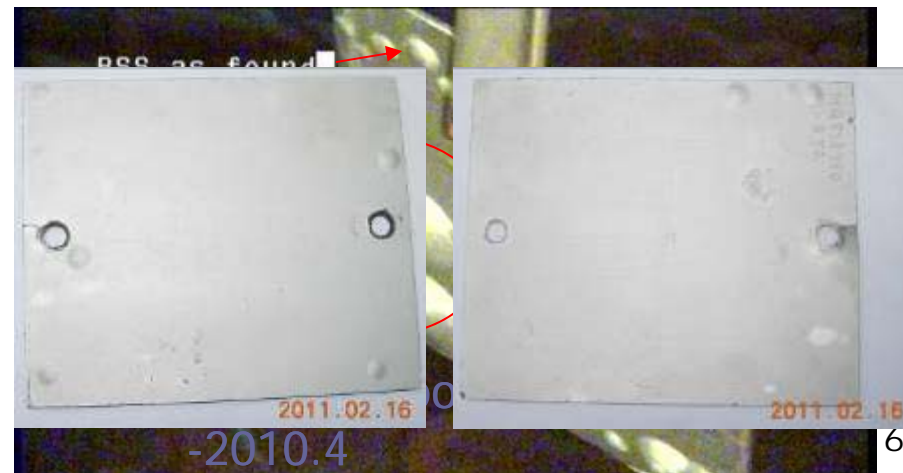
- Considering test result of CS in 2007 and NRC IN 2009-26 , additional visual inspection was first conducted during the refueling outage of Chinshan unit 1 in April 2010.
- It was noticed that all of the six coupons remained in the pool were with blisters.
- The next test is scheduled in Chinshan Unit 1 in Oct. 2011.

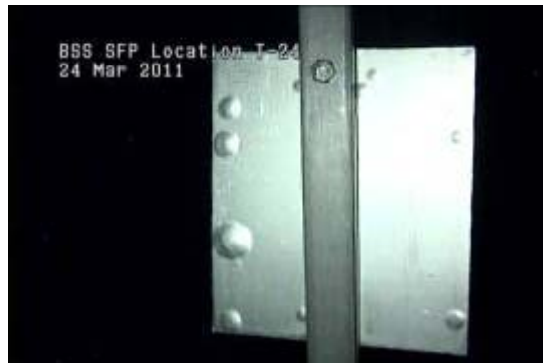
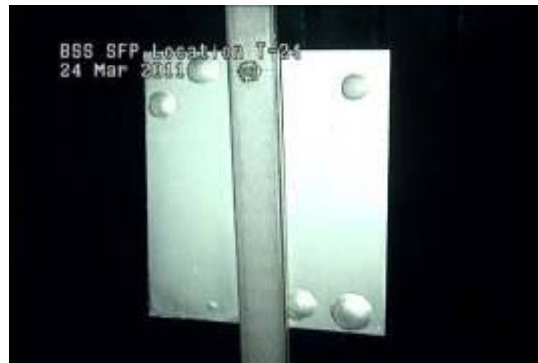
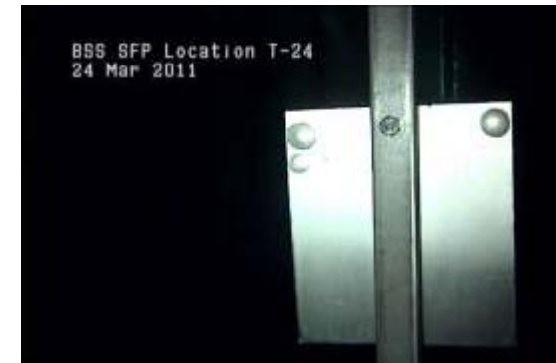
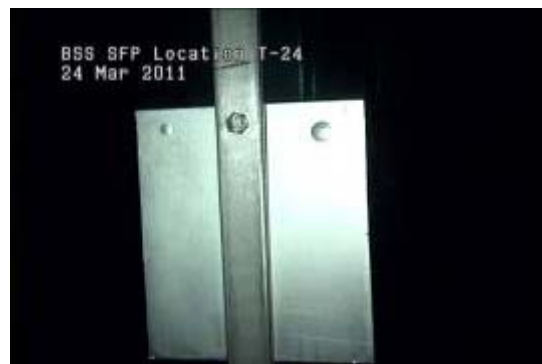
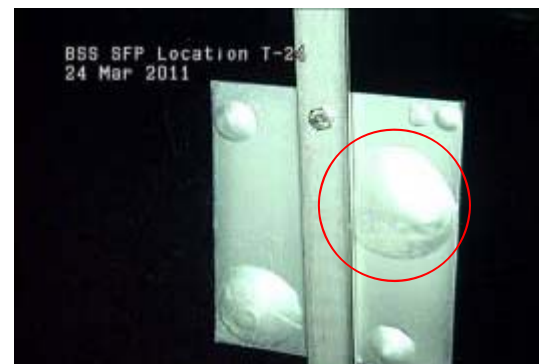
- In March 2011, a visual inspection was conducted during the refueling outage of Chinshan unit 2. All of the five coupons remained in the pool were with blisters.

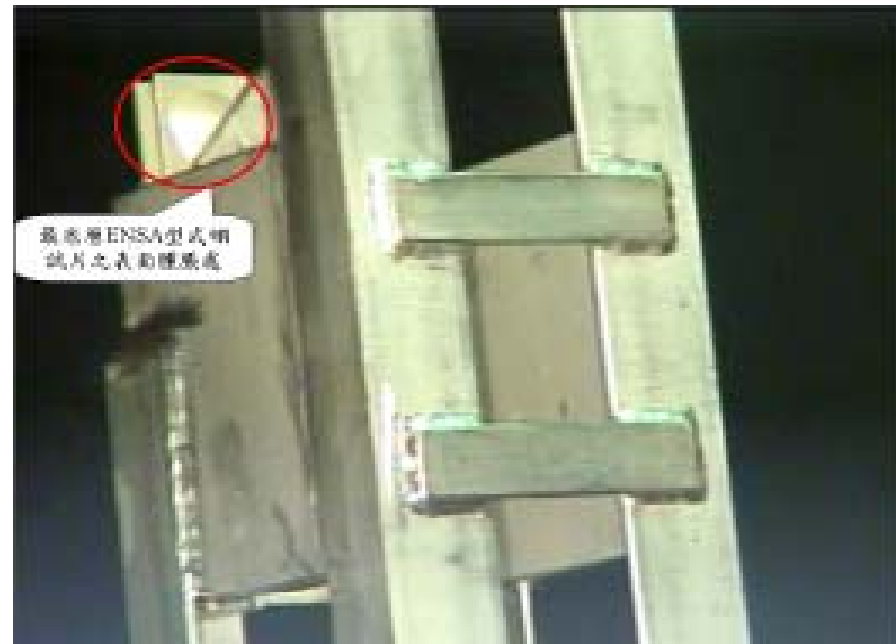
- Nevertheless, the non-jacketed coupons of the other manufacturer, ENSA, at Kuosheng had shown noticeable blisters through visual inspection during the refueling outage in March 2010, which is similar to Chinshan's operating experience.

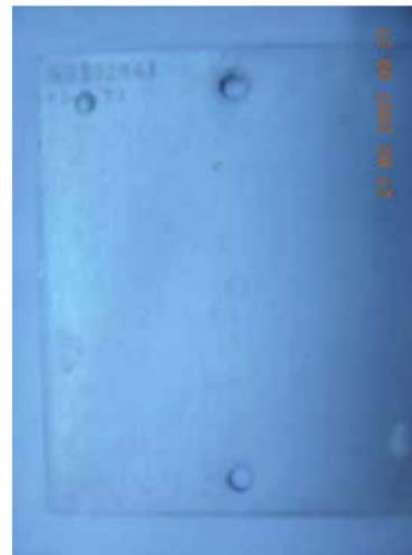
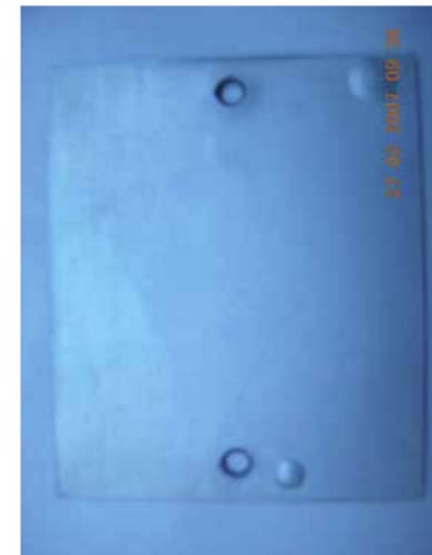
- Please provide more information about the blisters including:
    - The Holtec report evaluating the blisters seen in the 2010 inspection.
- A: Only HIB-44 “Swelling of Boral coupons from prolonged storage in fuel pools” was issued.
- Were blisters seen in previous four surveillance campaigns? If so, what were the quantity and dimensions of the blisters?
- A: Only the recent surveillance at Unit 1 in February 2007 showed 2 suspected blisters on each side of the coupon (see figures below). Dimensional measurement of blisters was not done at that time because they were suspected blisters and appeared the first time.

- The size and dimensions of all the blisters (Length, width, height/thickness).  
A: No measurement was done. The width and length can be estimated proportionally by the pictures in HIB-44 with coupon size of 5" by 6" (width by length).
