The Flood in the Unit 2 Reactor Building of the Lungmen NPP during Typhoon SINLAKU

Ming-Te HSU
Deputy Director
Department of Nuclear Regulation
Atomic Energy Council, Taiwan

7th USNRC-TAEC Bilateral Technical Meeting
Washington D.C. May 11-13, 2009

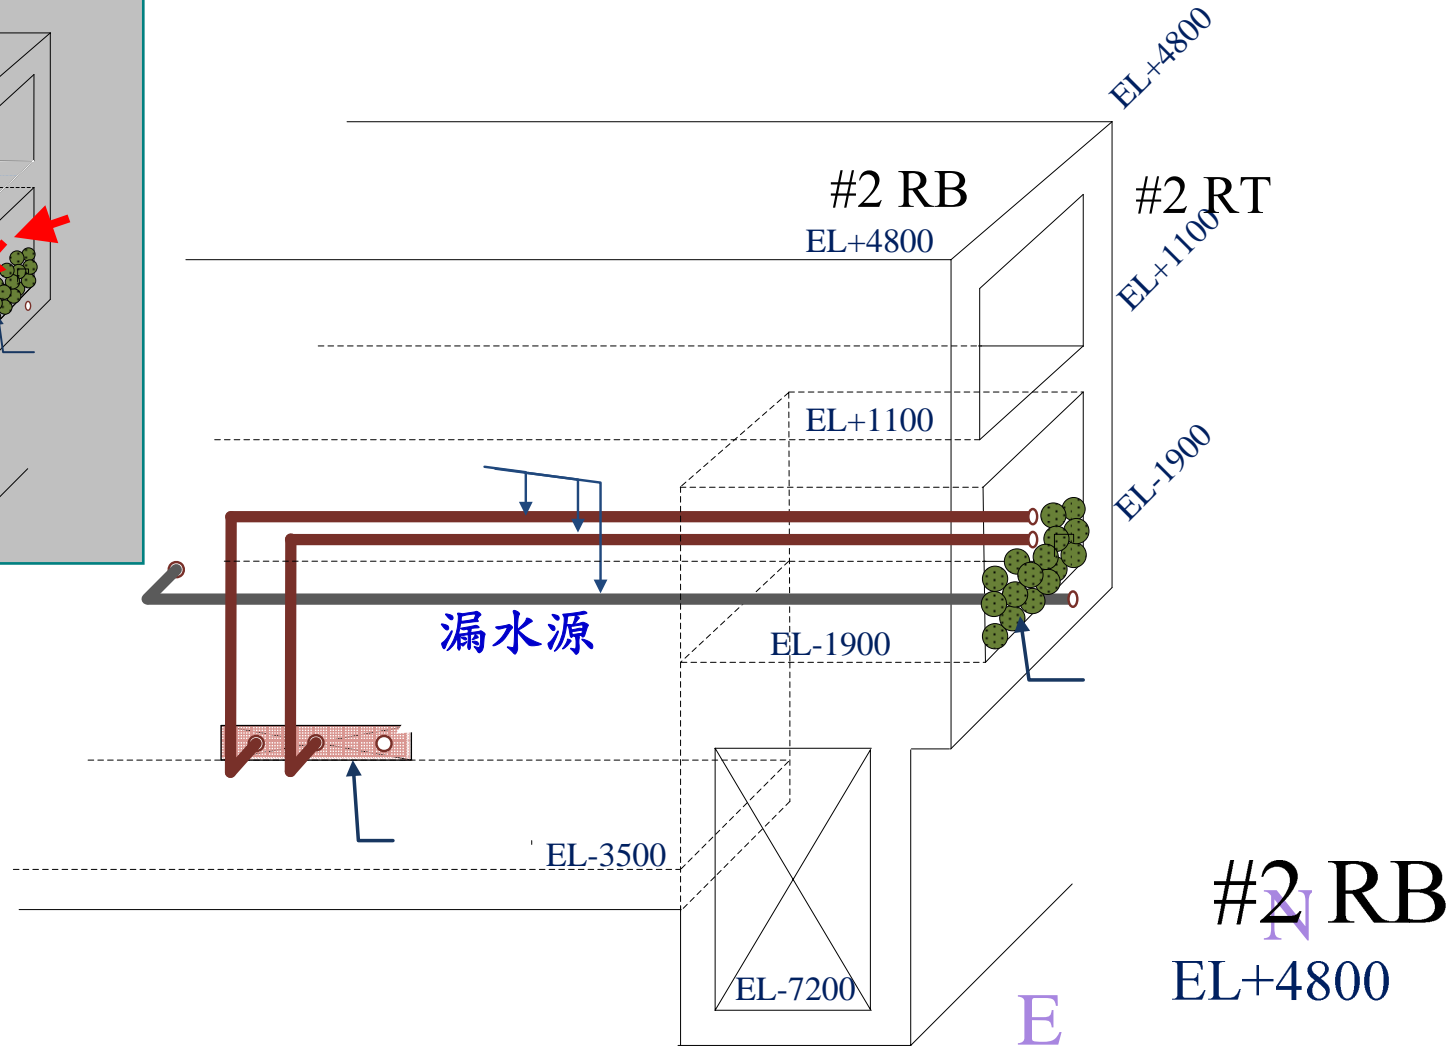
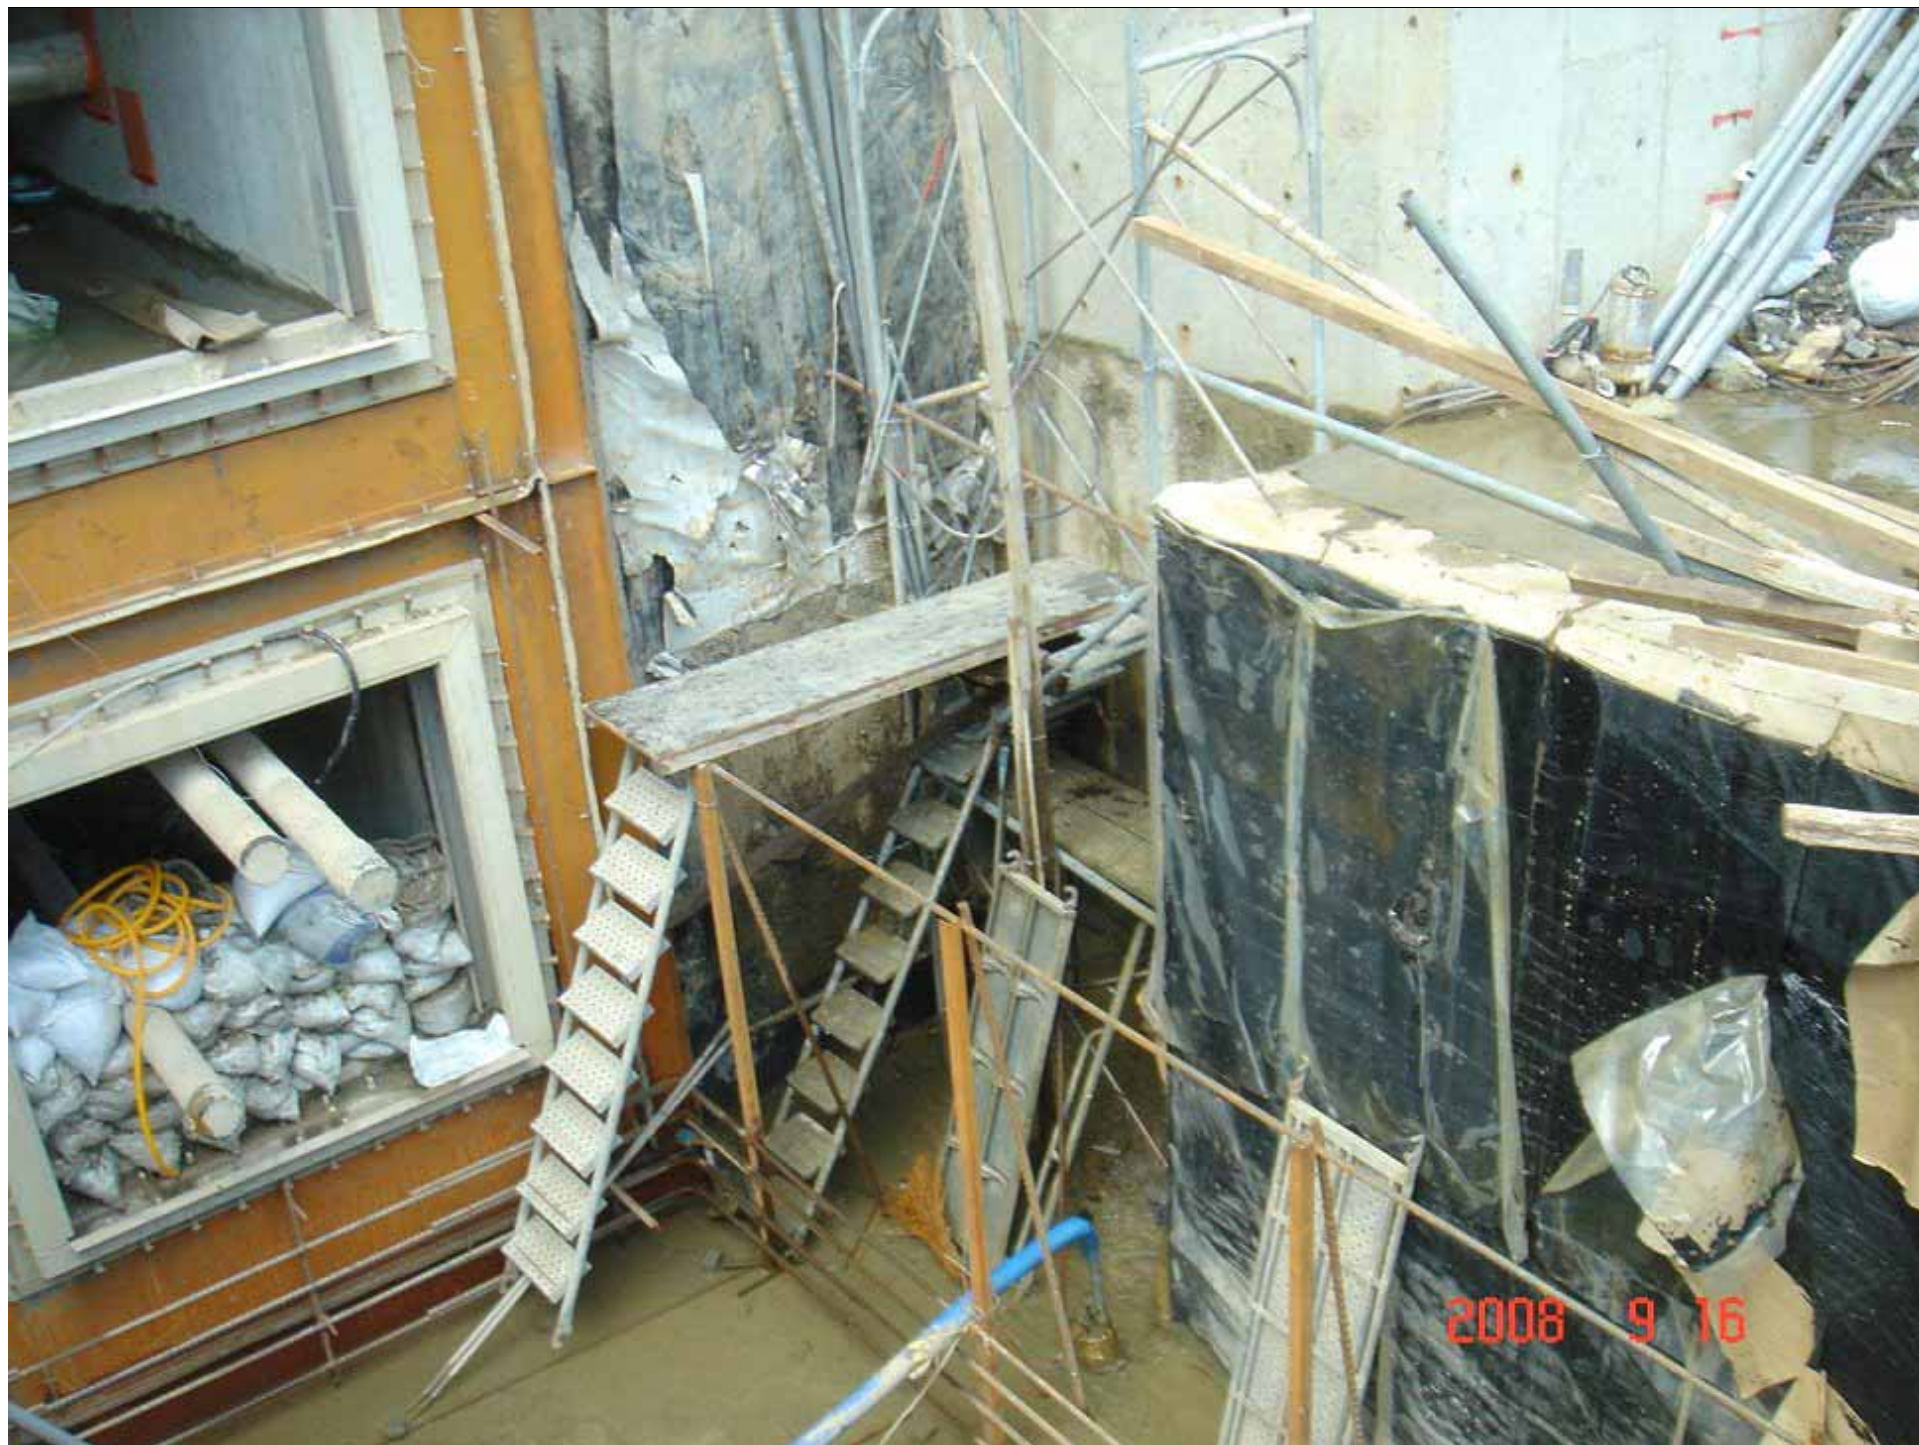
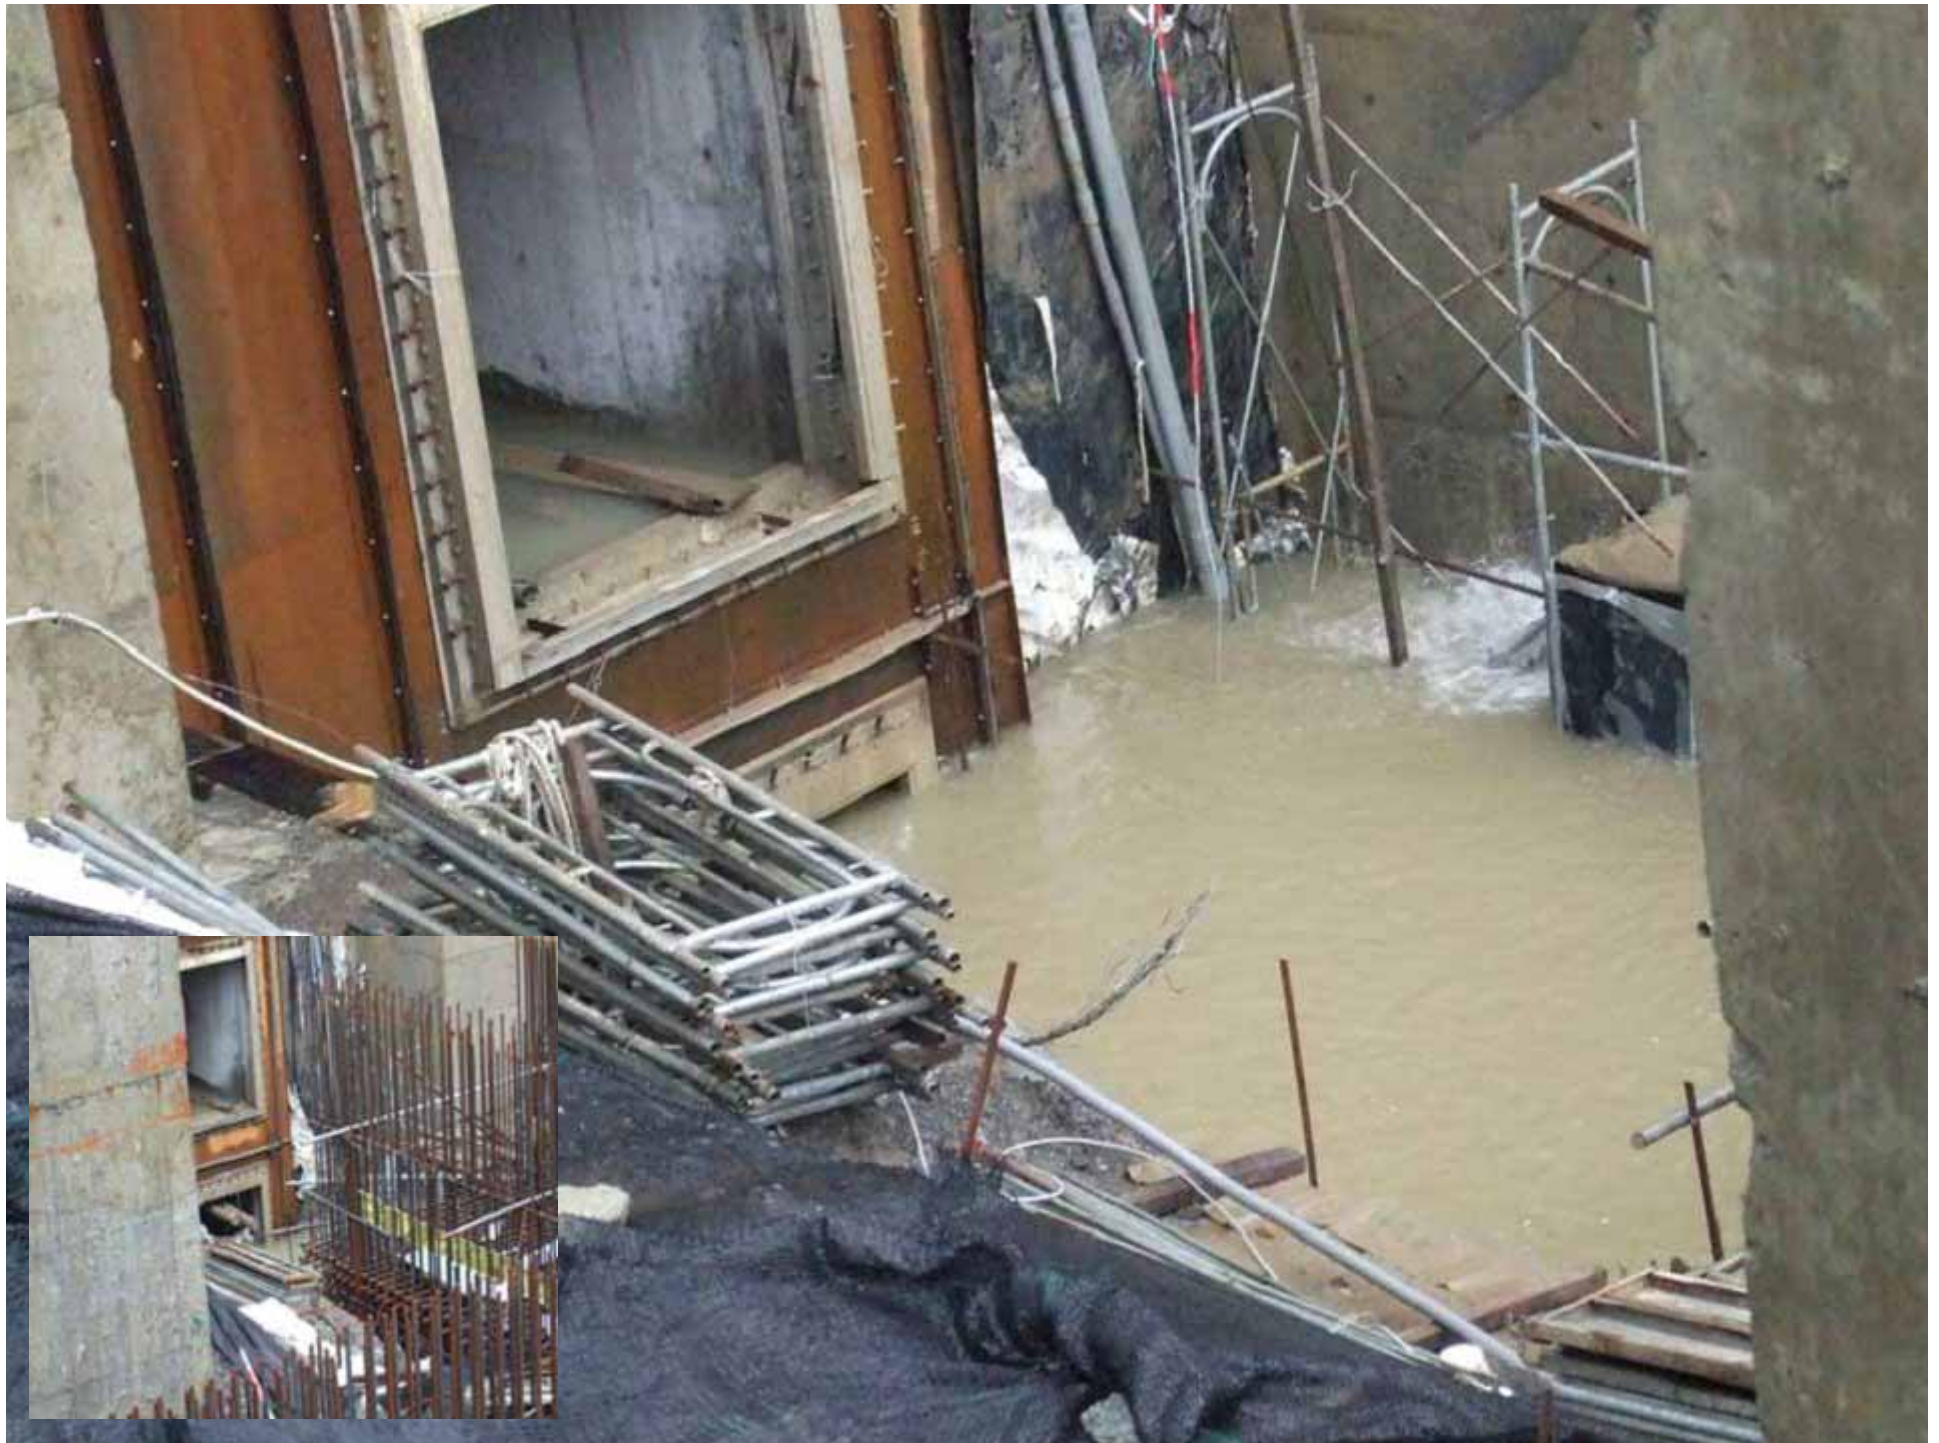
RB EL.-8200 Flooding Sketch Map

- The water flew through the hole into the RB, and flooded the pumps (not submersible pump) equipped at the basement (EL. -8200) . These 8 sets of non-submersible pump failed to function.
- The flood level eventually reached about 2 meters. (inside of RB)

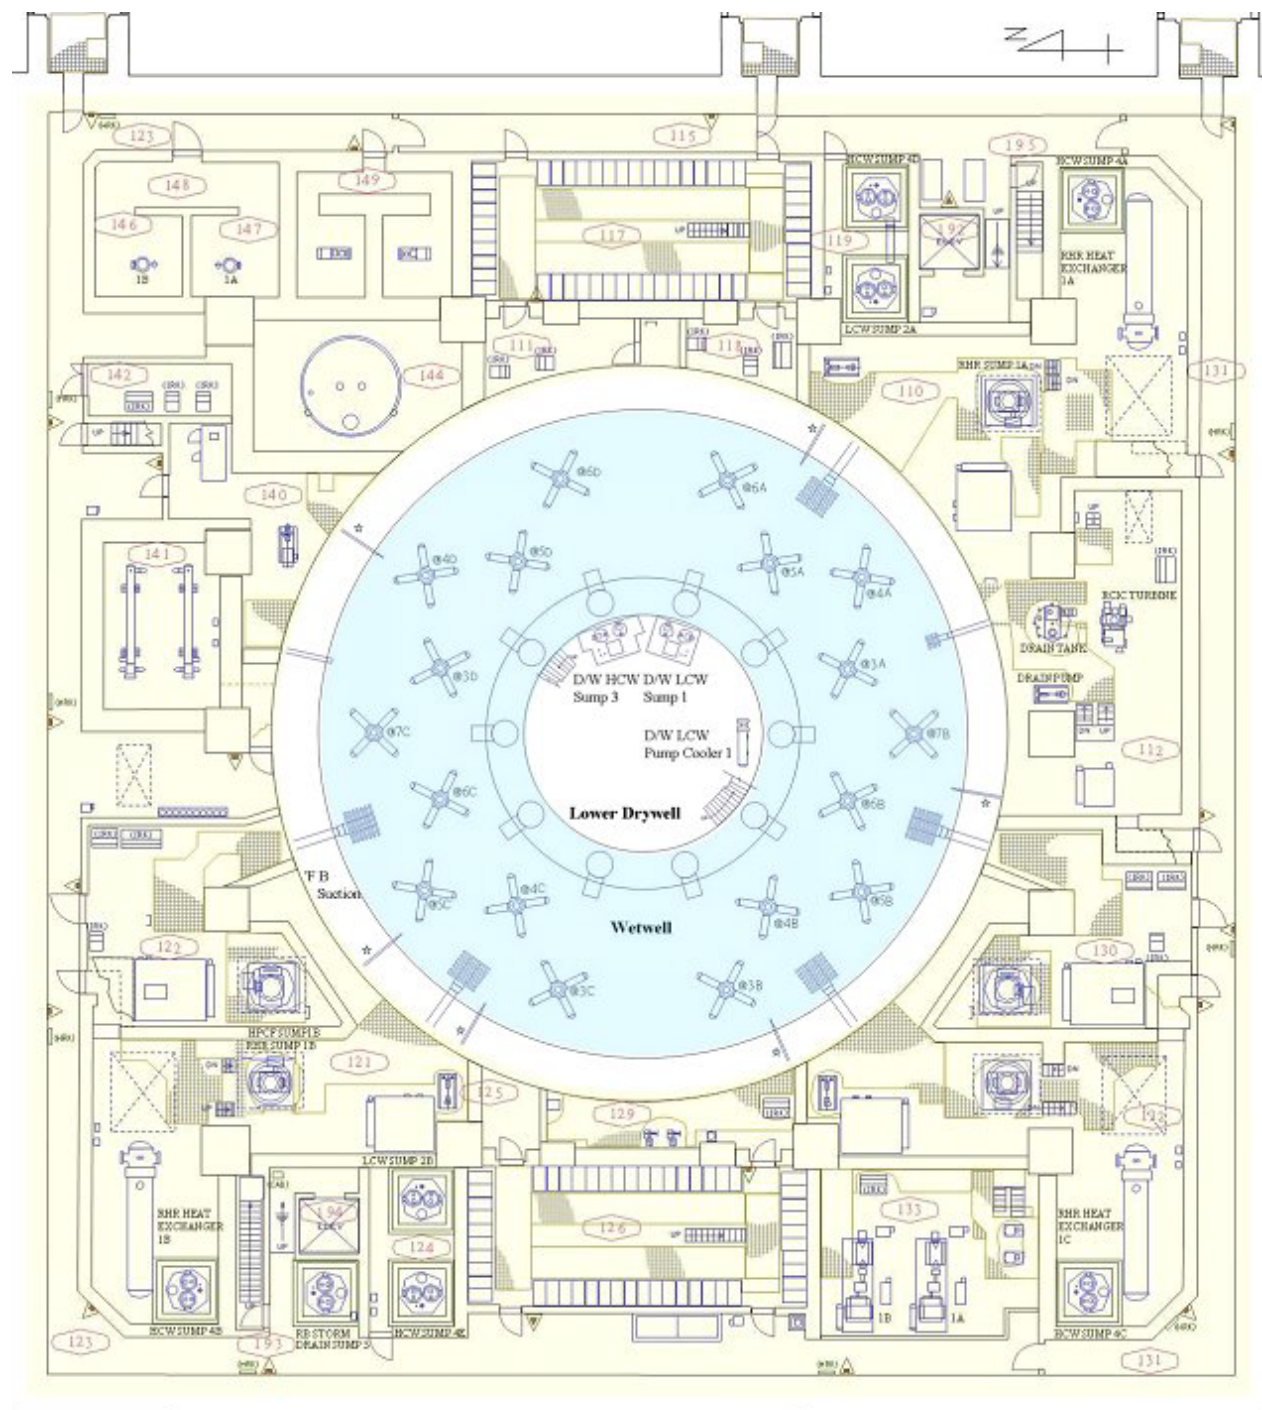
反應器廠房 B4F EL -8200

Flooding
Level:
2meters
