# **QA Regulation Report on Reactor Pedestal Fabrication for Fourth Nuclear Power Plant**

Nuclear Regulation Department  
May 30, 2002

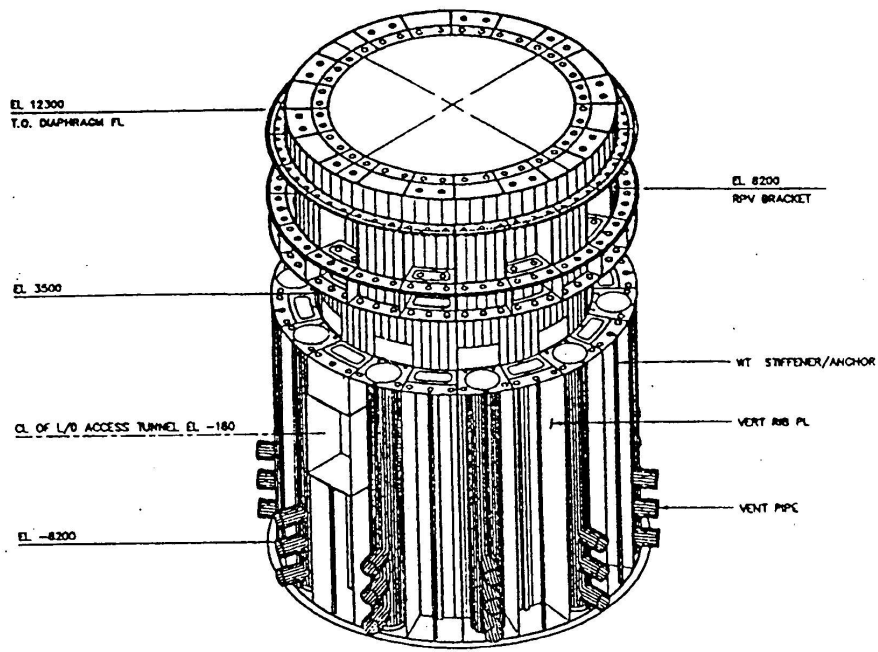
Reactor Pedestal Steel  
Structure Configuration

The reactor pressure vessel pedestal of the fourth nuclear power plant is a vertical hollow cylindrical annular thick steel structure filled with concrete in-between. The structure has an overall height of 20 meters, and outside diameter of 14 meters (see attached figure). The main function of this structure is to support the reactor pressure vessel, and also provides the paths for the safety piping systems. The total weight of the reactor pedestal structure is about 938 metric tons. And it belongs to the seismic class I structure category. The fabrication work has been contracted to New Asia Construction Company. The steel portion of the reactor pedestal has been subcontracted to China Shipbuilding Company for fabrication in Kaohsiung. For the convenience of shipping of the parts, manufacture process has been divided the support structure into five ring layers. After all completed parts arrived at the site, the parts will be assembled by welding and concrete will be poured to complete the structure.

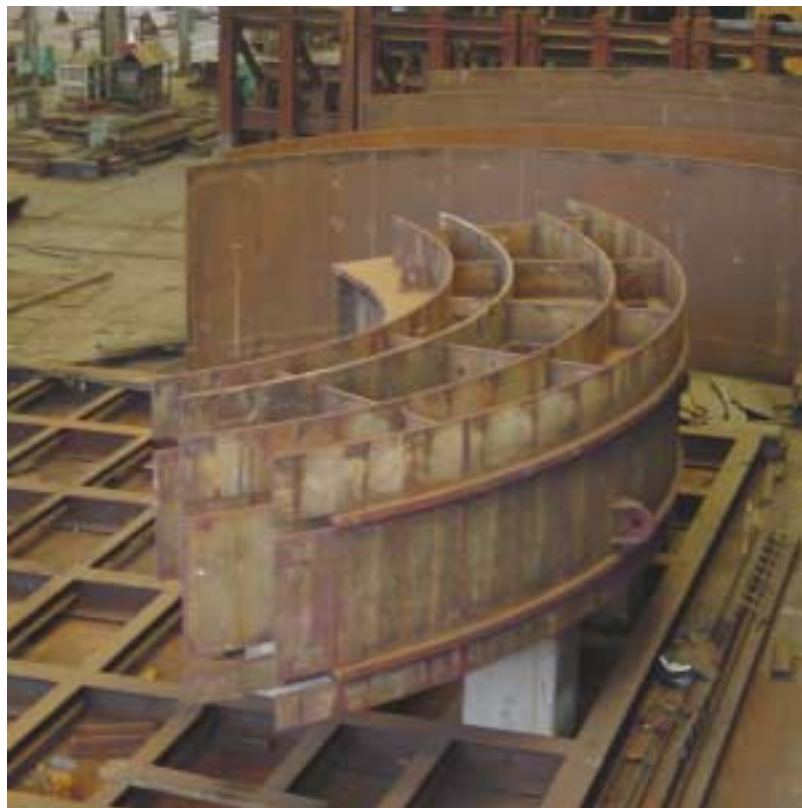
Quadrant View of the Third Layer  
of the Reactor Pedestal

On April 24, 2002, AEC noticed some quality deficiencies of the weld electrodes used for the unit 1 reactor pedestal ring structure fabricating at China Shipbuilding Company in Kaohsiung. The higher strength of the weld electrodes supposed to be applied at the 2 to 5 ring layers were replaced by the lower strength weld electrodes. Such condition could affect the safe operation of the fourth nuclear power plant in the future. AEC immediately dispatched staff to investigate the situation. After examining the welding QA records, in-situ weld visual inspection records, and taking weld samples from the completed parts for chemical analysis, it is certain that the weld quality deficiency does exist and has been found in many different locations.

meet the seismic class 1 structure requirements and no discount in quality can be tolerated in the manufacturing process. If there were fabrication deficiencies in quality were found, the parts can no longer be used in the plant for the sake of safety. After the circumstances of the 2~5 ring layer with weld deficiencies were made certain, AEC expressed the regulation position to TPC asking for corrective action. Subsequently, TPC has decided to re-fabricate this whole reactor pedestal assembly.
