**CONTAINMENT SUMP STRAINER REPLACEMENT  
PROJECT AT MAANSHAN NUCLEAR POWER PLANT  
(GSI-191 Issues)**

2010 AEC/NRC Bilateral Technical Meeting  
Taipei, Taiwan  
May 4, 2010

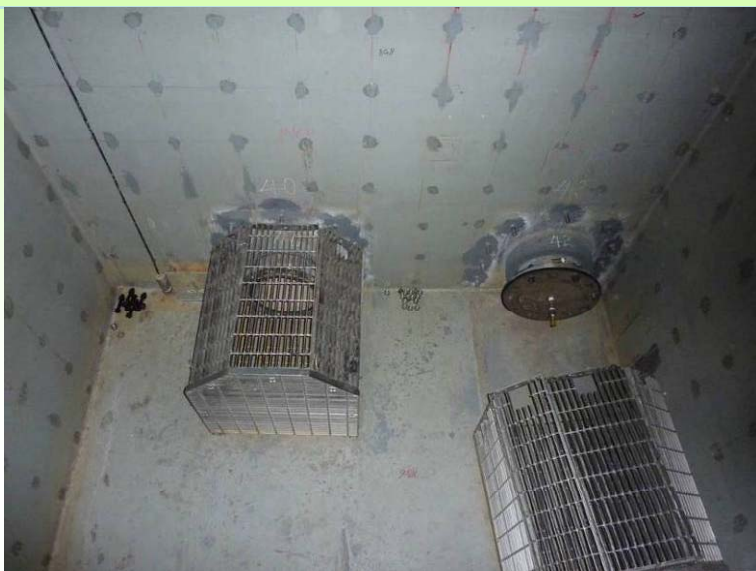
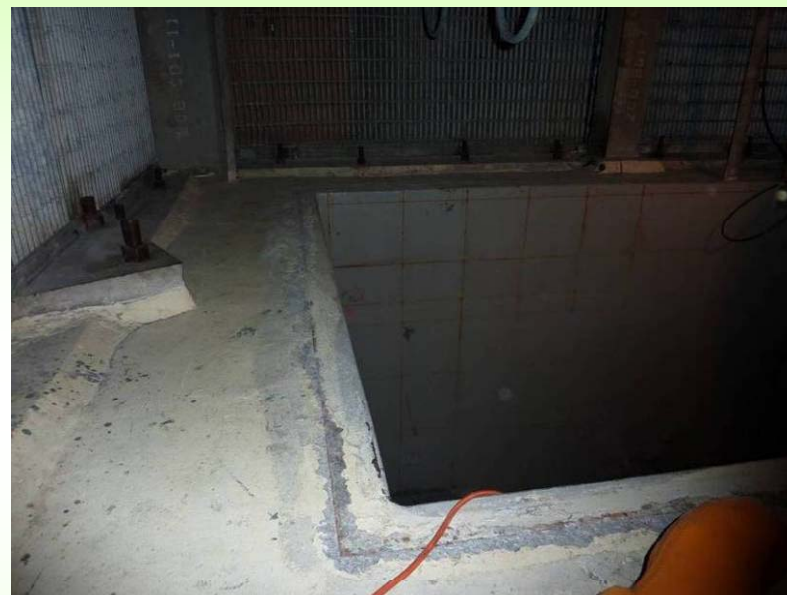
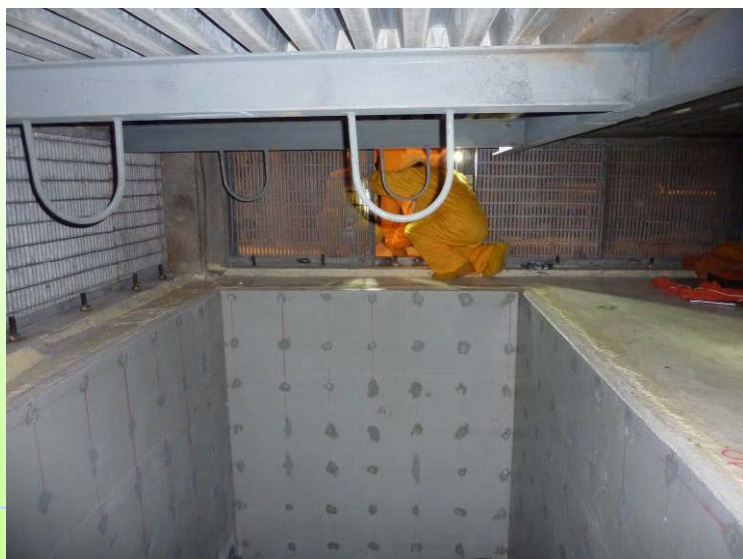
# Sump Pictures

- Sump dimensions are as indicated on design drawings
- Curb surrounding sump is beneficial
- Congested areas surrounding sump may hold-up some debris
- Concrete slab above the sump minimizes HELB/missile concerns
- Unobstructed floor space exists between sump & containment liner to add more modules at El. 100' if necessary
- Best transport path for strainer components appears to be via Polar Crane drop through stairwell above sump

- **Repair damaged fiberglass insulation and jacketing throughout containment**
- **Remove as much paper and tape from containment as possible and aluminum**
- **Replace aluminum labels with stainless steel tags**
- **More rigorous adherence to containment cleaning procedure**
- **Procedural change to modification process (e.g. GSI-191 Checklist ) to maintain or reduce debris amounts**
- **Transport strainer modules through north stairway for installation**

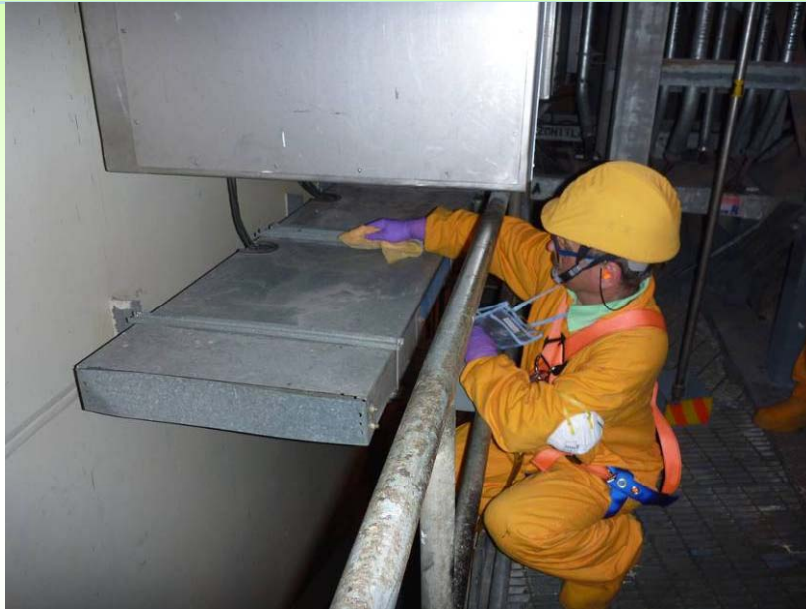
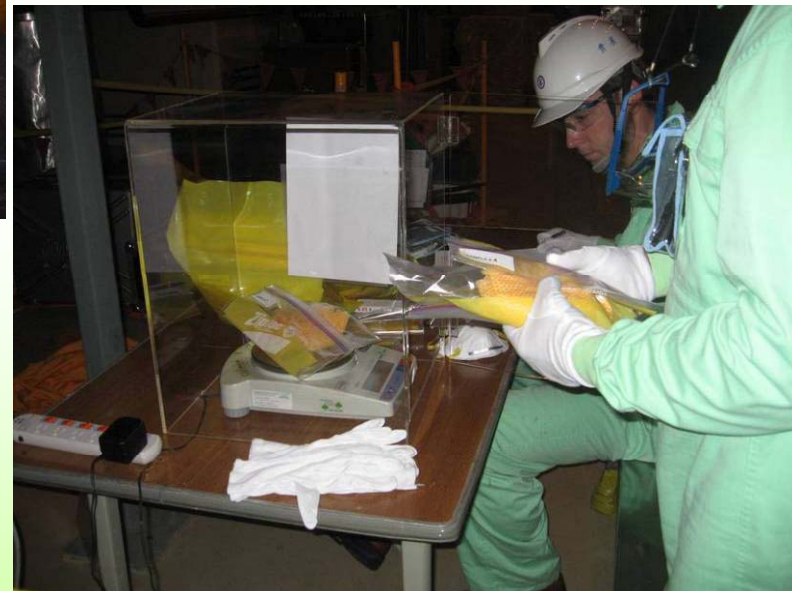
# Latent Debris Walkdown

- **Latent Debris Walkdown Observation**
  - Containment cleanliness is typical, nothing is out of ordinary
  - Recommend vacuuming latent debris from as many accessible horizontal surfaces as possible
  - Special attention to be placed on grated surfaces and penetrations
- **Latent Debris Calculation**
  - Amount estimates 165.4lb<sub>m</sub>

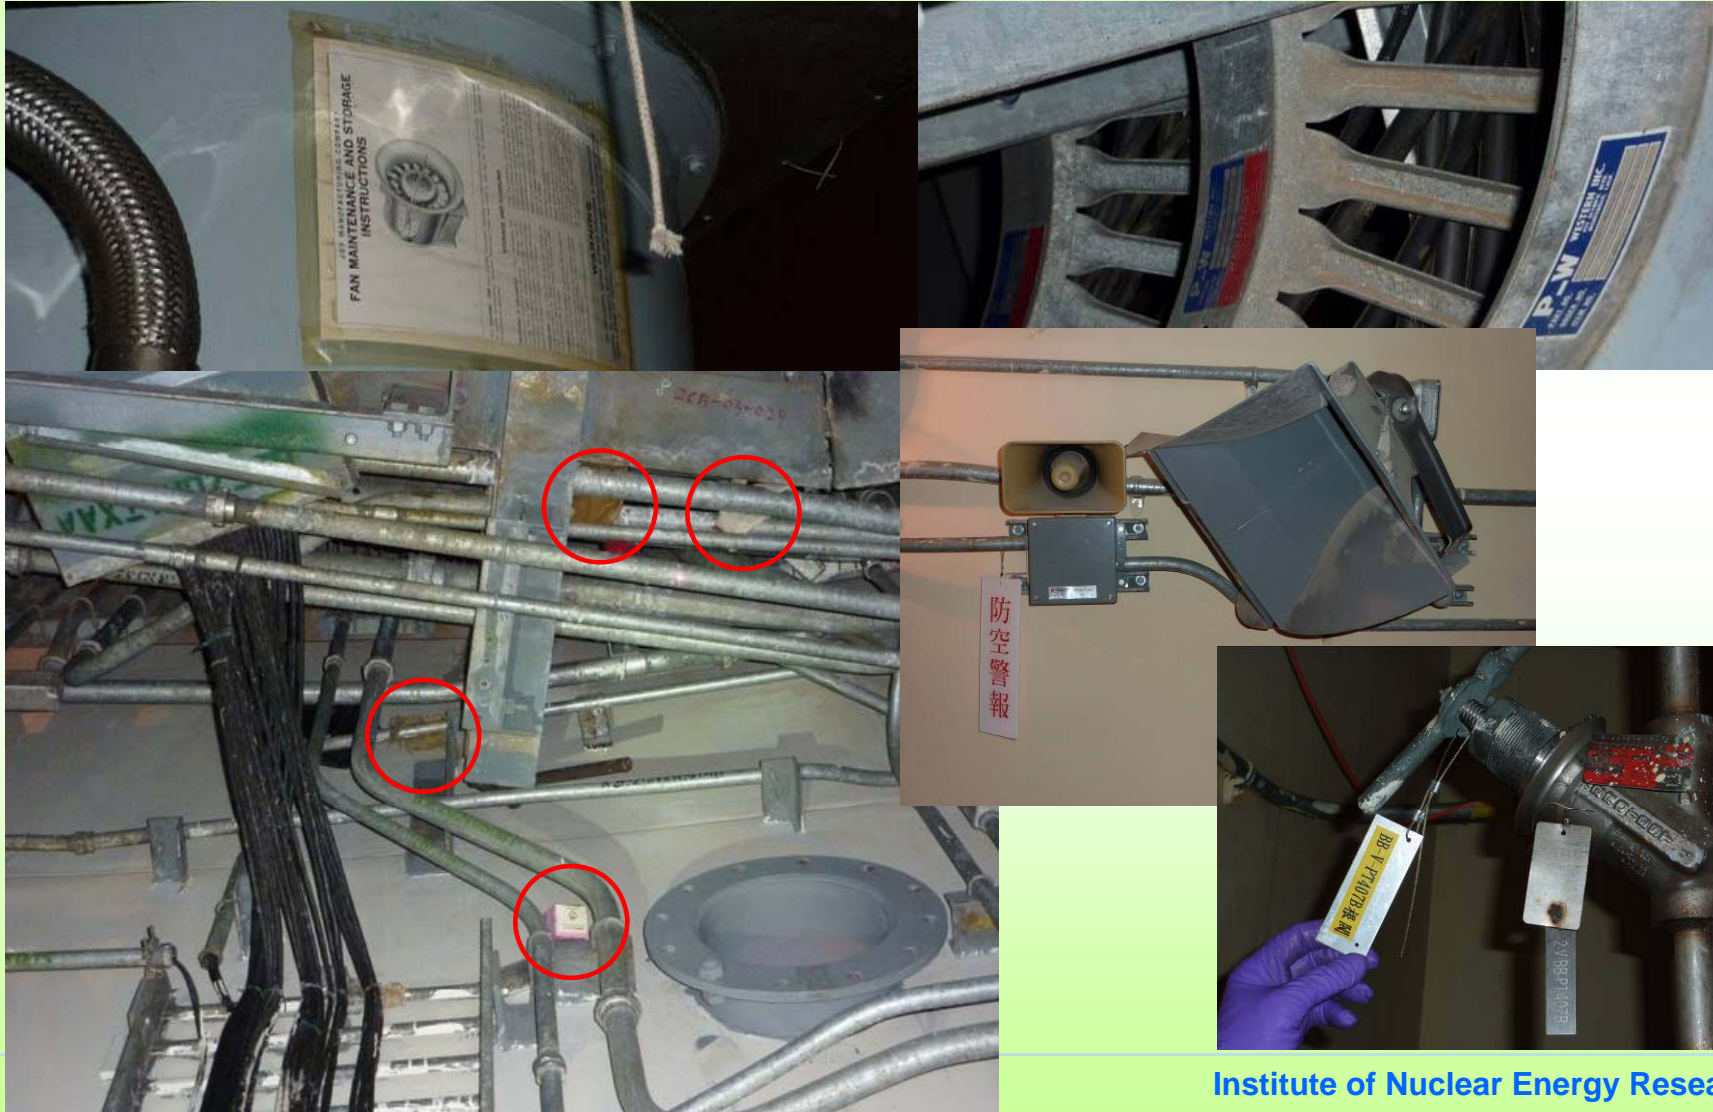
# Photos from Foreign Material Walkdown

- Miscellaneous debris of concern includes gloves (cotton and latex), tape & paper (particularly on electrical penetrations)
- Debris from top of accumulators should be removed
- Paper and tape are major contributors in the northern half of elevation 126'
- Plastic speakers are the largest contributor at the perimeter of the operating area
- It's about 1200 labels & tags for valves/components

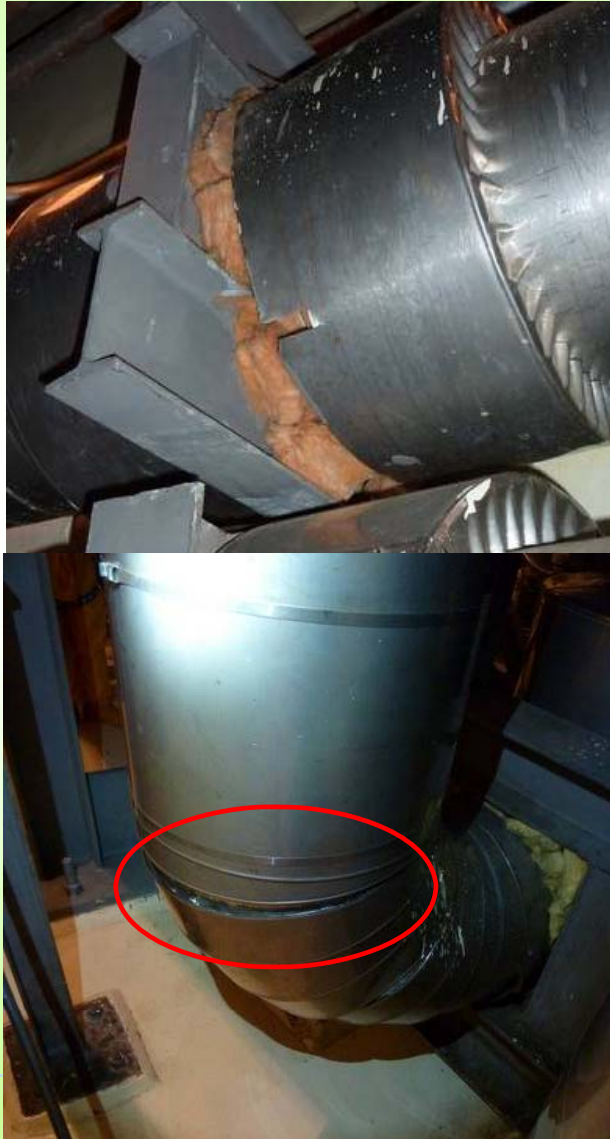
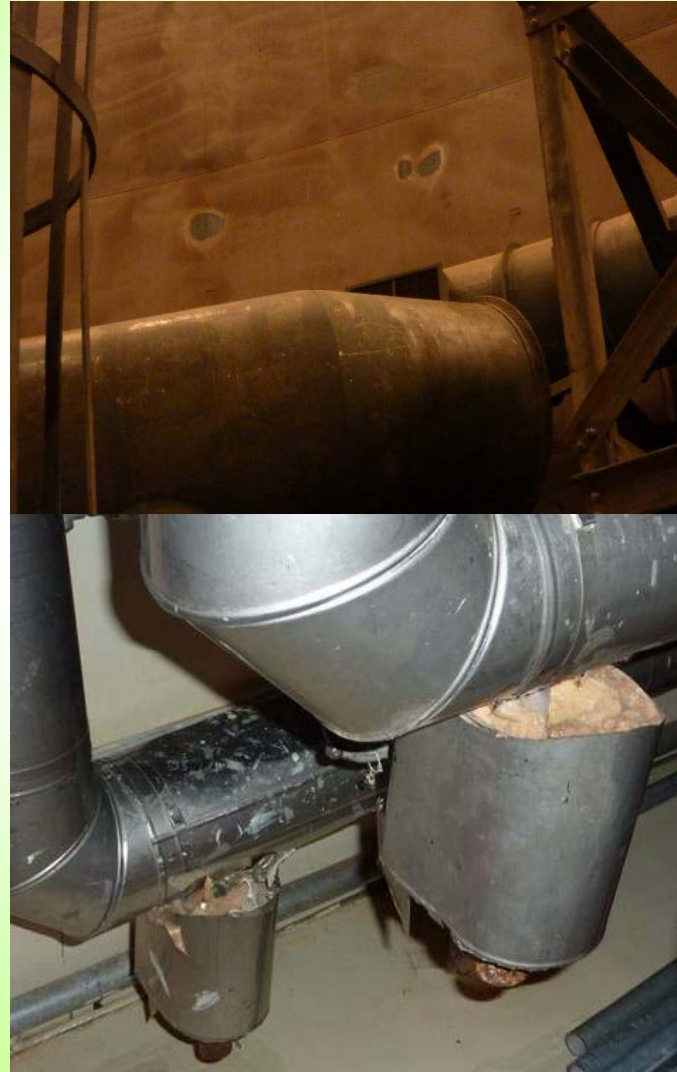
# Photos from GSI-191 Walkdown

- **GSI-191 (Debris Sources) Observation**
  - Most insulation is RMI, as confirmed by the insulation engineer
  - Fiberglass insulation mostly in good condition
  - No other types of insulation was found
  - Coatings appear to be in generally good condition
  - Flow path choke points observed at 100ft
  - Two water holdup areas found at the operating floor
