# Finding and Management of Abnormal Radioactive Material in Taiwan

Ju-chuan Huang  
Department of Radiation Protection, AEC  
July 1<sup>st</sup>, 2014

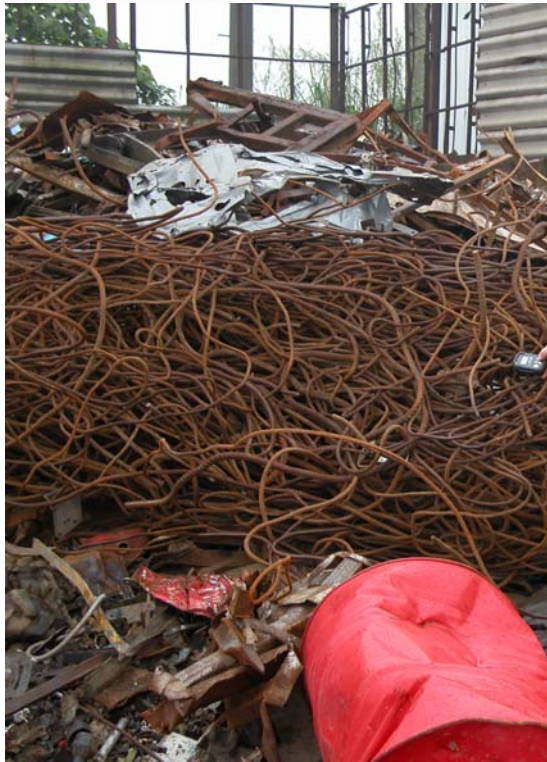
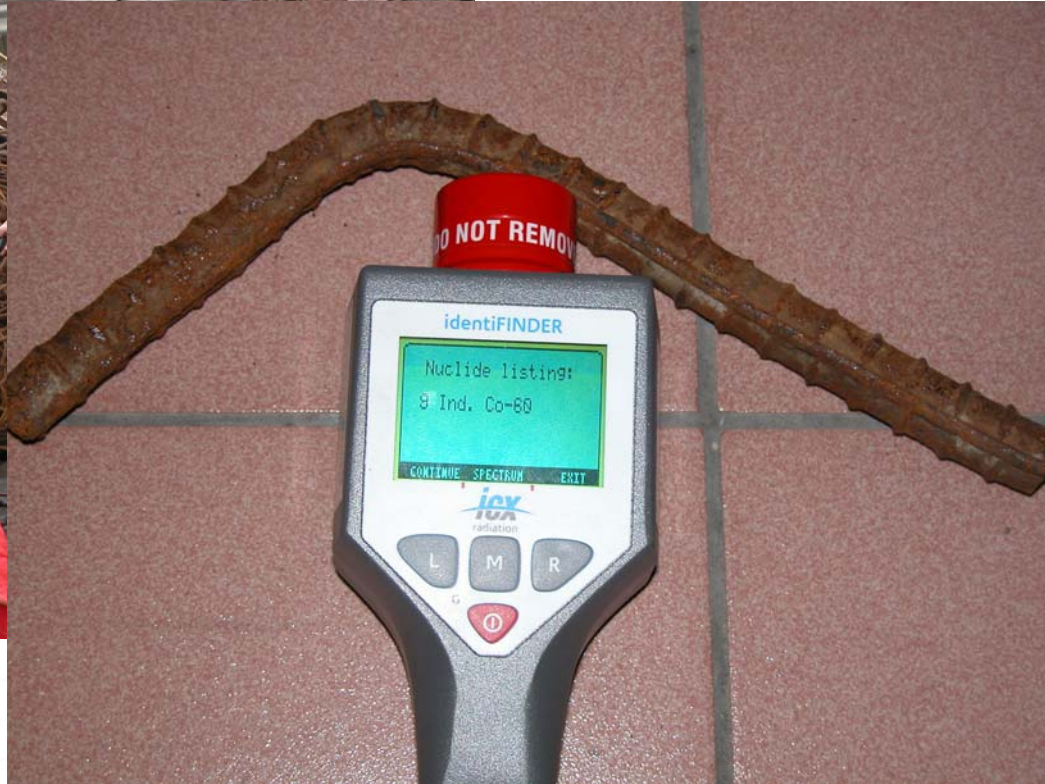
# Contaminated steel rebar found at a steel mill

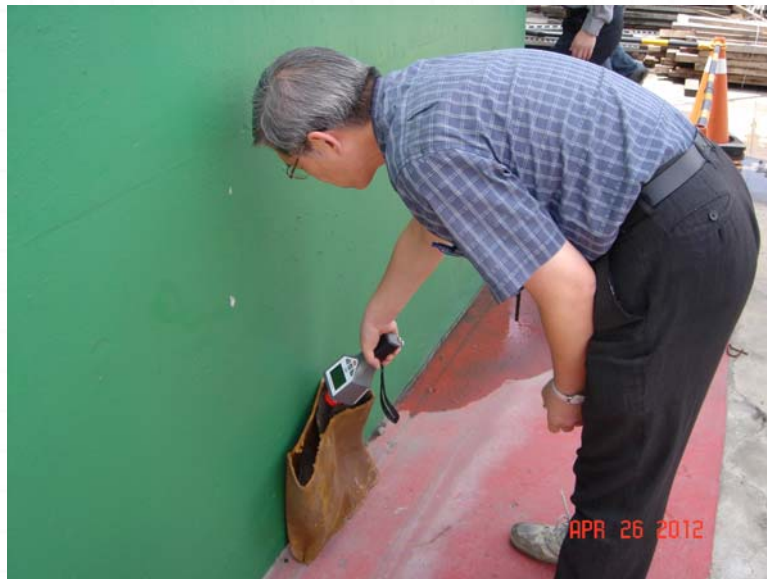
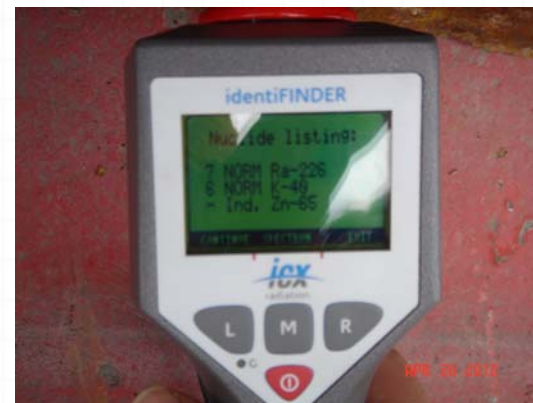
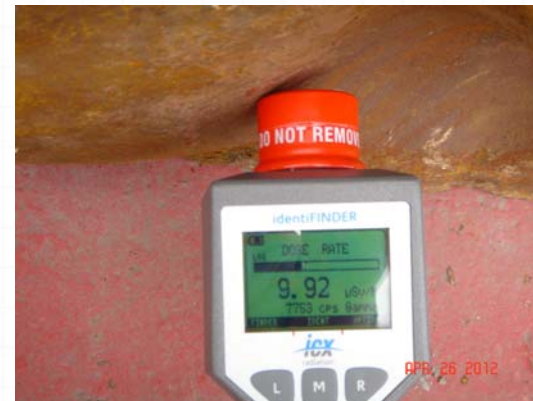
# NORM contamination on the surface of scrap metal

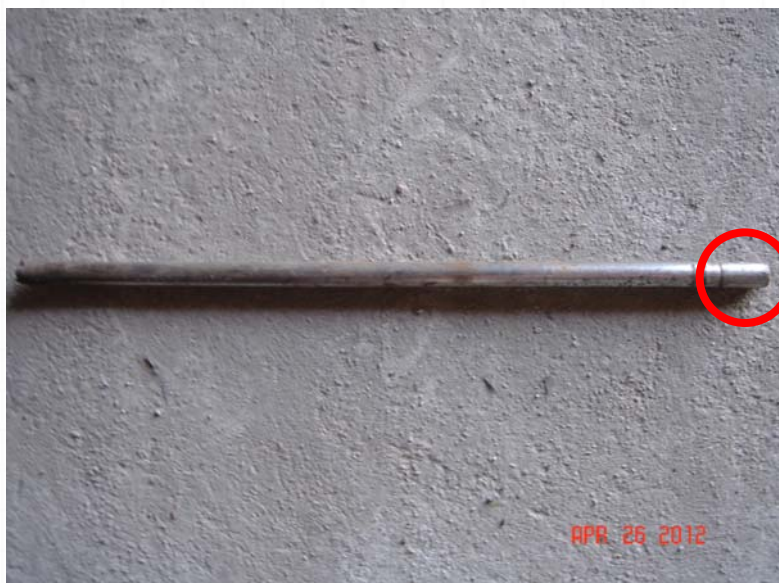
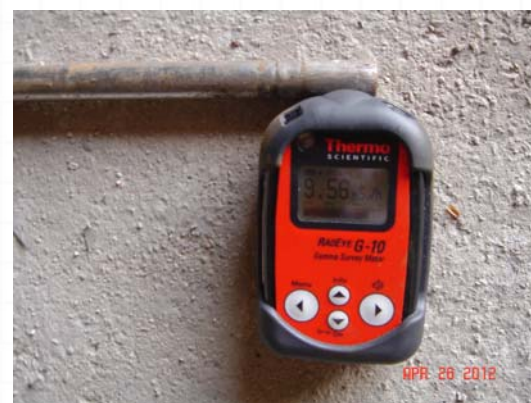
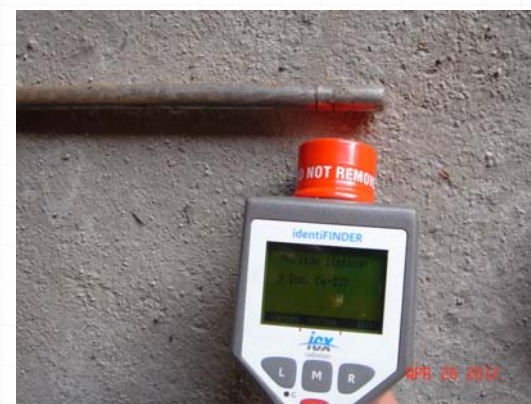
# Bare Cs-137 source found

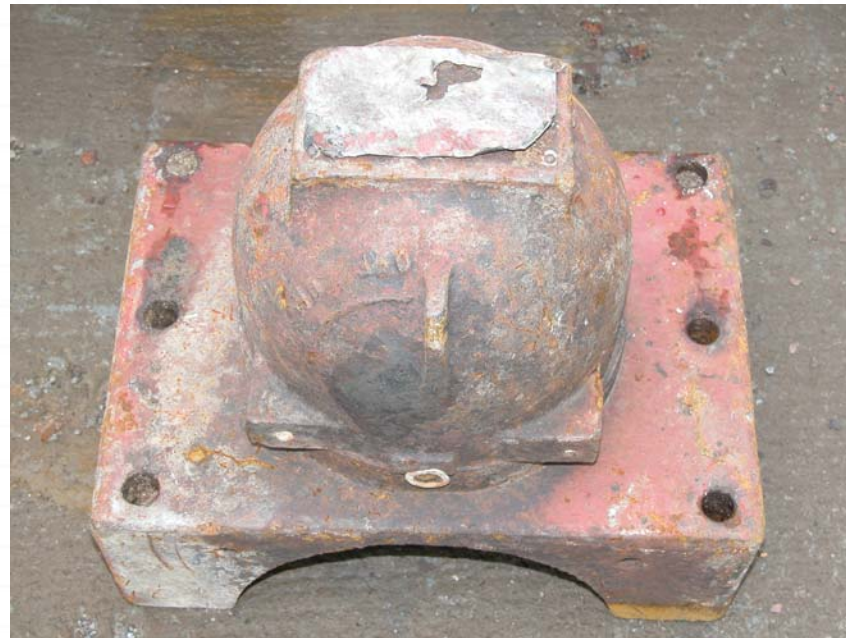
# Cs-137 source with shielding

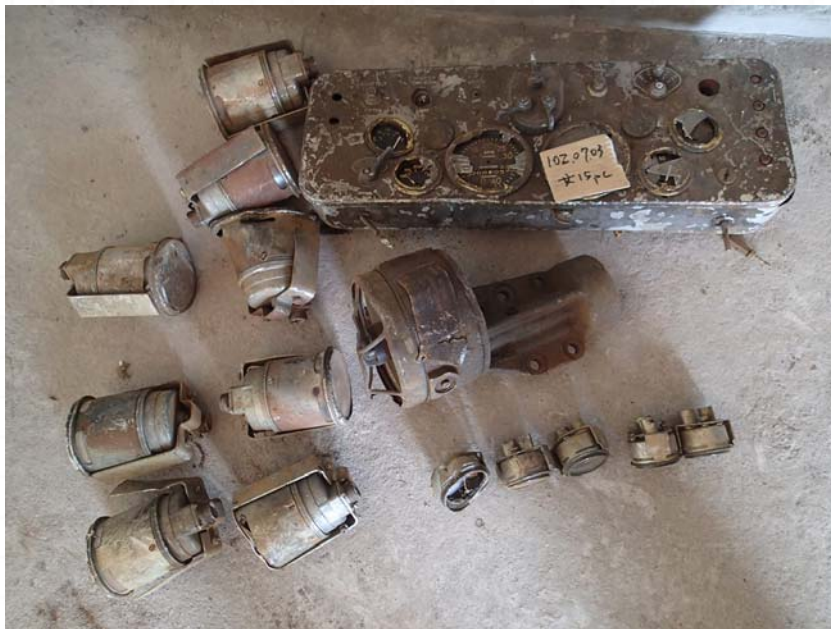
Gauges containing Ra-226

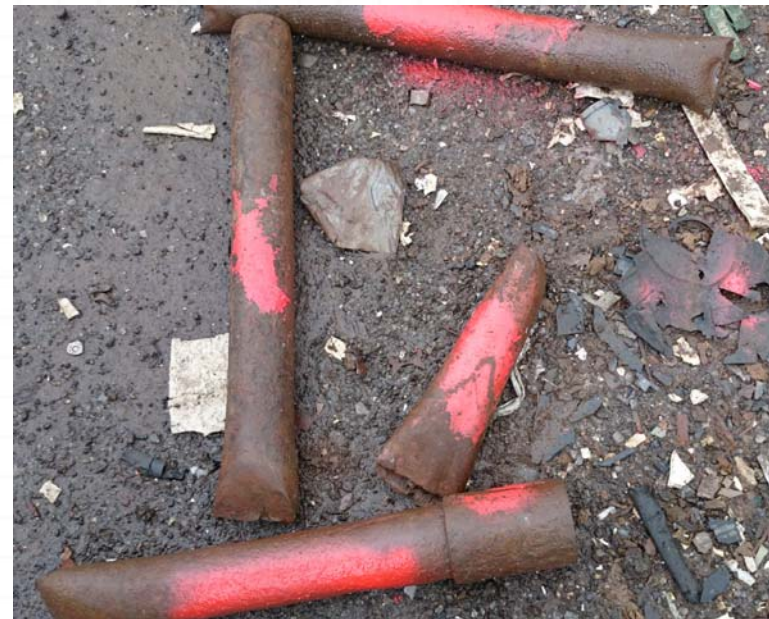
scale contaminated by NORM

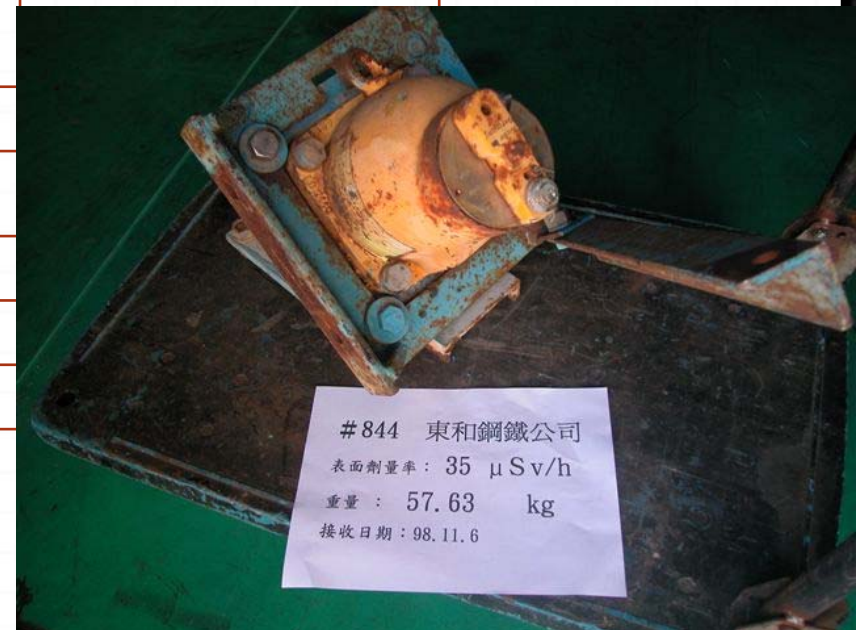
# Analysis Report For The Found Object

item	test results			organization
object type	Source			Institute of Nuclear Energy Research (INER)
radiation dose rate ( $\mu\text{Sv/h}$ )	surface	at 30 cm	at 100 cm	
	35	2.6	0.5	
nuclide	Cs-137			
activity	100mCi on the sign			
size	45cm $\times$ 45cm			
shape	Cylinder			
weight	57.63 kg

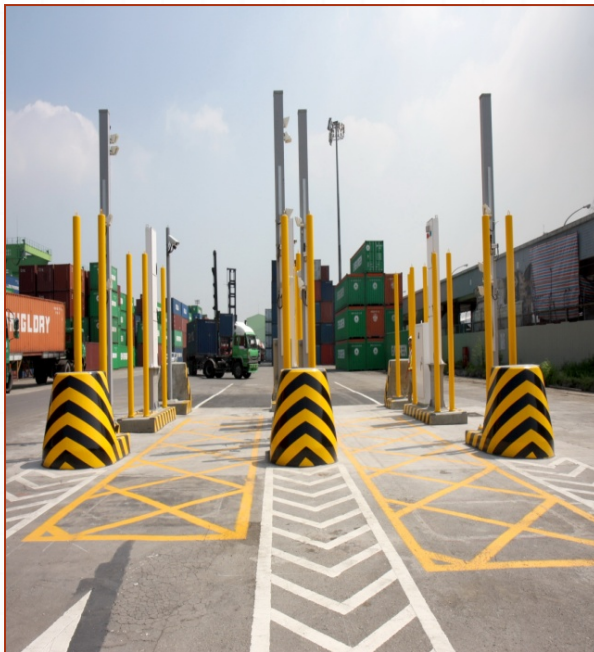
Radiation portal monitor  
as primary inspection

- 0 Initiated by the US DOE.
- 0 Any containers to be imported into the USA territory should be detected when transporting through the radiation portal monitors before leaving export ports.
- 0 This is originally purposed on threaten deterring, anti-smuggling or anti-proliferation of radioactive material.

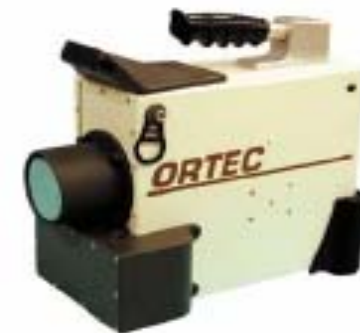
Ortec Detective

Personal radiation detector  
as secondary inspection
