行政院原子能委員會
委託研究計畫研究報告

LSM 鍍層對 SOFC 接合件高溫機械性質之影響
Effect of LSM Coating on High-Temperature Mechanical Properties
of SOFC Joint

計畫編號：1062001INER008

受委託機關(構)：國立中央大學

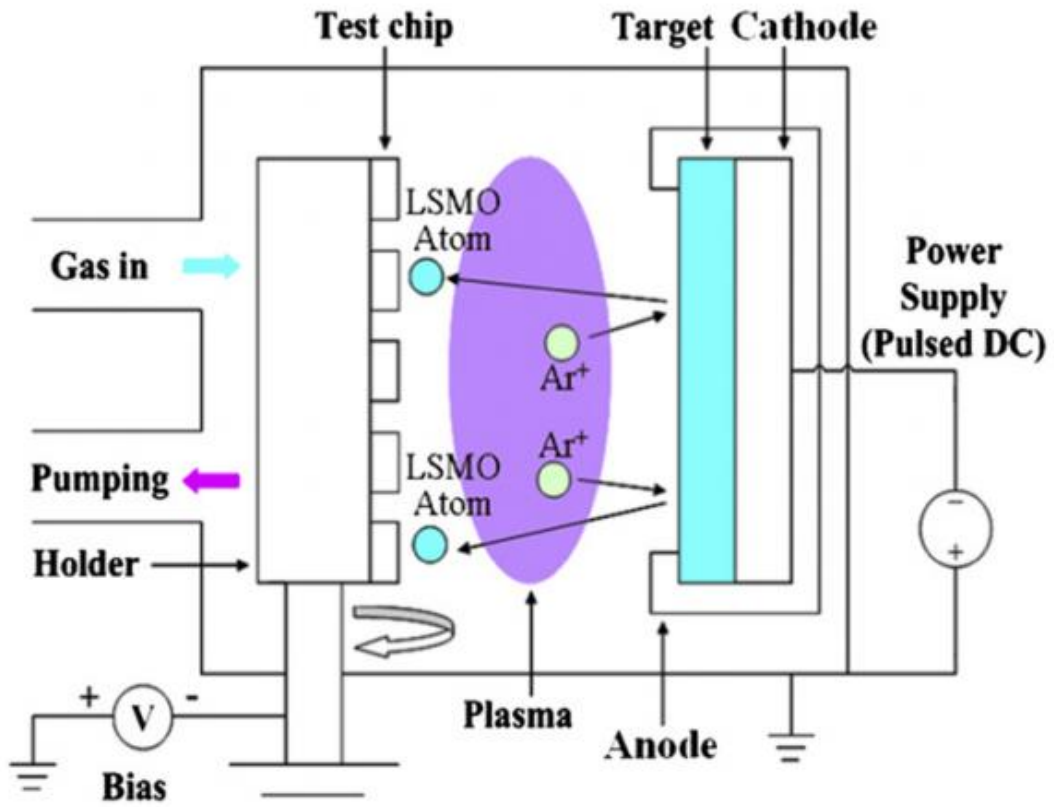
Fig. 6 Schematic diagram of a pulsed DC magnetron sputtering system. [58]

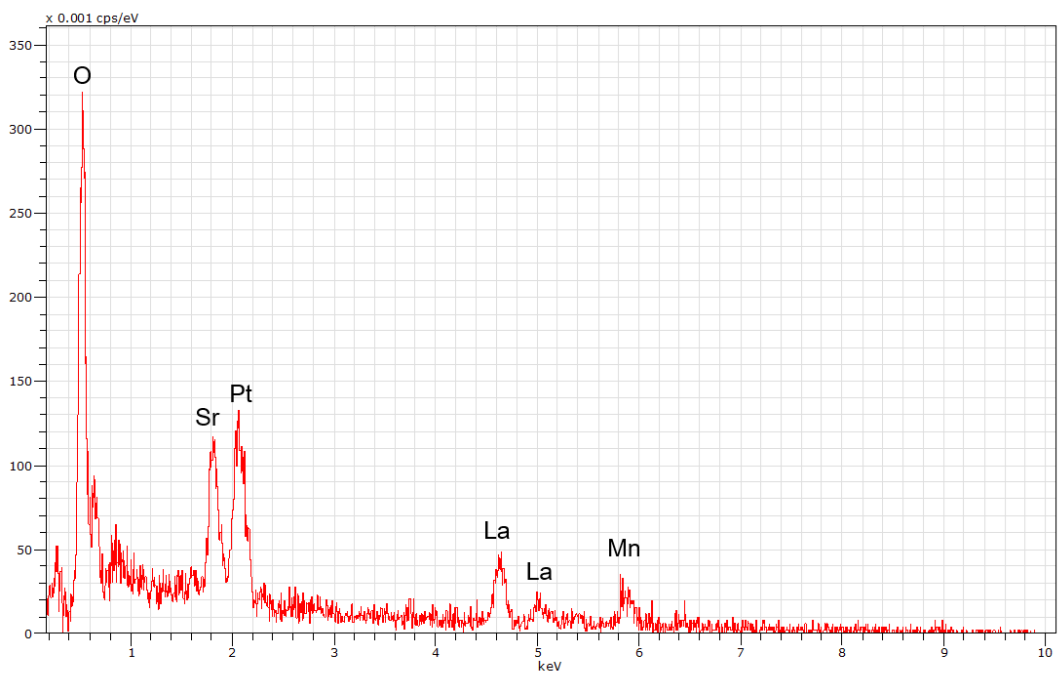
Fig. 22 EDS analysis result of the LSM coating observed in Fig. 21.

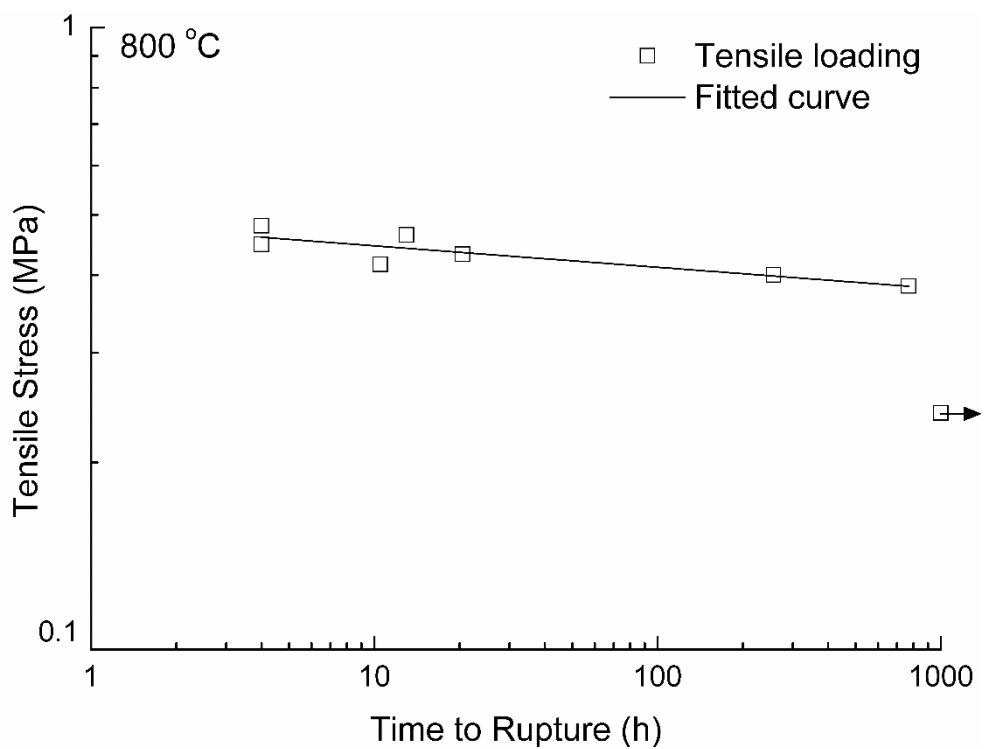
Fig. 50 Applied stress versus rupture time for 1000 h-aged joint specimens subjected to constant (a) shear and (b) tensile loading.
