行政院原子能委員會
委託研究計畫研究報告

環境效應對 SOFC 玻璃陶瓷接合劑高溫機械性質之影響
**Environmental Effects on the Mechanical Properties of
Glass-Ceramic Sealant in Solid Oxide Fuel Cell**

計畫編號：1032001INER025

受委託機關（構）：國立中央大學

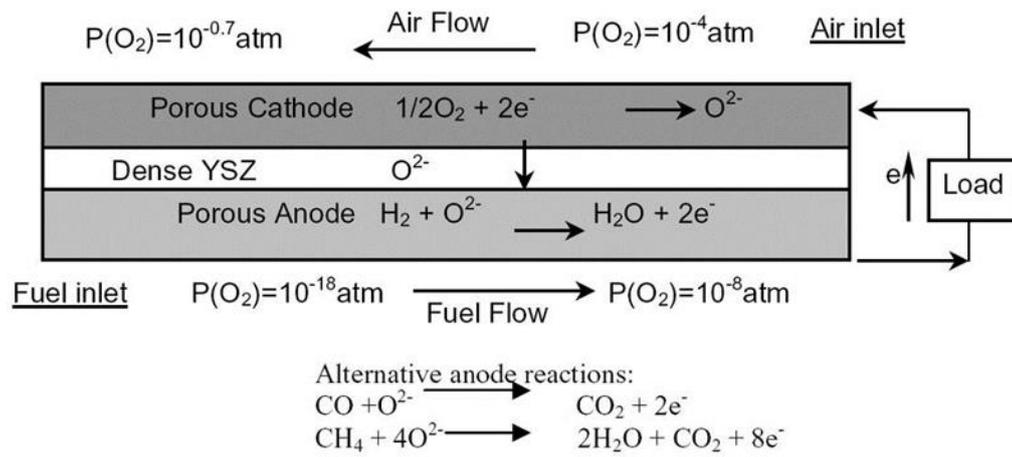
Fig. 1 Operating principle of a single SOFC unit using hydrogen as fuel. [3]

Figure 1 shows the operating principle of an SOFC using hydrogen as fuel [3]. The electrochemical reactions involved are expressed below:

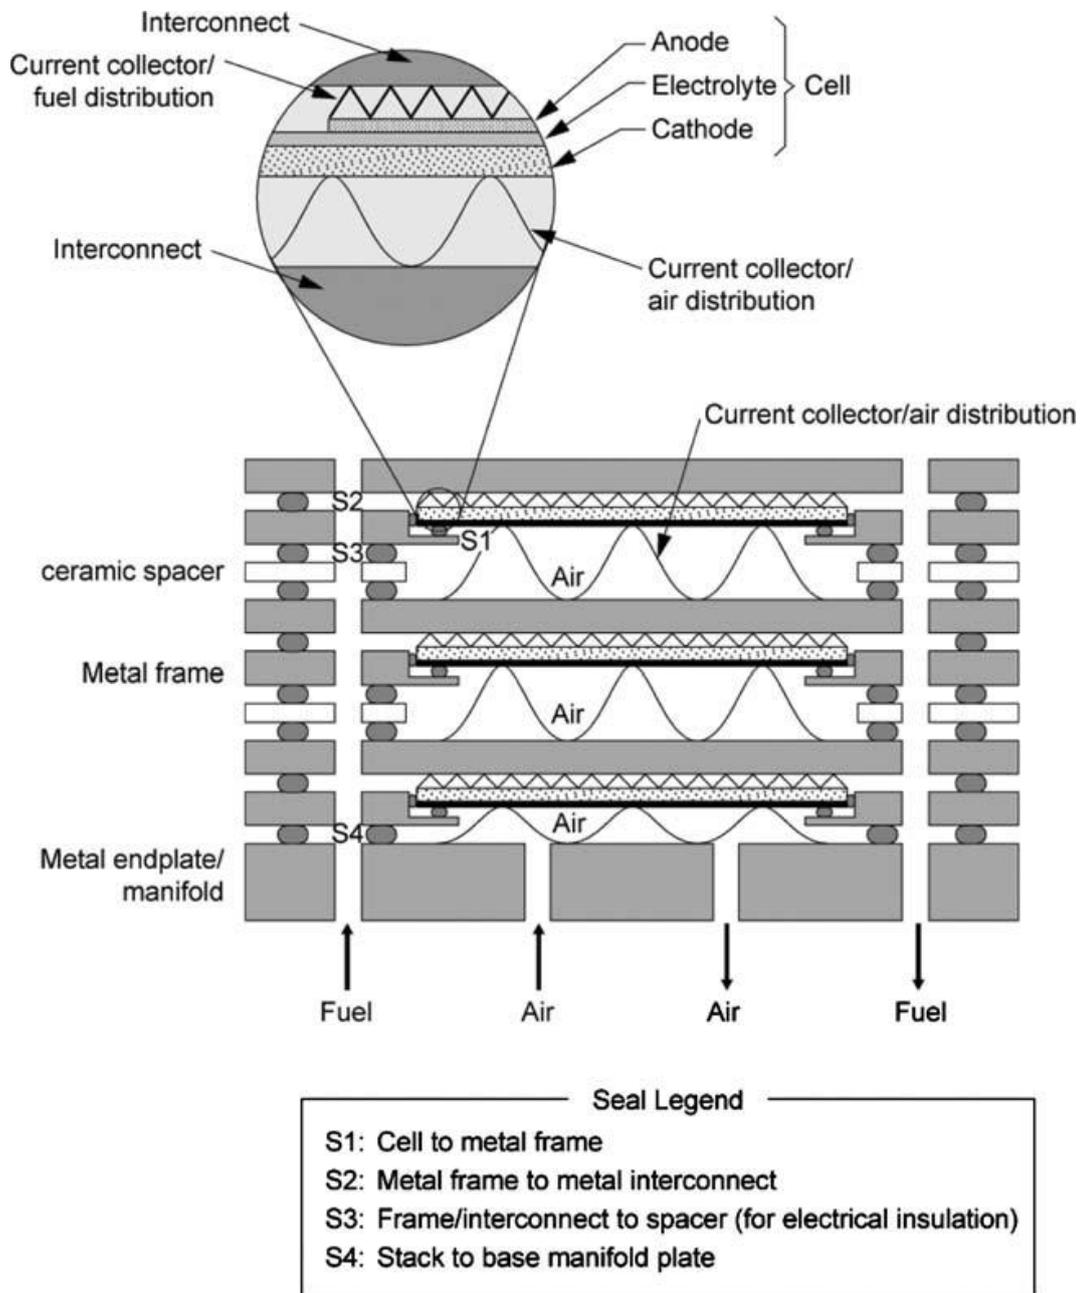
Fig. 3 Scheme of seals used in a planar SOFC stack with metallic interconnects and metallic internal gas manifold channels. [12]

As mentioned in Section 1.3, glass-ceramic sealants are applied as a rigid sealing to bond each layer together and prevent direct mixing of air and fuel SOFC stack. Among the four sealing locations shown in Fig. 3 [12], sealing of a metallic frame to a metallic interconnect (S2) or of a stack to a base manifold plate (S4) is regarded as a joint of glass-ceramic sealant and metallic interconnect. In order to simulate the conditions of a joint subjected to thermal stresses at room temperature and operating temperature, two types of sandwich-like specimens (metal/sealant/metal) are designed in this study for determining the mechanical properties of the joint and investigating the interfacial reactions.

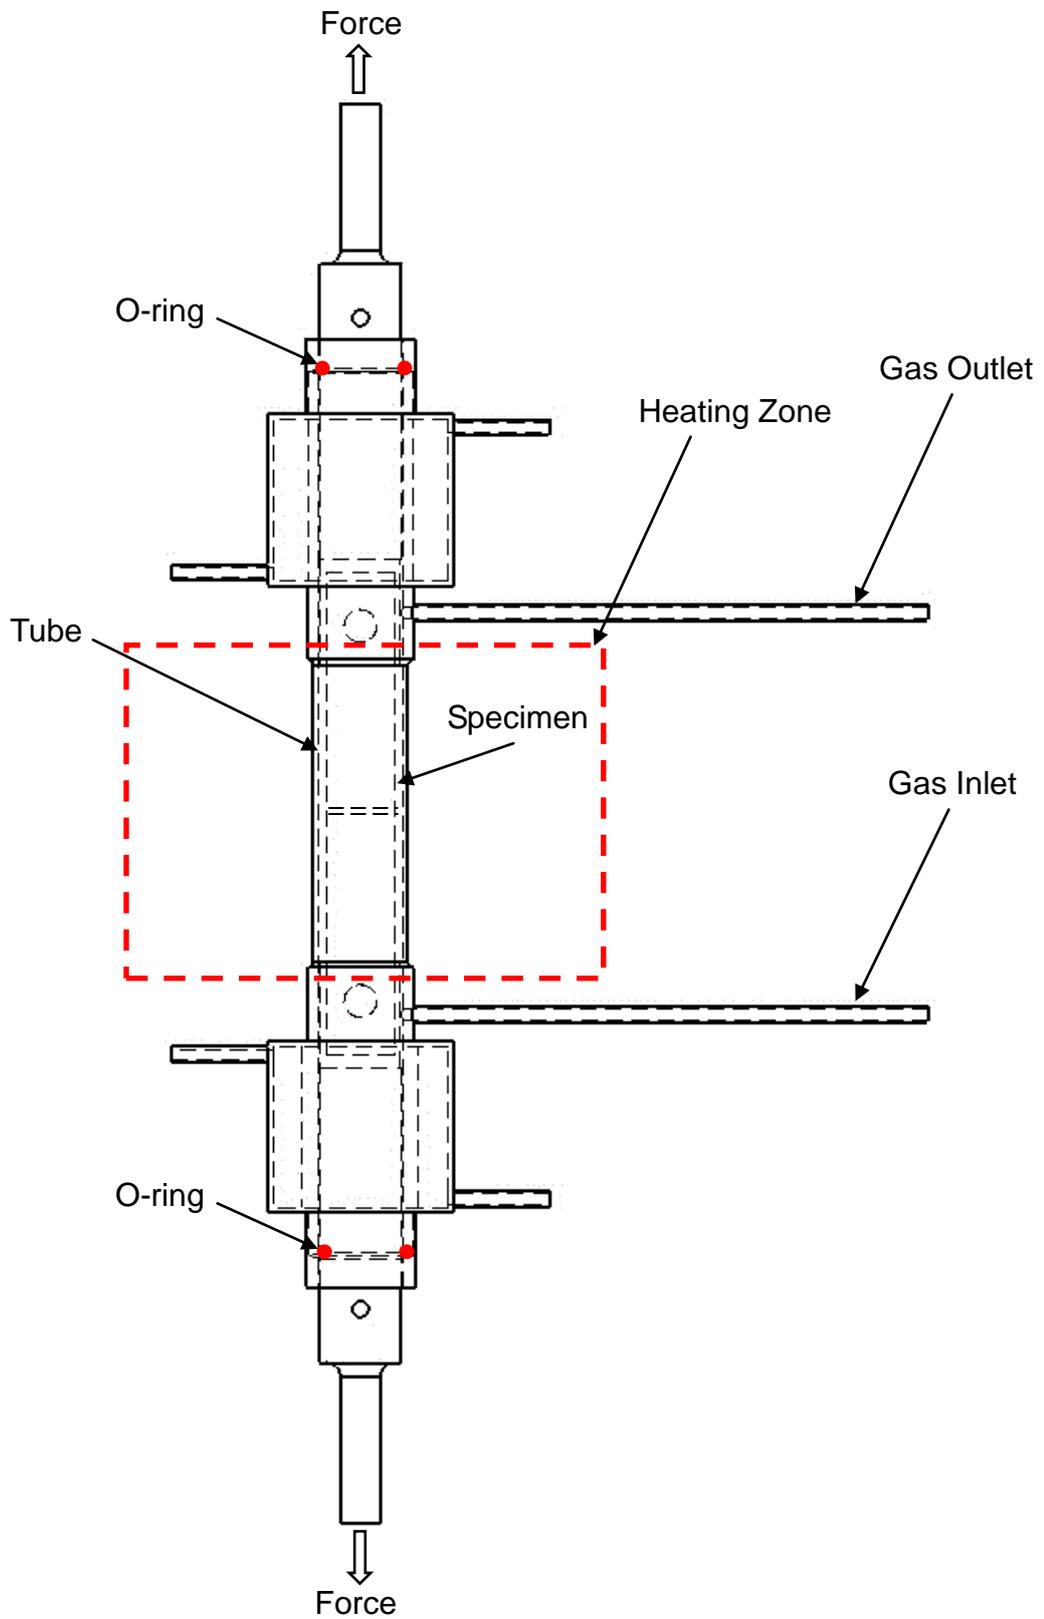
Fig. 6 Schematic of specimen enclosed by a gas-tight tube in mechanical test.

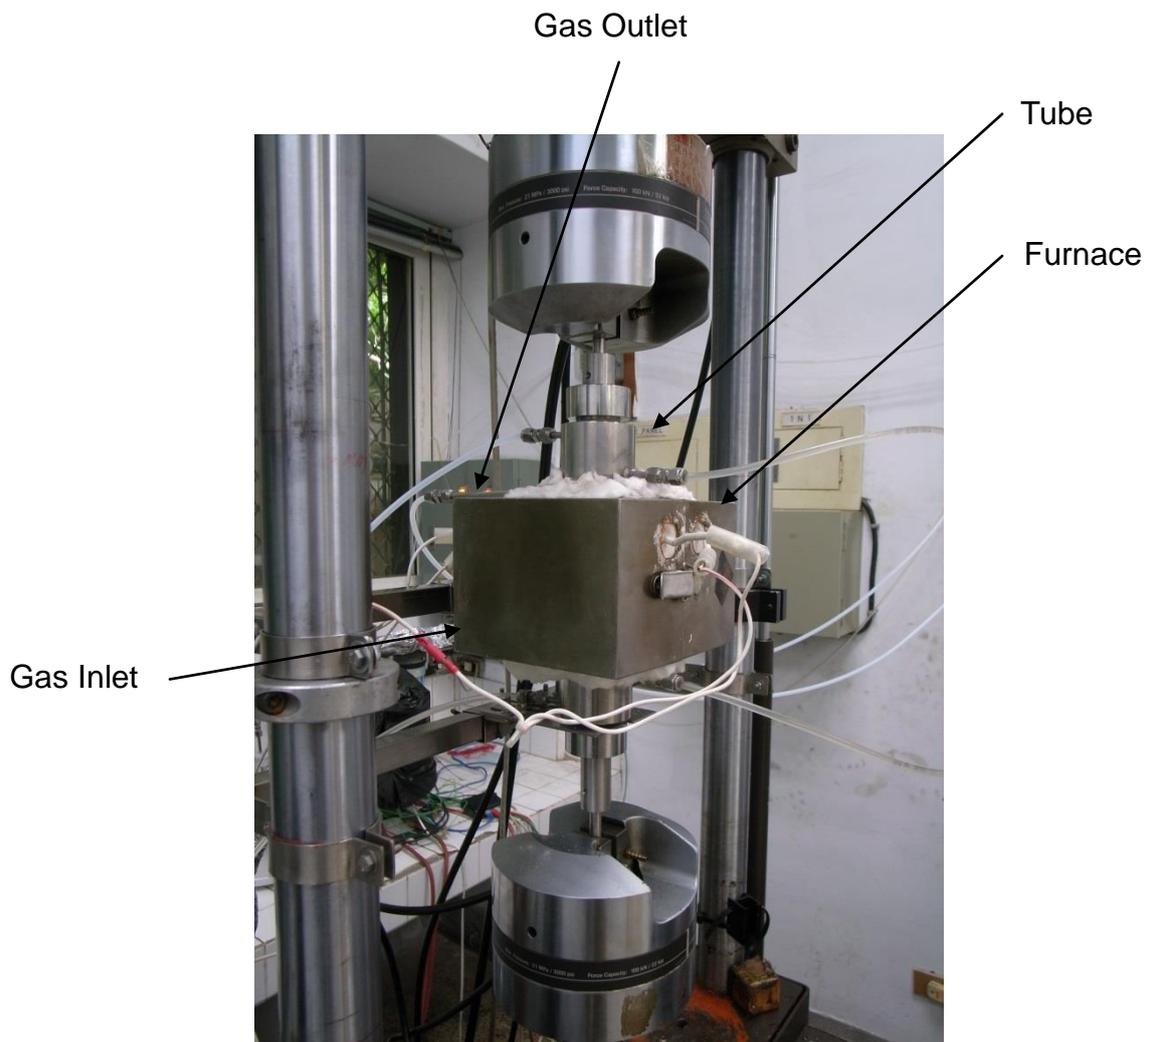
Fig. 7 Photograph of experimental setup for mechanical test.

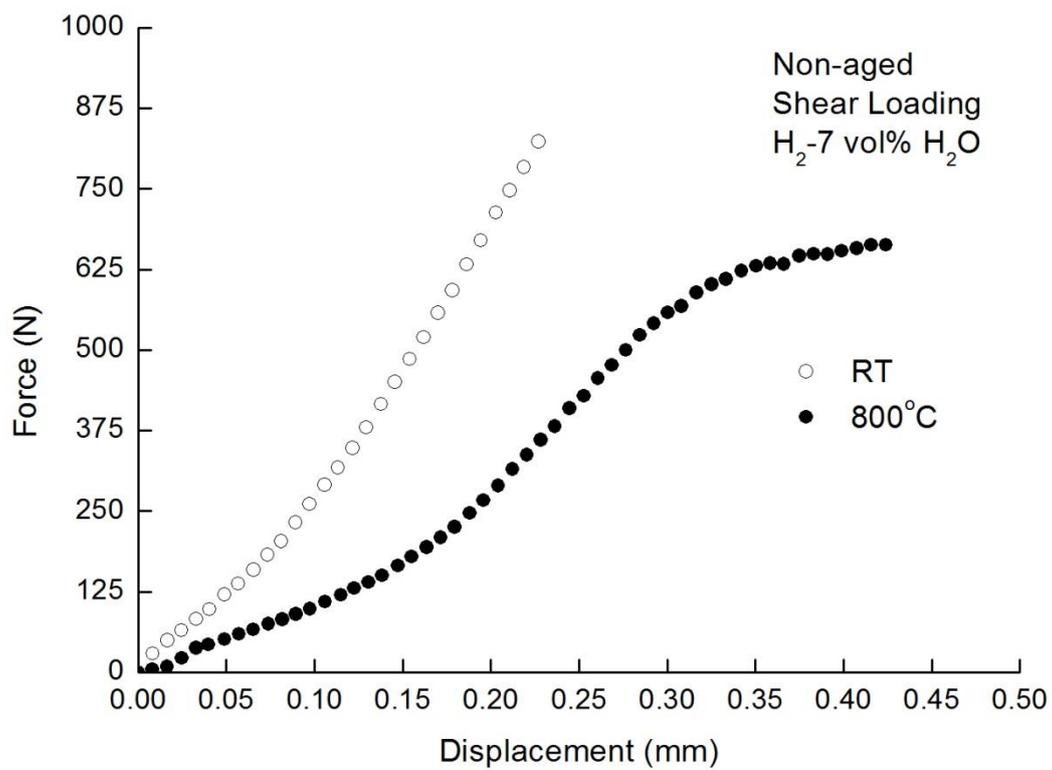
Fig. 9 Typical force-displacement curves of the non-aged joint specimens tested under shear loading in H₂-7 vol% H₂O at room temperature and 800 °C.

After sintering, the non-aged specimens were tested under tensile or shear loading in H₂-7 vol% H₂O at room temperature and 800 °C. Typical force-displacement curves for the non-aged shear specimens tested at room temperature and 800 °C are shown in Fig. 9. The force-displacement curve at room temperature exhibits a typical pattern of brittle fracture with fracture taking place at the linear portion. However, the force-displacement curve at 800 °C exhibits a non-linear failure mode. As the testing temperature of 800 °C is higher than the softening temperature (745 °C) of the GC-9 glass-ceramic, the failure behavior at 800 °C changes from a brittle mode to a ductile one.

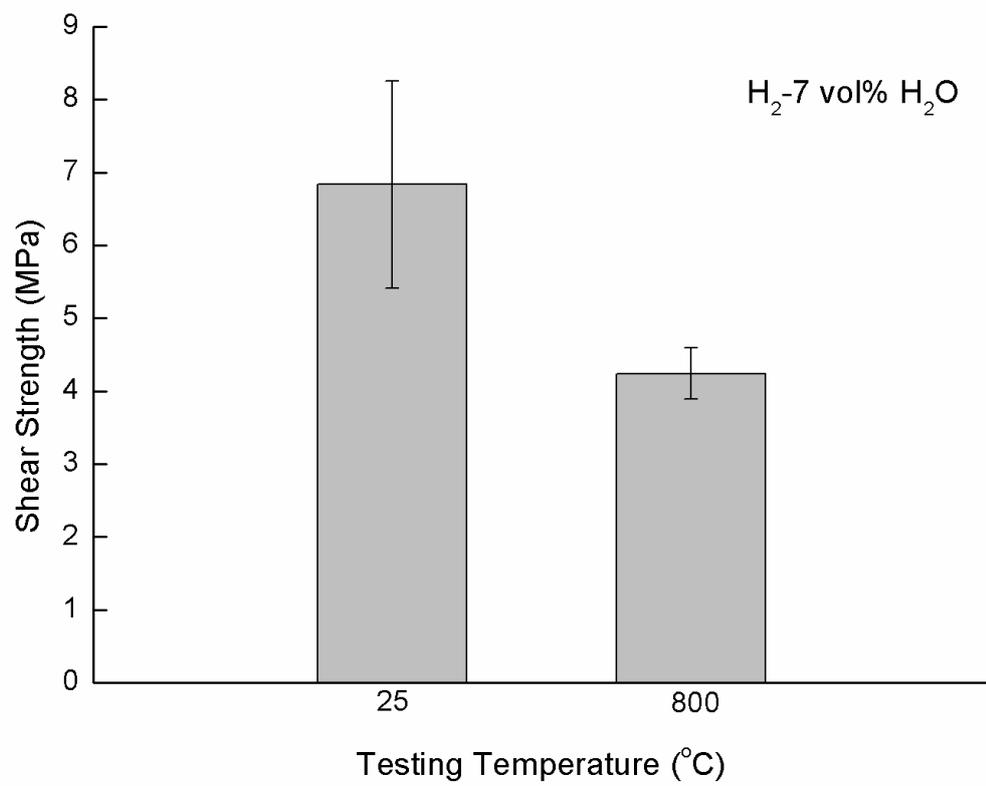
Fig. 10 Shear strength of non-aged joint specimens tested in H₂-7 vol% H₂O at room temperature and 800 °C.

The average shear strength of the non-aged joint specimens tested at room temperature and 800 °C are shown in Fig. 10. In Fig. 10, the height of a solid bar indicates the average strength value and the attached error bar represents the standard deviation for each given condition. For the shear loading mode, the average joint strength is 6.8 MPa at room temperature and decreases to 4.2 MPa at 800 °C. The standard deviation is 1.4 MPa and 0.3 MPa, respectively. Figure 11 shows the failure patterns in the non-aged shear specimens tested at room temperature and 800 °C. There are two Crofer 22 H slices in Fig. 11(a); the upper one is separated from the glass-ceramic after testing and the lower one is still adhered with the GC-9 glass-ceramic. There is a shining region in the middle of the upper Crofer 22 H slice, and there is a corresponding darker region in the lower half on the surface of the GC-9 with a shape similar to the shining region. The darker region is the chromia layer which is peeled from the metal substrate. Hence, a metallic luster of the metal substrate appears in the shining region. Note that BaCrO₄ chromate also appears at the periphery of the shining region in Fig. 11(a). However, this phenomenon is not observed in Fig. 11(b). No such shining region is observed on the upper Crofer 22 H slice in Fig. 11(b), but a slightly bright region is observed on the top surface of the Crofer 22 H slice. The composition of the slightly bright region is identified to be the GC-9. Again, BaCrO₄ chromate appears at the periphery of the slightly bright region in Fig. 11(b). Evidences of microstructural observation for selected regions in the fracture surfaces of Fig. 11(a) and 11(b) are provided as follows. Optical and SEM micrographs of two outlined regions of the fracture surface without adhered glass-ceramic in the upper micrograph of Fig. 11(a) are shown in Fig. 12. As Cr, Fe, and O elements are detected in Fig. 12(b), the shining region is indeed the metal substrate. By means of EDX analysis, Cr, Ba, and O elements are detected in Fig. 12(c), indicating that this region is a BaCrO₄ chromate layer. Such microstructural features of SEM for the metal substrate and BaCrO₄ chromate are similar to those observed by Chen [30]. The EDX results of Fig. 12(b) and

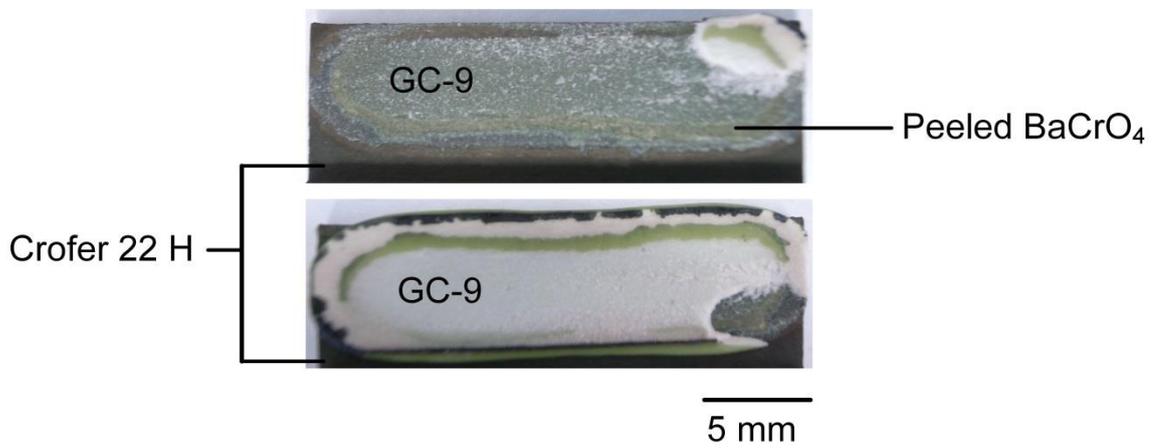
Fig. 11 Failure patterns of non-aged shear specimens tested in H₂-7 vol% H₂O at (a) room temperature and (b) 800 °C.

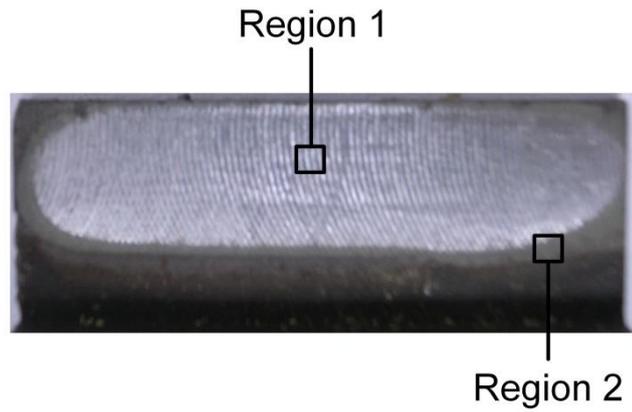
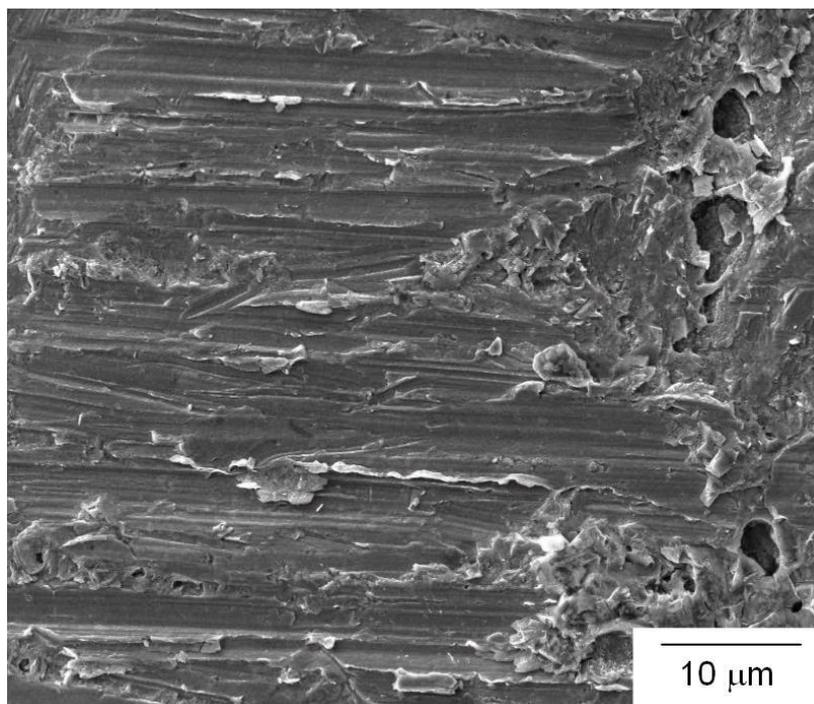
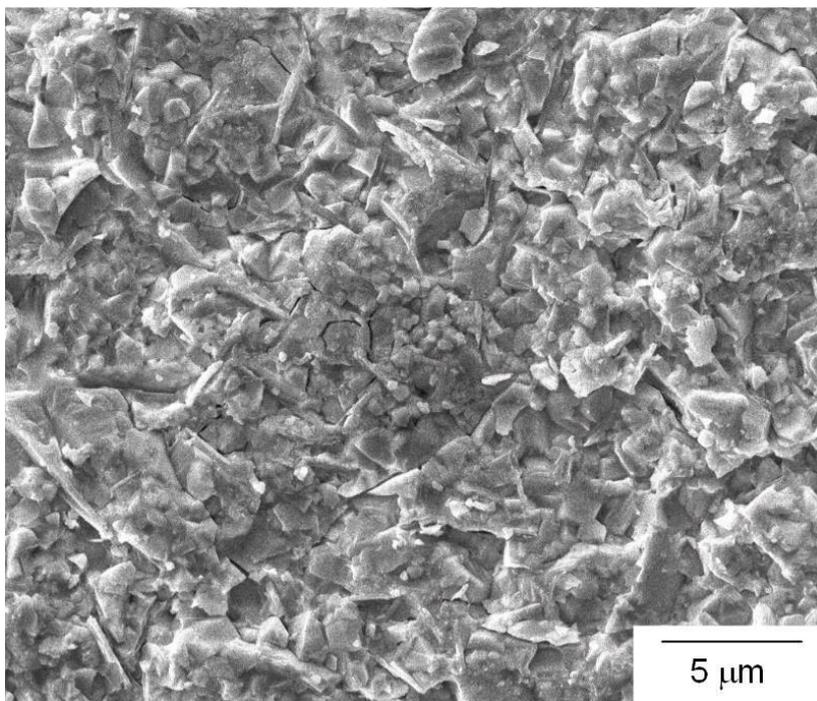
Fig. 12 A fracture surface region of the non-aged shear specimen shown in the upper part of Fig. 11(a): (a) optical micrograph showing the observed regions of SEM; (b) SEM micrograph of region 1 (metal substrate); (c) SEM micrograph of region 2 (BaCrO_4 chromate).

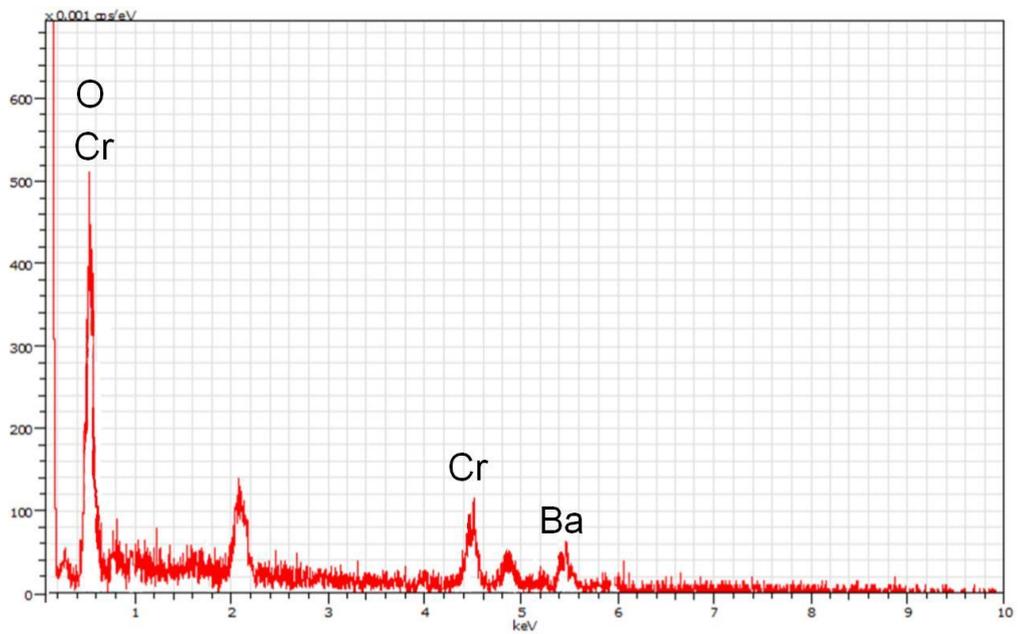
Fig. 13 EDS analysis results of the fracture surface of a non-aged shear joint specimen: (a) metal substrate (in Fig.12(b)); (b) BaCrO₄ chromate layer (in Fig. 12(c)).

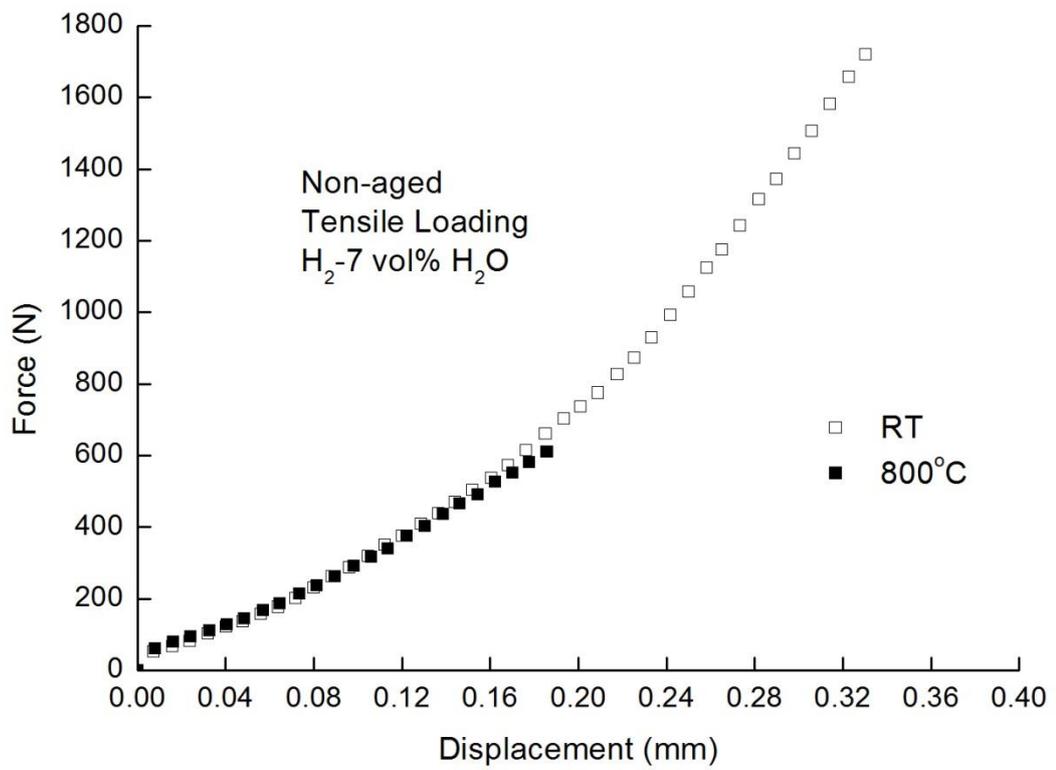
Fig. 14 Typical force-displacement curves of the non-aged joint specimens tested in H₂-7 vol% H₂O under tensile loading at room temperature and 800 °C.

Typical force-displacement curves for the non-aged tensile specimens tested in H₂-7 vol% H₂O at room temperature and 800 °C are shown in Fig. 14. The force-displacement curves at room temperature and 800 °C both exhibit a typical linear brittle fracture pattern. Figure 15 shows the tensile strength of the non-aged joint specimens tested in H₂-7 vol% H₂O at room temperature and 800 °C. For the tensile loading mode, the average joint strength at room temperature is about 31.3 MPa and drops to about 11.9 MPa at 800 °C. The standard deviation for room temperature and 800 °C is 4.4 MPa and 4.7 MPa, respectively. The fracture patterns of non-aged tensile specimens tested at room temperature and 800 °C are not as diverse as those of shear specimens. Figure 16 shows the typical failure patterns of tensile specimens tested at room temperature and 800 °C. Optical and SEM micrographs of an outlined region in the upper micrograph of Fig. 16(a) are shown in Fig. 17. Needle-shape crystalline phases (α -Ba (Al₂Si₂O₈)) are observed in Fig. 17(c), indicating the fracture surface is covered with a glass-ceramic layer. Figure 18 shows the optical and SEM micrographs of an outlined region in the lower micrograph of Fig. 16(b). High-magnification SEM micrographs of the glass-ceramic features are presented in Fig. 18(c). These fractography observations indicate that delamination occurs within the glass-ceramic layer for the tensile specimens tested in H₂-7 vol% H₂O at room temperature. Figures 19 and 20 show the SEM micrographs of the upper and lower parts of Fig. 16(b), respectively. Similar to the results of the tensile specimens tested at room temperature, fracture also occurs within the glass-ceramic layer for tensile specimens tested in H₂-7 vol% H₂O at 800 °C.

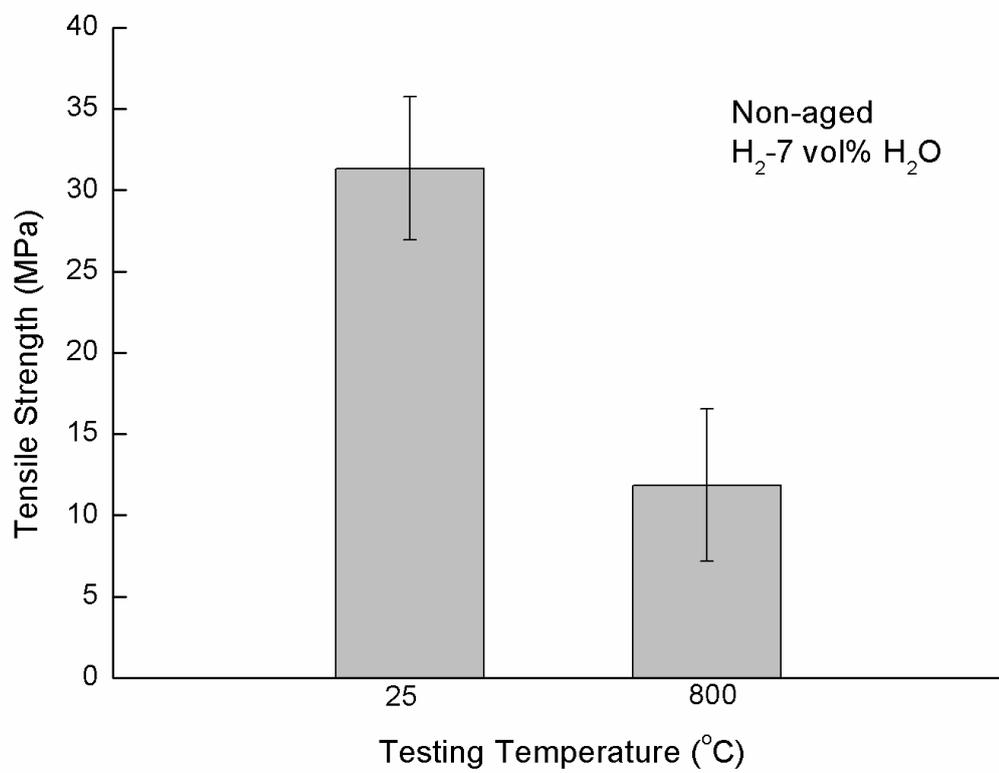
Fig. 15 Tensile strength of non-aged joint specimens tested in H₂-7 vol% H₂O at room temperature and 800 °C.

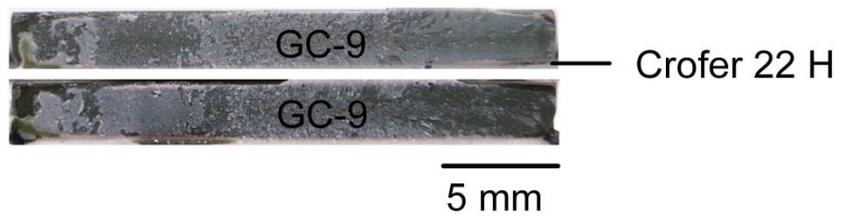
Fig. 16 Failure patterns of non-aged tensile specimens tested in H_2 -7 vol% H_2O at (a) room temperature and (b) 800 °C.

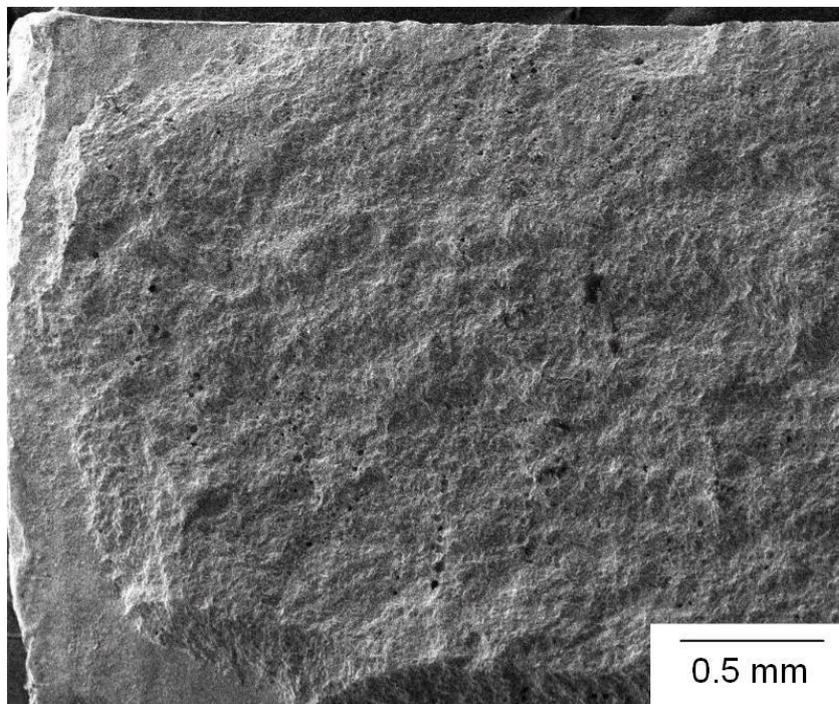
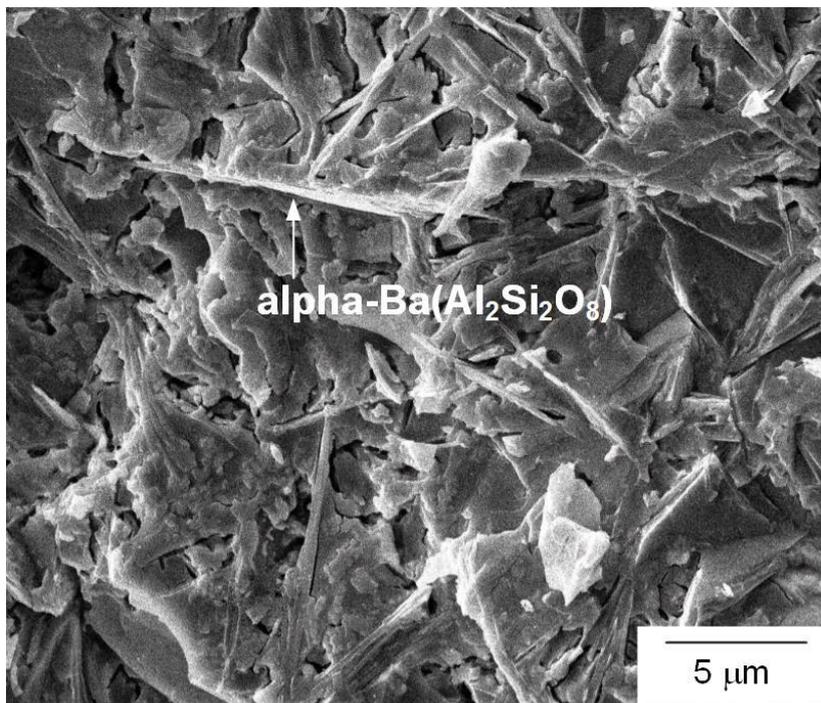
Fig. 17 A fracture surface region of the non-aged tensile specimen shown in the upper part of Fig. 16(a): (a) optical micrograph showing the observed region of SEM; (b) SEM micrograph of the outlined region (glass-ceramic layer); (c) microstructure of GC-9 glass-ceramic.

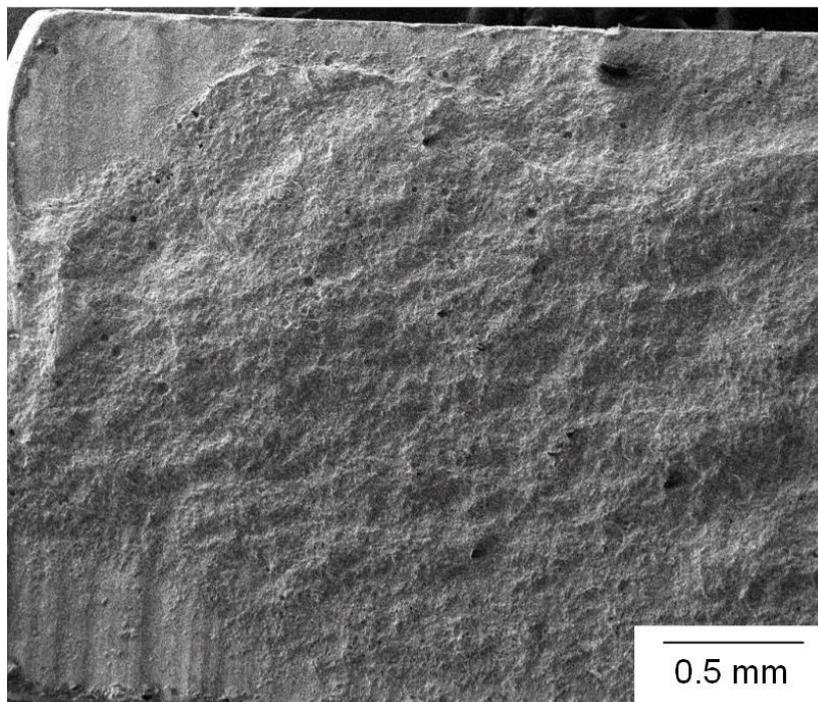
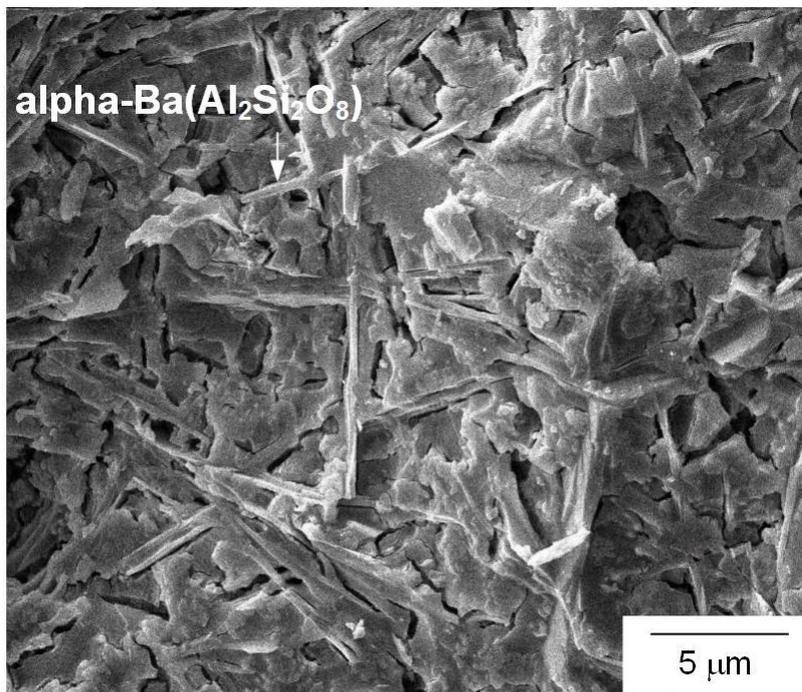
Fig. 18 A fracture surface region of the non-aged tensile specimen shown in the lower part of Fig. 16(a): (a) optical micrograph showing the observed region of SEM; (b) SEM micrograph of the outlined region (glass-ceramic layer); (c) microstructure of GC-9 glass-ceramic.

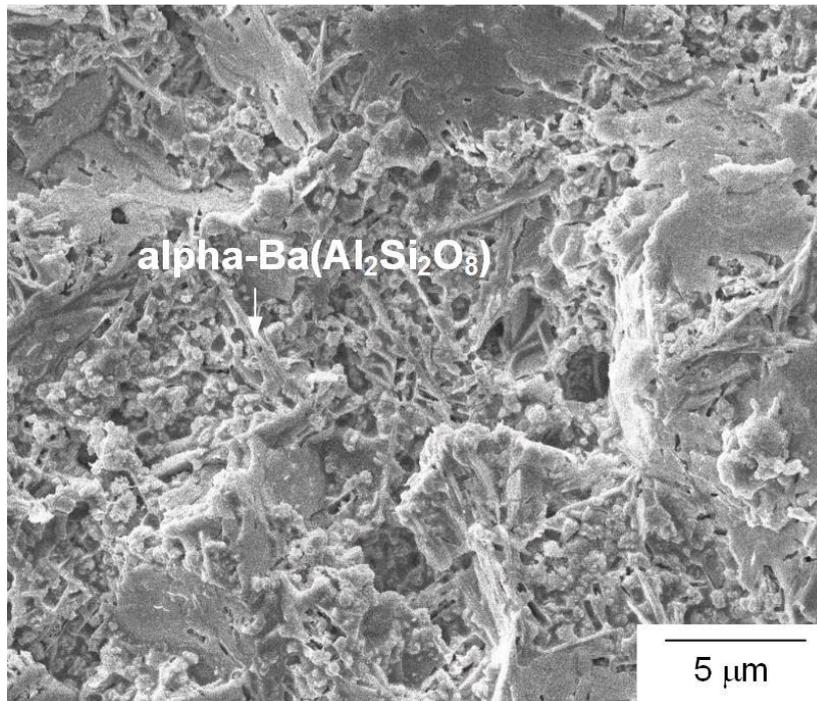
Fig. 19 A fracture surface region of the non-aged tensile specimen shown in the upper part of Fig. 16(b): (a) optical micrograph showing the observed region of SEM; (b) microstructure of GC-9 glass-ceramic.

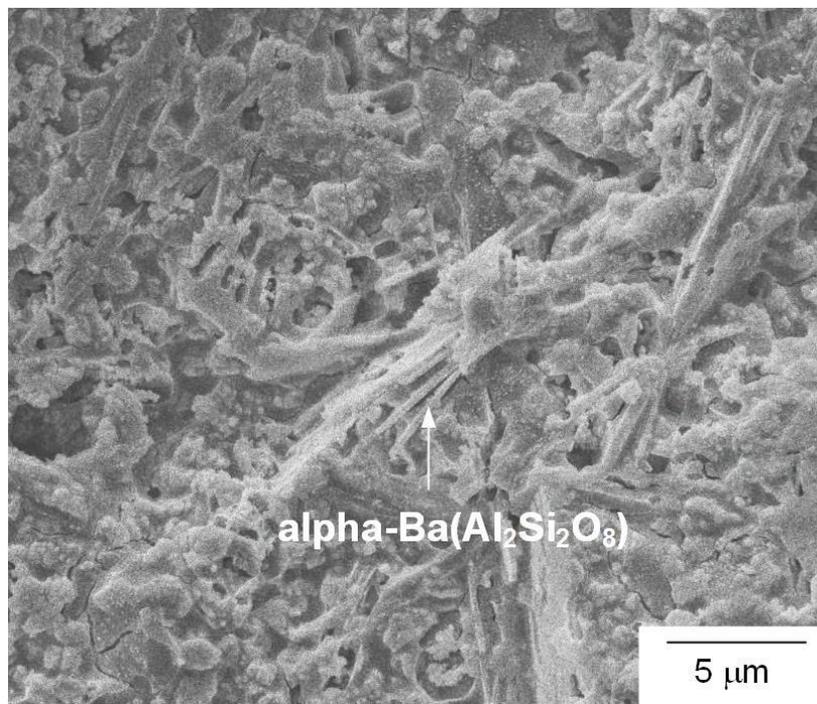
Fig. 20 A fracture surface region of the non-aged tensile specimen shown in the lower part of Fig. 16(b): (a) optical micrograph showing the observed region of SEM; (b) microstructure of GC-9 glass-ceramic.

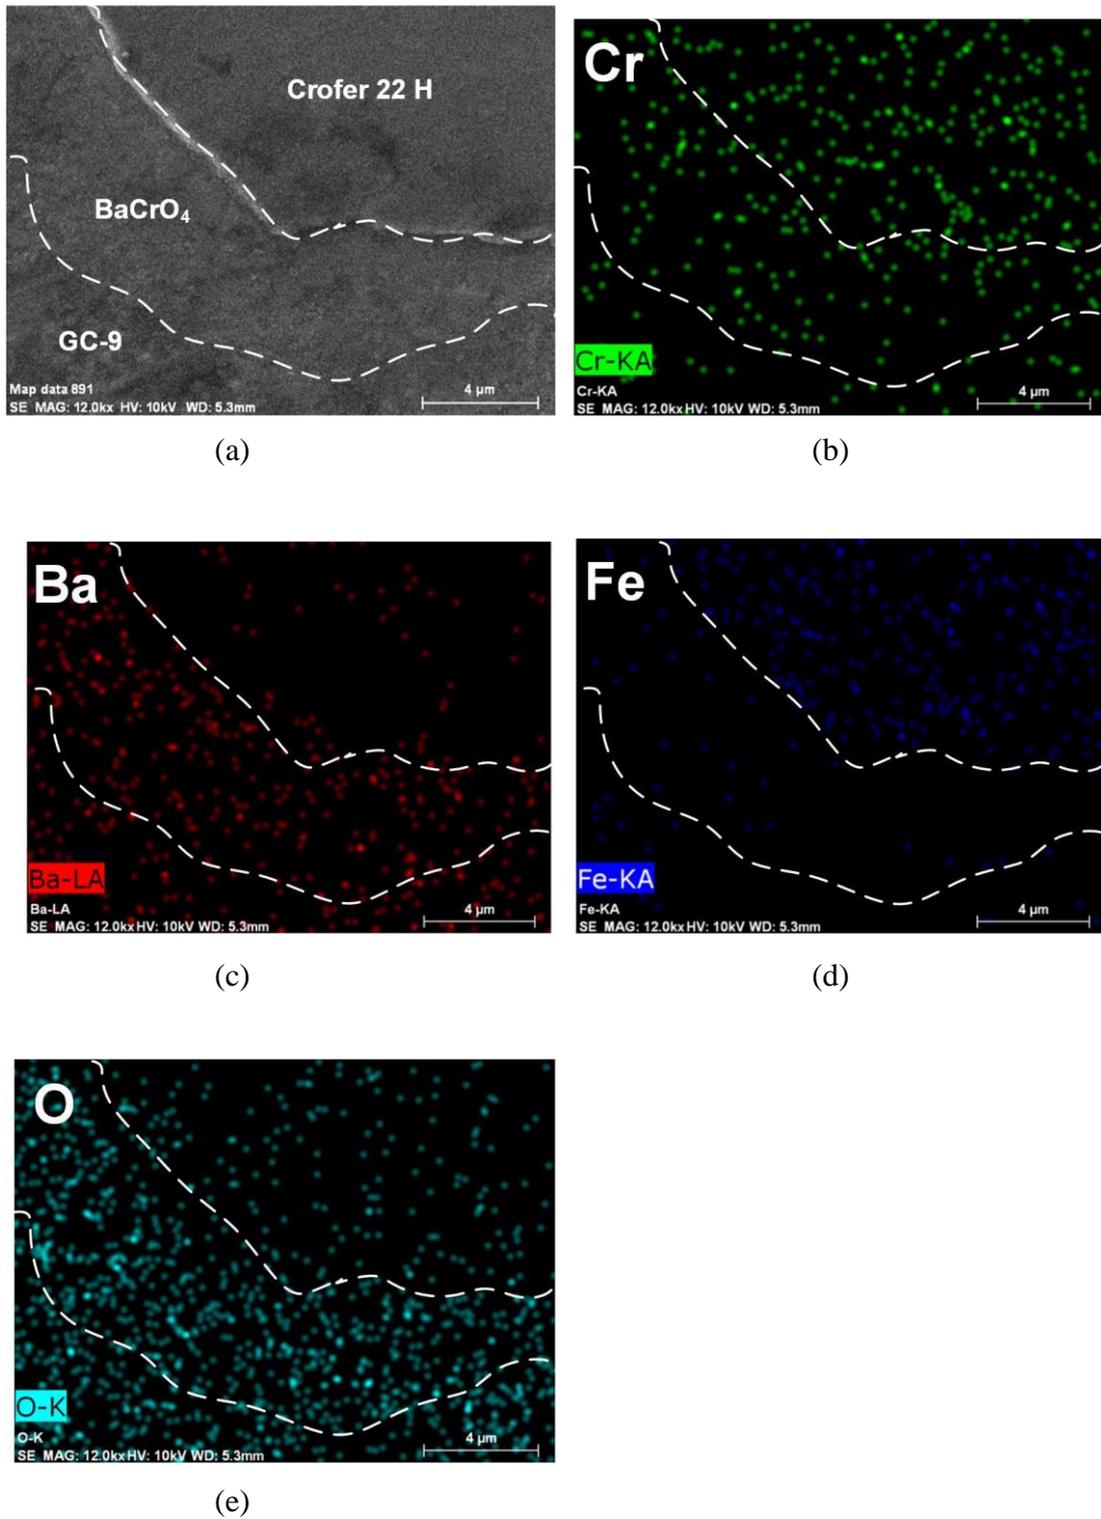
Fig. 22 EDS mapping of elements on the cross section of an interface between the GC-9 and Crofer 22 H shown in Fig. 21(b): (a) mapping region; (b) Cr; (c) Ba; (d) Fe; (e) O.

which is expected to be exposed to more oxygen during the assembling process, compared to that formed at the central region of the joint. Through EDS analysis, element distributions in these zones are confirmed and shown in Fig. 22. A high intensity of Cr and Fe is found in the region of Crofer 22 H, as expected. As shown in Fig. 22(b), 22(c), and 22(e), a high intensity of Cr, Ba, and O is found in the light gray region, indicating that this region is a BaCrO₄ chromate layer. As mentioned before, the main mechanism of interfacial joining between the glass-ceramic and metallic interconnect is formation of two oxide layers with a Cr₂O₃ layer on the surface of Crofer 22 APU connected with a BaCrO₄ chromate layer on the surface of GC-9 [17]. As shown in Fig. 21(c), a chromia oxide (Cr₂O₃) layer on the metal side is seen and has a thickness about 0.2 μm. However, the BaCrO₄ chromate layer is barely found in the SEM micrographs at the central region of the joint. It is implied that the BaCrO₄ chromate layer is too thin to be observed due to a less amount of oxygen available in the inner central region. Similar observations of formation of a chromate layer at the outer sealing edges are also reported in the study of Chou et al. [24].

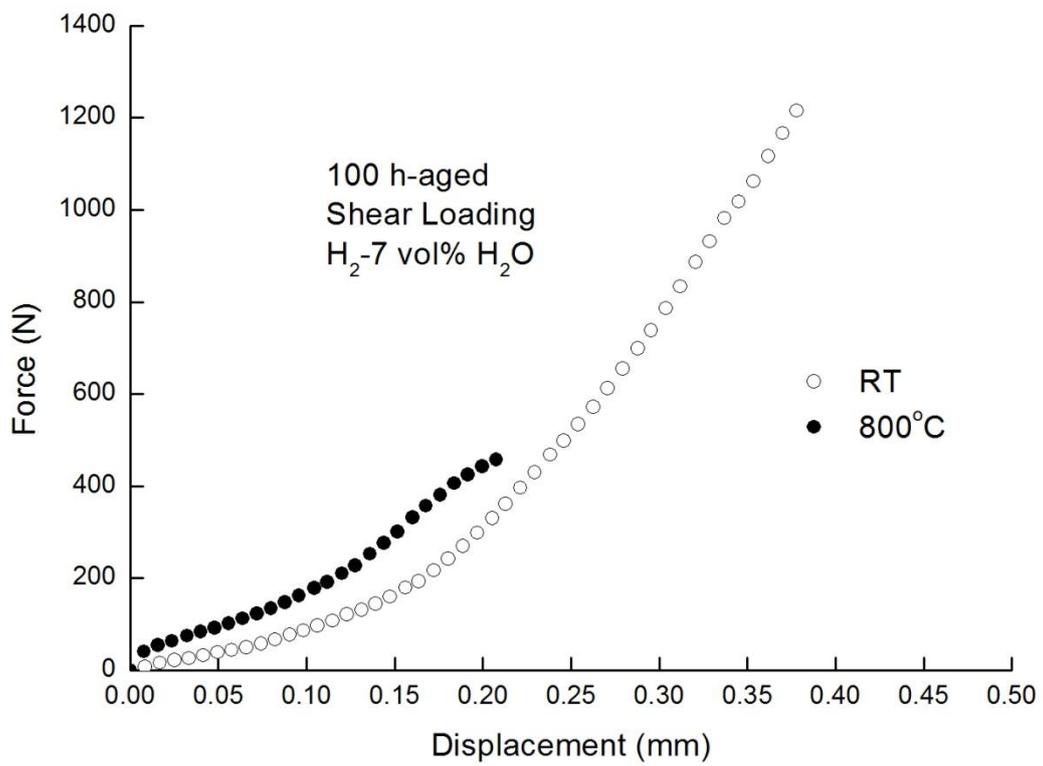
Fig. 23 Typical force-displacement curves of the 100 h-aged joint specimens tested under shear loading in H₂-7 vol% H₂O at room temperature and 800 °C.

After a 100-h aging treatment, the aged specimens were tested under tensile or shear loading in H₂-7 vol% H₂O at room temperature and 800 °C. The force-displacement curves for the 100 h-aged shear specimens tested in H₂-7 vol% H₂O at room temperature and 800 °C exhibit a typical pattern of brittle fracture and a non-linear failure mode, respectively (Fig. 23). For the 100 h-aged tensile specimens tested in H₂-7 vol% H₂O at room temperature and 800 °C, the force-displacement curves both exhibit a typical pattern of brittle fracture (Fig. 24.).

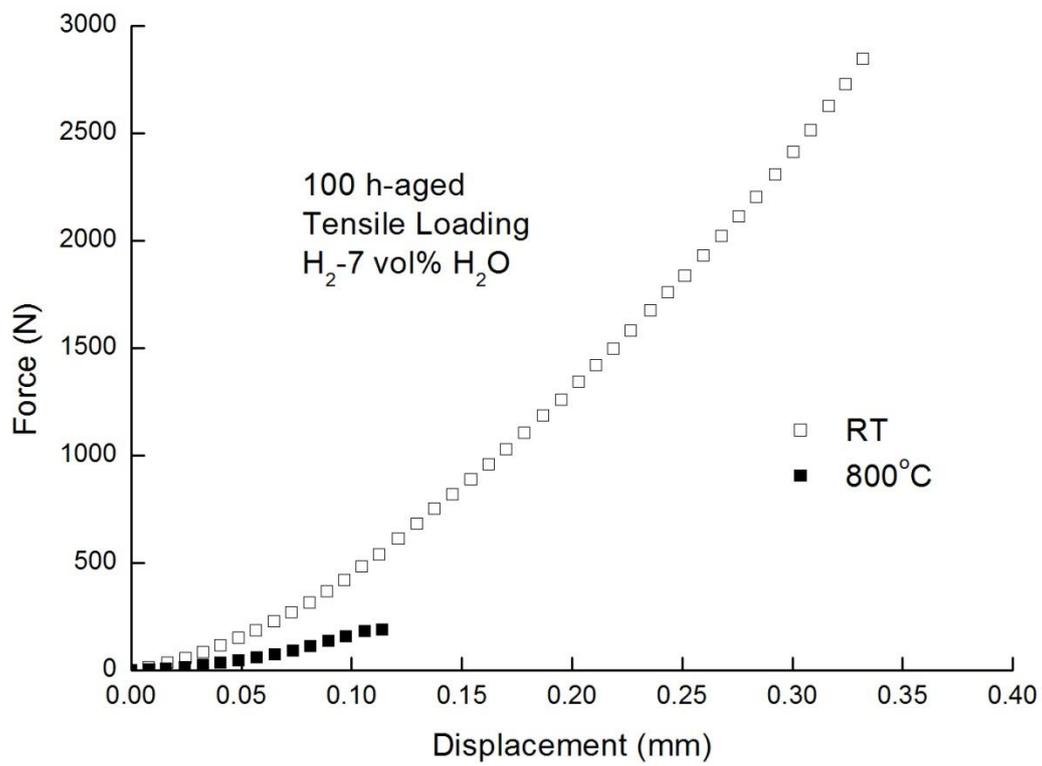
Fig. 24 Typical force-displacement curves of the 100 h-aged joint specimens tested under tensile loading in H₂-7 vol% H₂O at room temperature and 800 °C.

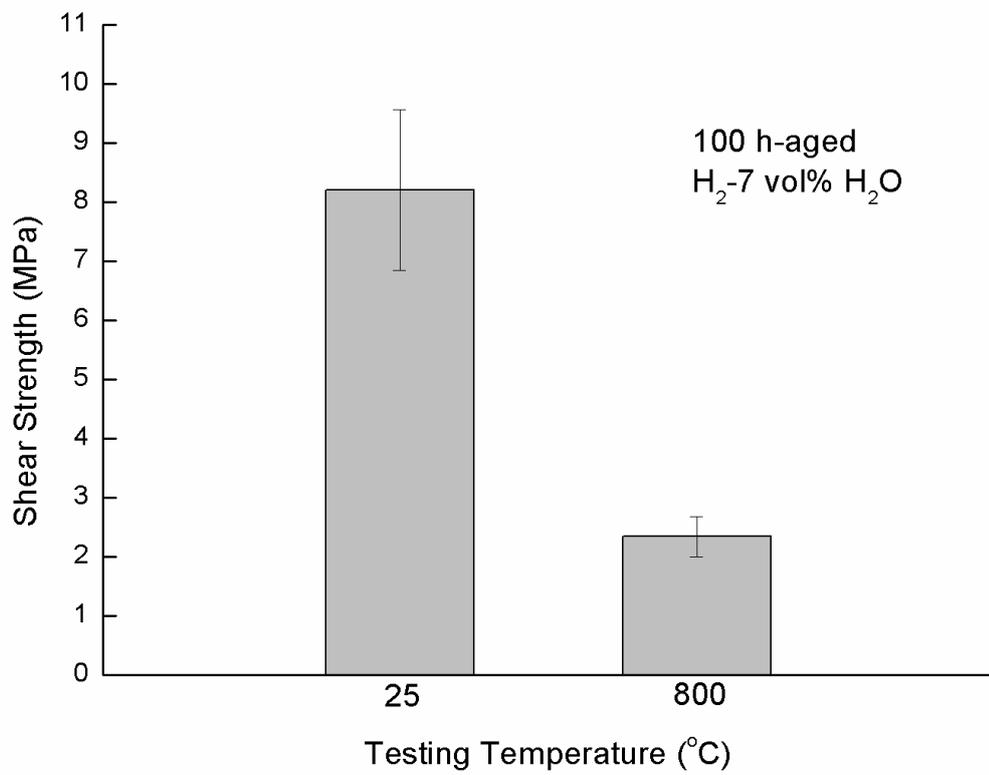
Fig. 25 Shear strength of 100 h-aged joint specimens tested in H₂-7 vol% H₂O at room temperature and 800 °C.

The average shear strength of the 100 h-aged joint specimens tested at room temperature and 800 °C is shown in Fig. 25. For the 100 h-aged shear specimens, the average joint strength is 8.2 MPa at room temperature and decreases to 2.3 MPa at 800 °C due to a high-temperature softening mechanism. The standard deviation is 1.4 MPa and 0.3 MPa, respectively. Figure 26 shows the failure patterns in the 100 h-aged shear specimens tested in H₂-7 vol% H₂O at room temperature and 800 °C. As shown in each of Fig. 26(a) and 26(b), the upper Crofer 22 H slice is peeled from the glass-ceramic layer after testing and the lower one is still adhered with the GC-9 glass-ceramic/BaCrO₄ chromate layer. Figures 27 and 28 show the SEM micrographs of the upper and lower parts of Fig. 26(a), respectively. A slightly bright region is observed on the fracture surface of the upper Crofer 22 H slice in Fig. 26(a). Optical and SEM micrographs of an outlined region

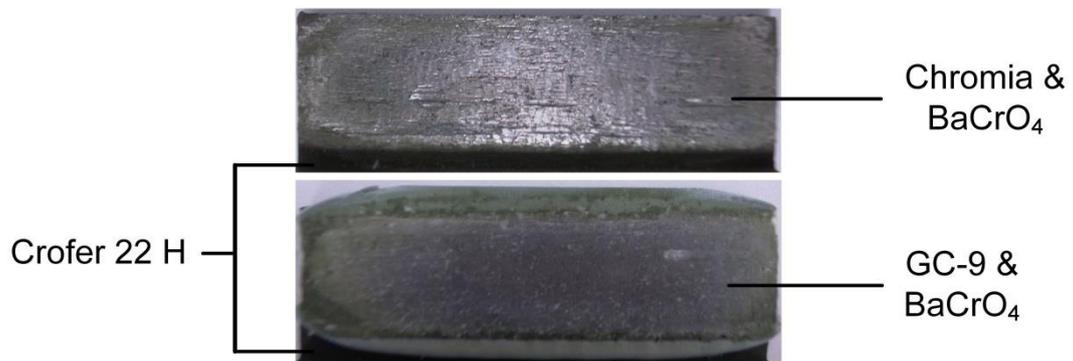
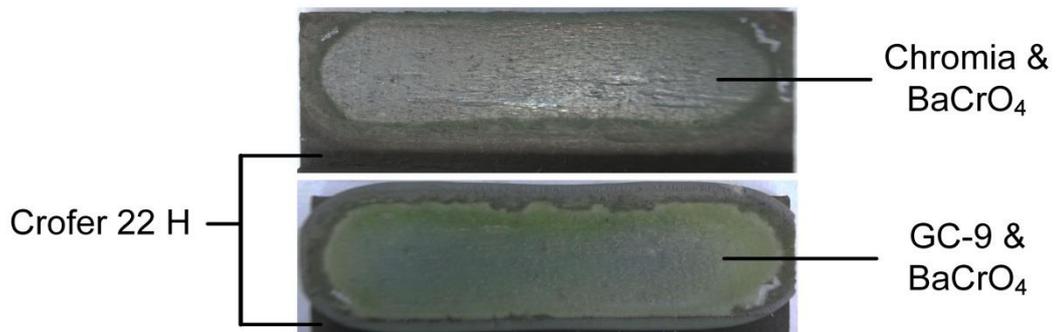
Fig. 26 Failure patterns of 100 h-aged shear specimens tested in H₂-7 vol% H₂O at (a) room temperature and (b) 800 °C.
