行政院原子能委員會
委託研究計畫研究報告

環境效應對 SOFC 玻璃陶瓷接合劑高溫機械性質之影響
**Environmental Effects on the Mechanical Properties of
Glass-Ceramic Sealant in Solid Oxide Fuel Cell**

計畫編號：1032001INER025

受委託機關（構）：國立中央大學

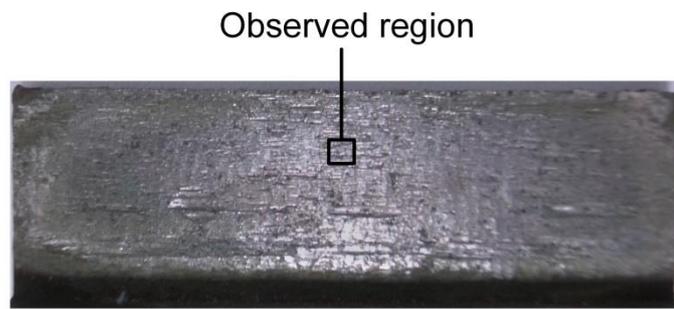
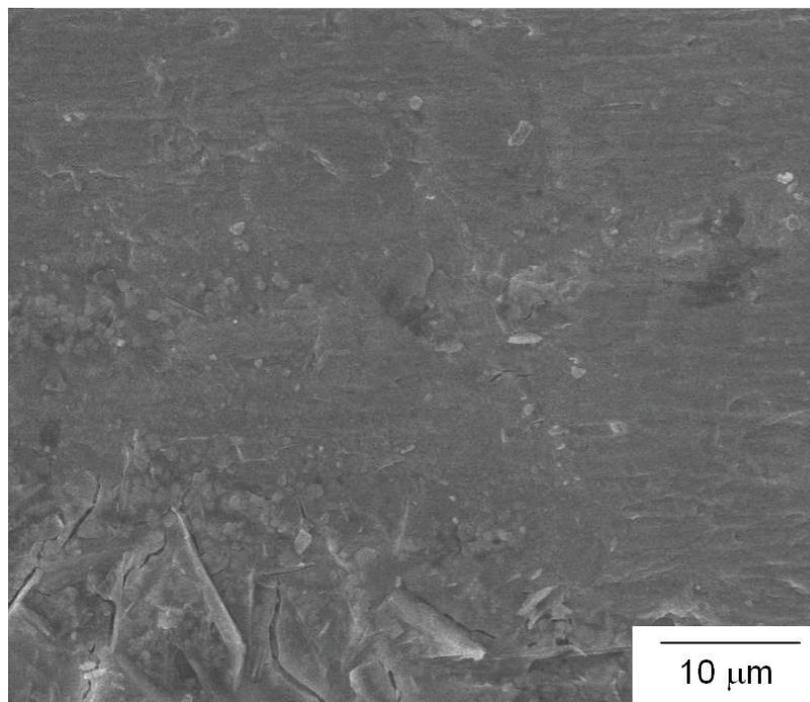
Fig. 27 A fracture surface region of the 100 h-aged shear specimen shown in the upper part of Fig. 26(a): (a) optical micrograph showing the observed region of SEM; (b) microstructure of BaCrO₄ Chromate.

of the fracture surface without adhered glass-ceramic in the upper micrograph of Fig. 26(a) are shown in Fig. 27. As Cr, Ba, Fe, and O elements are detected in Fig. 27(b), the region observed is indeed a chromia layer with some residual BaCrO₄ chromate. Optical and SEM micrographs of an outlined region in the lower micrograph of Fig. 26(a) are shown in Fig. 28. Aggregated particles and few needle-shape crystals are observed in Fig. 28(b). As aggregated particles are buried in the residual glass of GC-9 glass-ceramic, it is difficult to identify their phases. Needle-shape crystals are the crystalline phase, alpha-Ba(Al₂Si₂O₈). By means of EDX analysis, Si, Ba, and O elements are detected in Fig. 28(b), indicating that this region is a GC-9 glass-ceramic layer. Accordingly, for the 100 h-aged shear specimens tested at room temperature, delamination occurs mostly at the interfacial mixed layer of glass-ceramic/chromate/chromia. Figures 29 and 30 show the SEM micrographs of the upper and lower parts of Fig. 26(b), respectively. By means of EDS analysis, Cr and O elements are mainly detected in Fig. 29(b). However, some Mn and Ba elements are also found here, revealing that the Crofer 22 H slice is covered with a chromia layer and some spinel phases ((Cr,Mn)₃O₄). In Fig. 30(b), O, Si, and Ba are detected for a high level of content such that the region observed is indeed a glass-ceramic layer. However, Cr is also found in this area. The possible reasons are as follows. (1) Delamination occurs at the interfacial mixed layer of glass-ceramic/chromate/chromia with a thin BaCrO₄ chromate layer formed in the center of the joining area such that O, Si, Ba, and Cr are all detected in the observed area. (2) Chromium vapor species provide a source of chromium for interfacial diffusion between the glass-ceramic layer and metallic interconnect such that Cr is found at the fracture surface. These observations indicate that fracture occurs within the interfacial mixed layer of glass-ceramic/chromate/chromia for the 100 h-aged shear specimens tested at 800 °C.

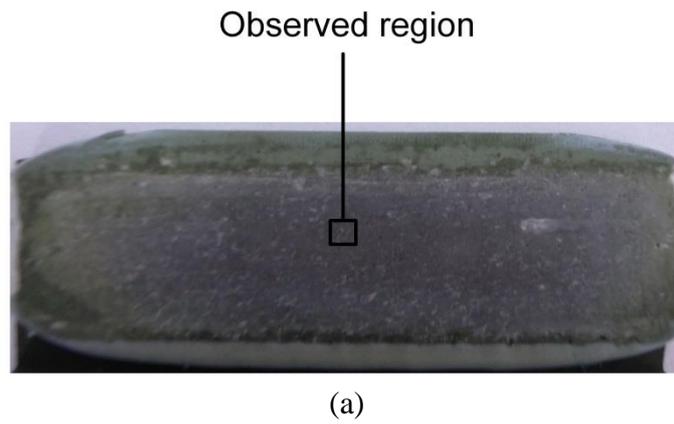
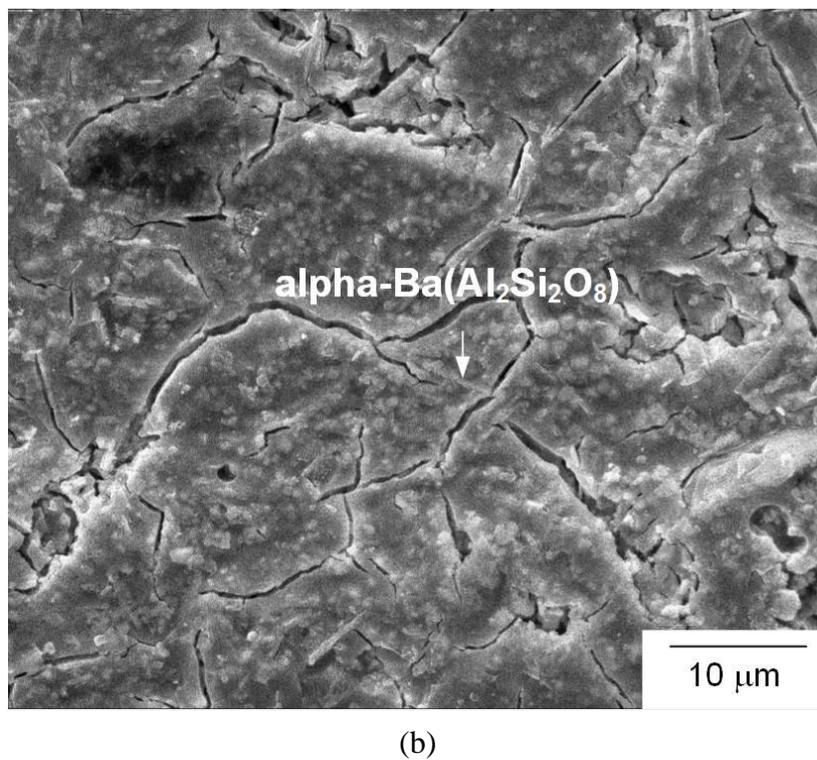
Fig. 28 A fracture surface region of the 100 h-aged shear specimen shown in the lower part of Fig. 26(a): (a) optical micrograph showing the observed region of SEM; (b) microstructure of GC-9 glass-ceramic.

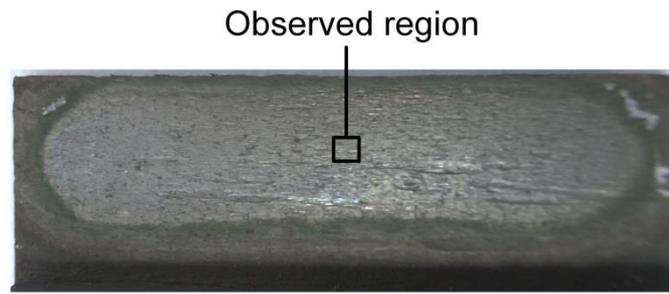
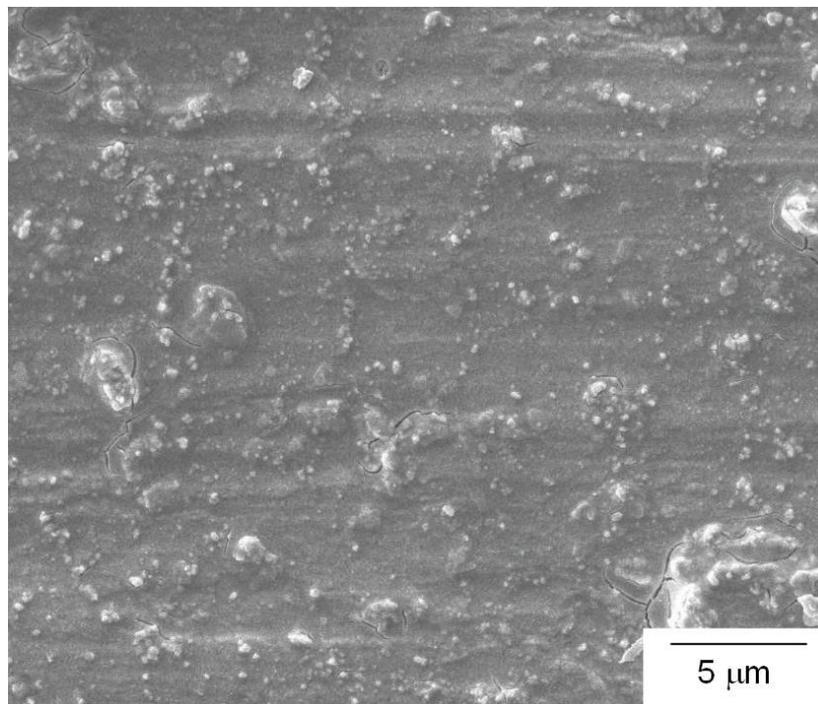
Fig. 29 A fracture surface region of the 100 h-aged shear specimen shown in the upper part of Fig. 26(b): (a) optical micrograph showing the observed region of SEM; (b) microstructure of BaCrO₄ Chromate.

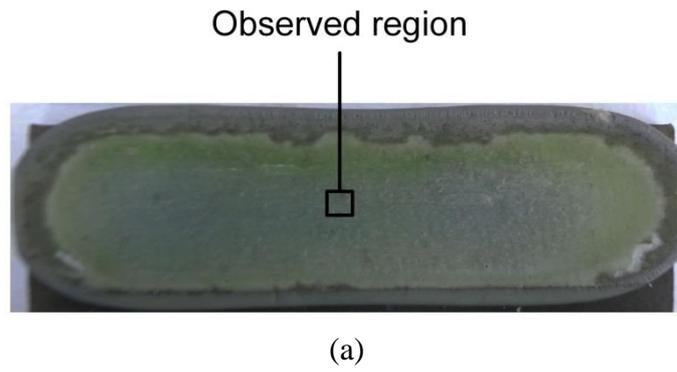
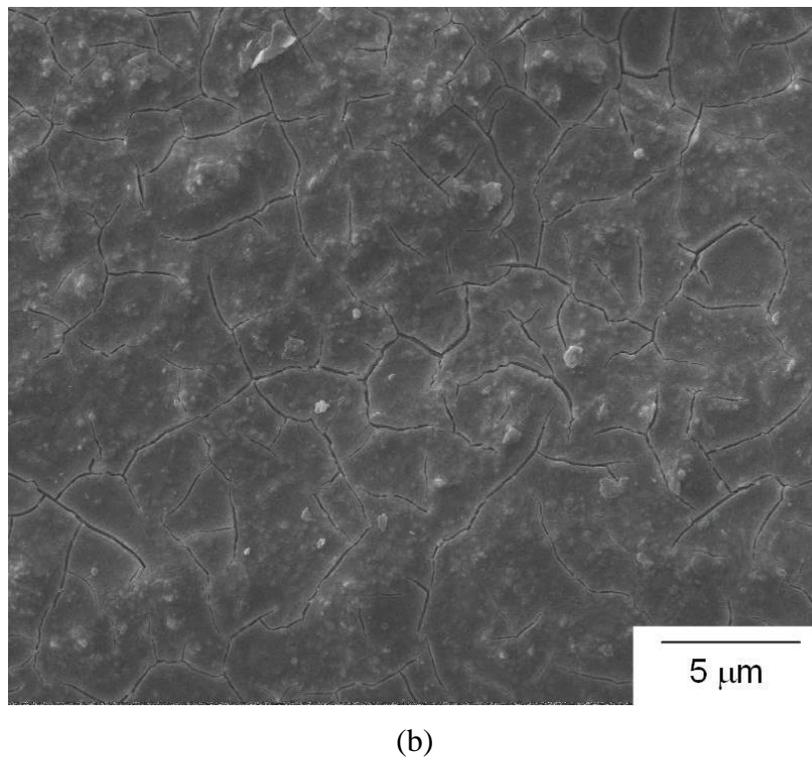
Fig. 30 A fracture surface region of the 100 h-aged shear specimen shown in the lower part of Fig. 26(b): (a) optical micrograph showing the observed region of SEM; (b) microstructure of BaCrO₄ Chromate.

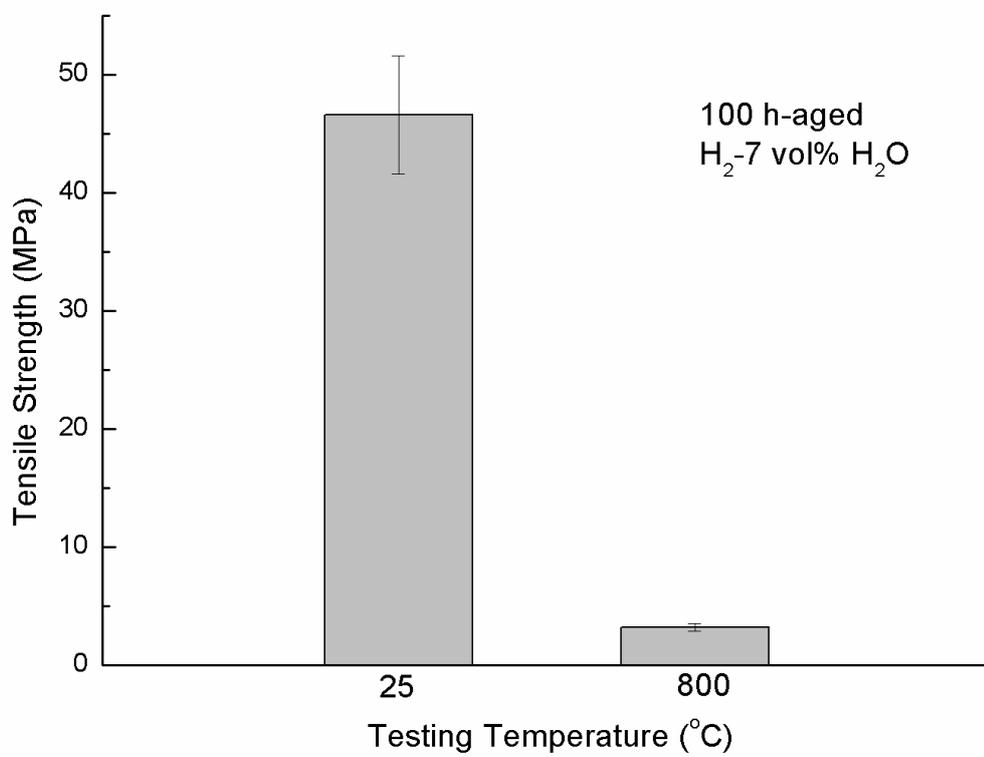
Fig. 31 Tensile strength of 100 h-aged joint specimens tested in H₂-7 vol% H₂O at room temperature and 800 °C.

Figure 31 shows the tensile strength of the 100 h-aged joint specimens tested in H₂-7 vol% H₂O at room temperature and 800 °C. The average joint strength under tensile loading at room temperature is about 46.6 MPa and reduces to about 3.2 MPa at 800 °C. Again, this is due to a high-temperature softening effect. The standard deviation for the results of room temperature and 800 °C is 5.0 MPa and 0.3 MPa, respectively. The failure patterns of the 100 h-aged tensile specimens tested in H₂-7 vol% H₂O at room temperature and 800 °C are shown in Fig. 32. A white region is visible at the right portion of the upper and lower micrographs in Fig. 32(a). Microstructure of the GC-9 glass-ceramic is observed in this white region. Figures 33 and 34 show the SEM micrographs of the upper and lower parts of Fig. 32(a), respectively. By means of EDX analysis, the regions observed in Figs. 33(b) and 34(b) are metal substrate and chromia, respectively. Therefore, for the 100 h-aged tensile specimens tested at room temperature, delamination occurs at the

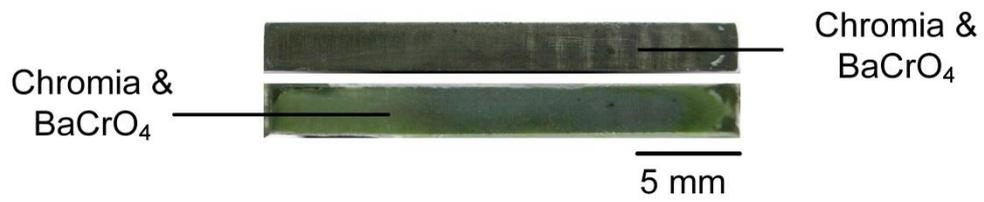
Fig. 32 Failure patterns of 100 h-aged tensile specimens tested in H₂-7 vol% H₂O at (a) room temperature and (b) 800 °C.

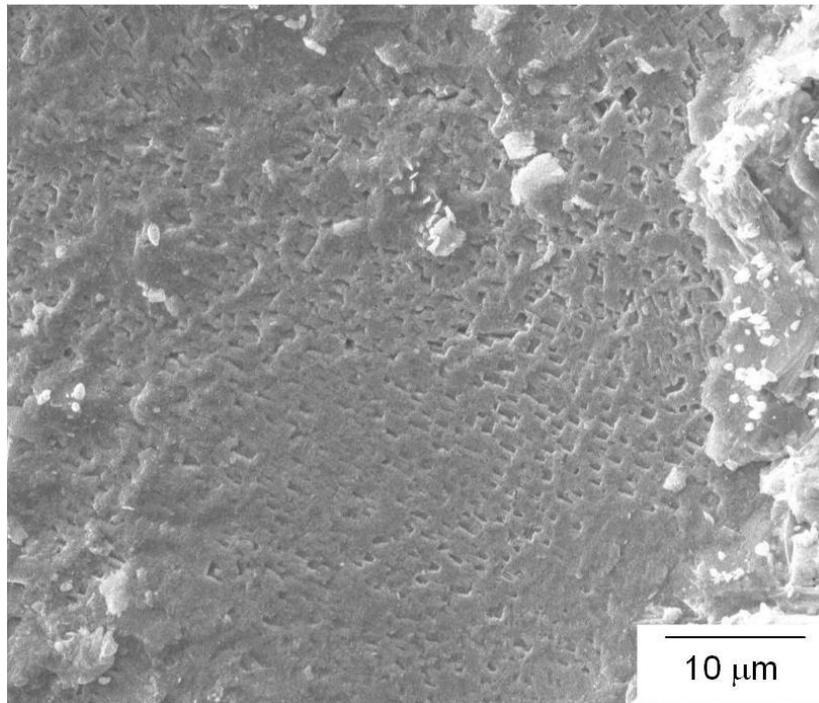
Fig. 33 A fracture surface region of the 100 h-aged tensile specimen shown in the upper part of Fig. 32(a): (a) optical micrograph showing the observed region of SEM; (b) microstructure of metal substrate.

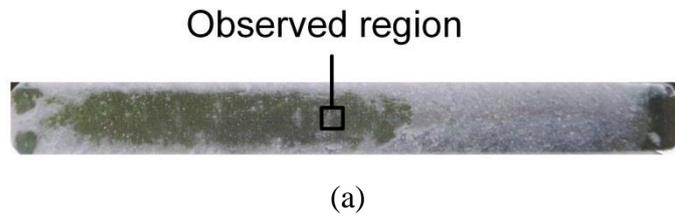
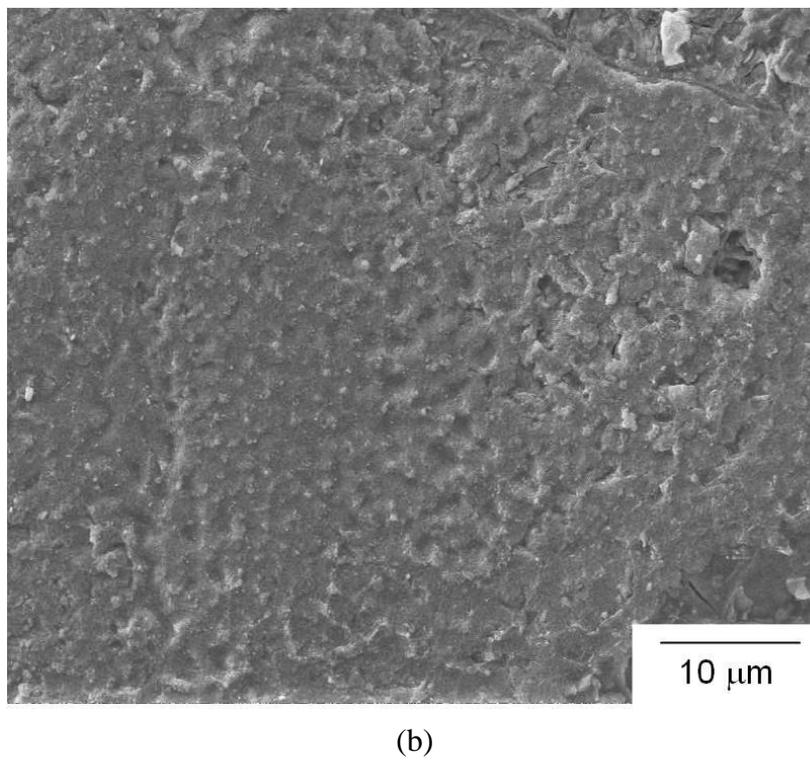
Fig. 34 A fracture surface region of the 100 h-aged tensile specimen shown in the lower part of Fig. 32(a): (a) optical micrograph showing the observed region of SEM; (b) microstructure of chromia.

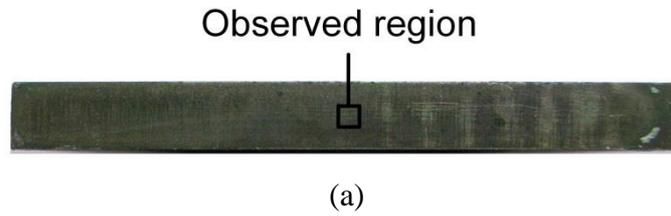
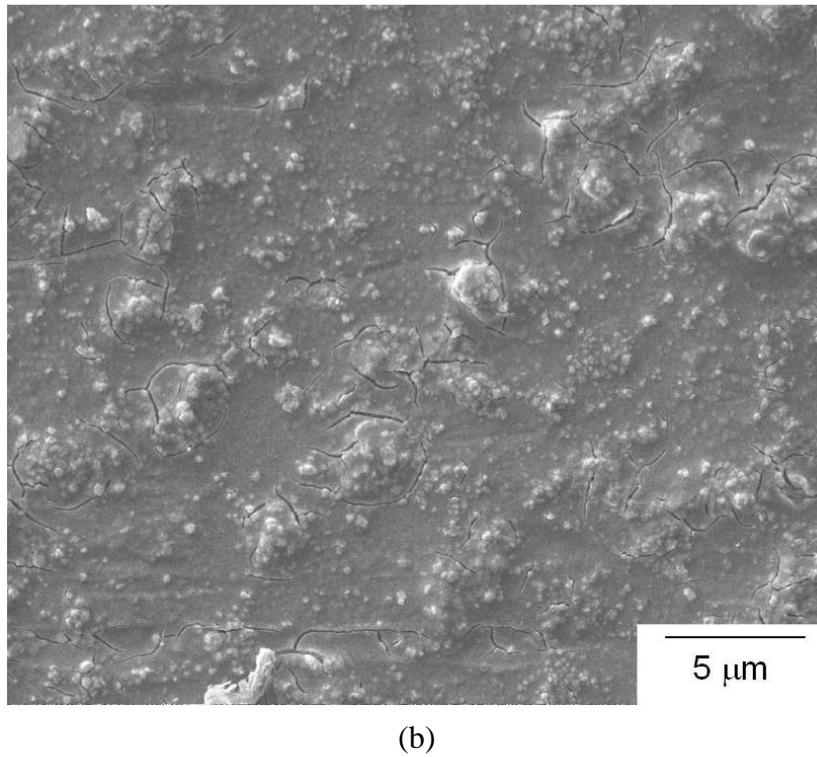
Fig. 35 A fracture surface region of the 100 h-aged tensile specimen shown in the upper part of Fig. 32(b): (a) optical micrograph showing the observed region of SEM; (b) microstructure of BaCrO₄ Chromate.

interfaces between the metal substrate and chromia and within the glass-ceramic layer. SEM micrographs of the upper and lower parts of Fig. 32(b) are shown in Figs. 35 and 36, respectively. The microstructures in the upper and lower micrographs of the 100 h-aged tensile specimens tested at 800 °C are similar to those of the 100 h-aged shear specimens tested at 800 °C. EDX analysis results are also similar to those for 100 h-aged shear specimens tested at 800 °C indicating that fracture occurs within the interfacial mixed layer of glass-ceramic/chromate/chromia for the 100 h-aged tensile specimens tested at 800 °C.

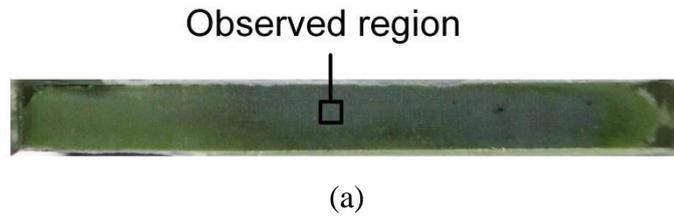
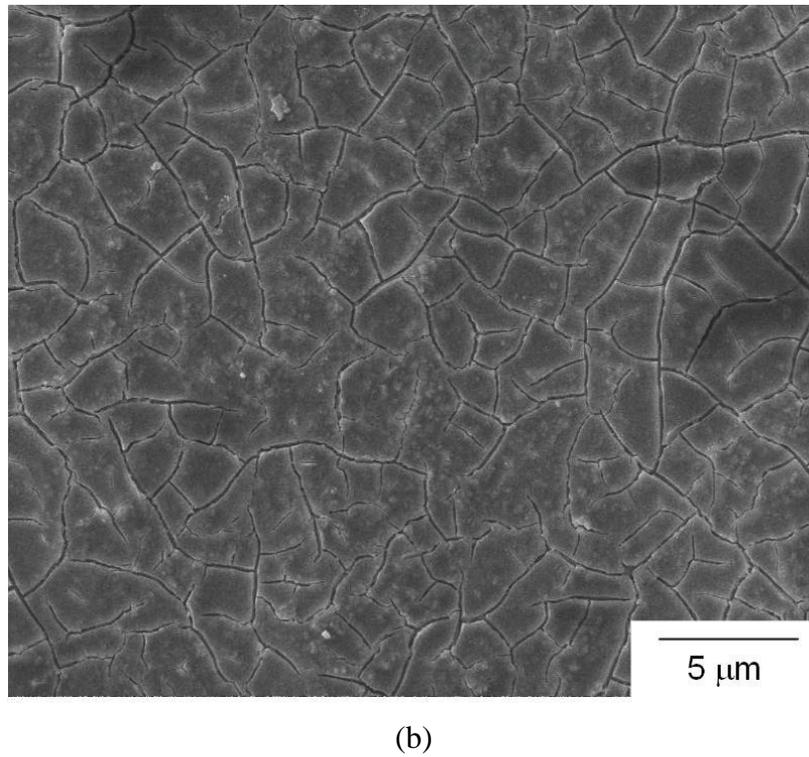
Fig. 36 A fracture surface region of the 100 h-aged tensile specimen shown in the lower part of Fig. 32(b): (a) optical micrograph showing the observed region of SEM; (b) microstructure of BaCrO_4 Chromate.

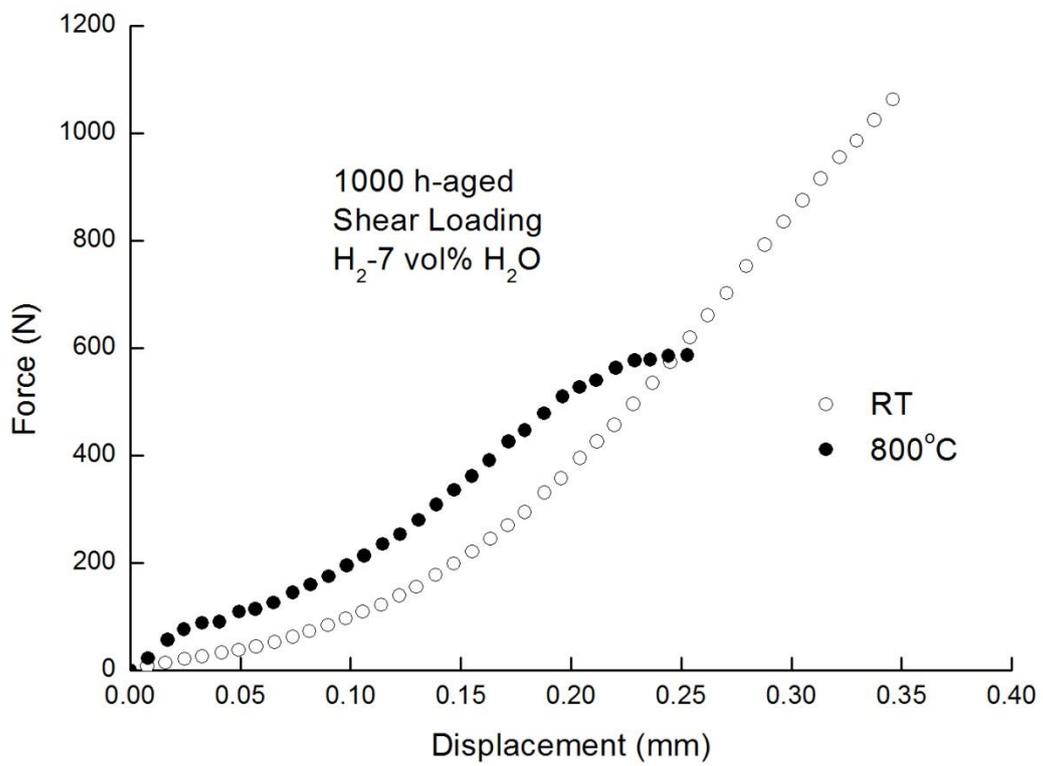
Fig. 38 Typical force-displacement curves of the 1000 h-aged joint specimens tested under shear loading in H₂-7 vol% H₂O at room temperature and 800 °C.

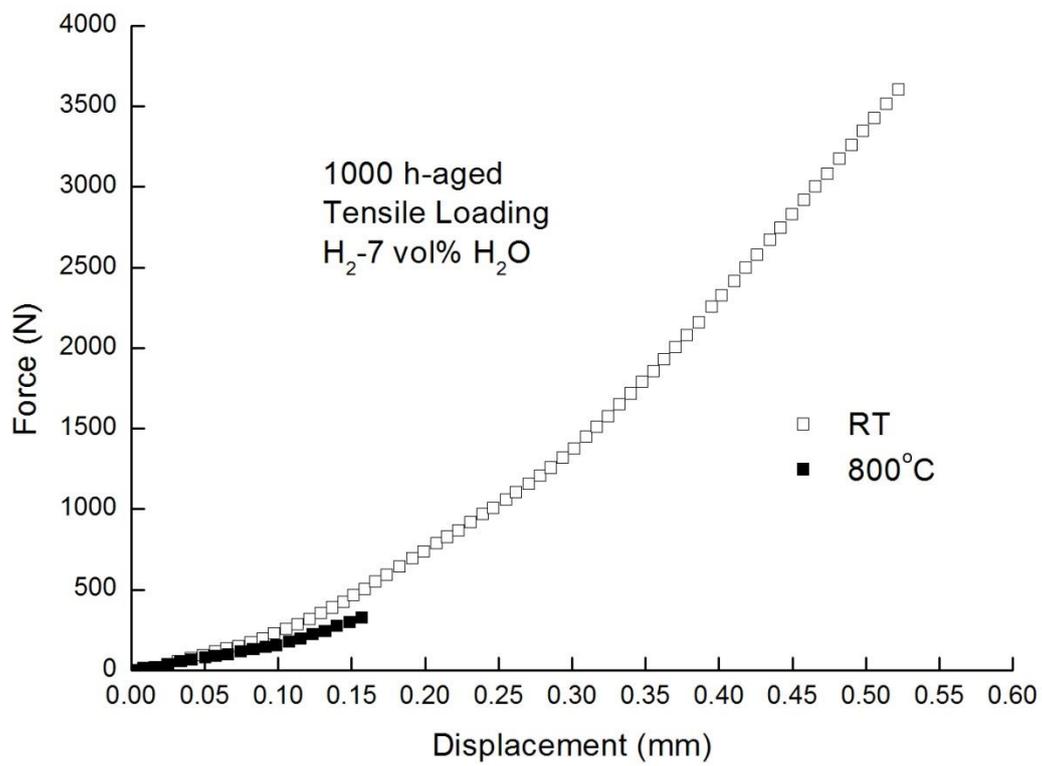
Fig. 39 Typical force-displacement curves of the joint specimens tested under tensile loading in H₂-7 vol% H₂O at room temperature and 800 °C.

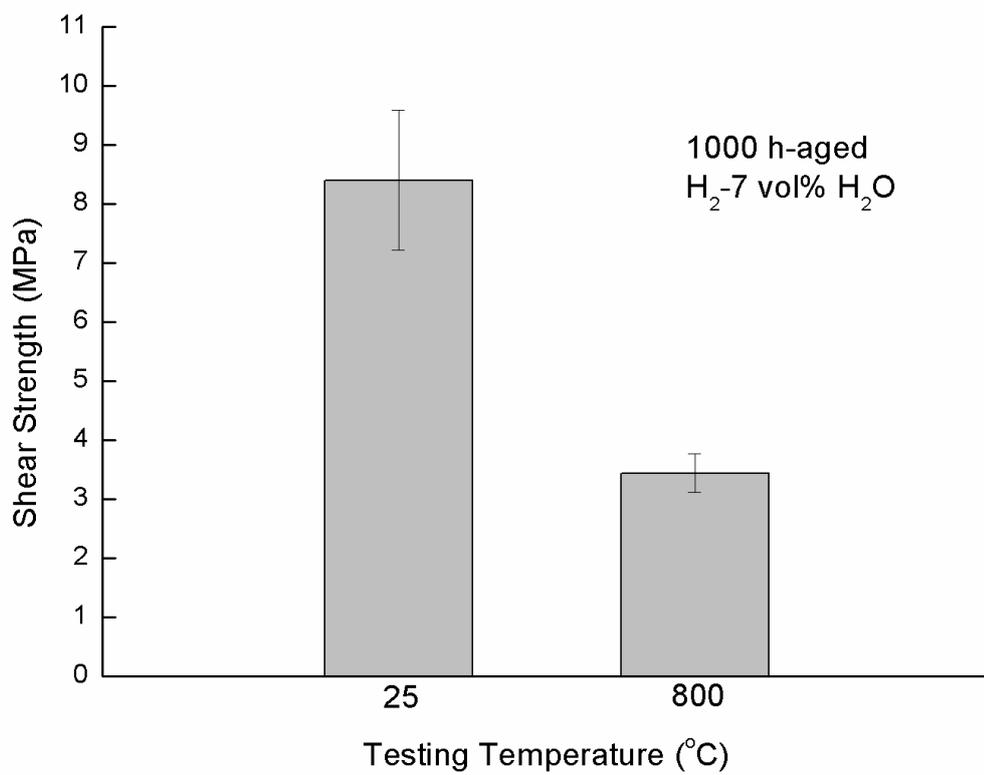
Fig. 40 Shear strength of 1000 h-aged joint specimens tested in H₂-7 vol% H₂O at room temperature and 800 °C.

respectively, for the 1000 h-aged joint specimens tested at room temperature and 800 °C. Figure 40 shows the shear strength of the 1000 h-aged joint specimens tested in H₂-7 vol% H₂O at room temperature and 800 °C. For the 1000 h-aged shear specimens, the average joint strength is 8.4 MPa at room temperature and decreases to 3.4 MPa at 800 °C due to a high-temperature softening mechanism. The standard deviation is 1.2 MPa and 0.3 MPa, respectively. Typical failure patterns in the 1000 h-aged shear specimens tested at room temperature and 800 °C are shown in Fig. 41. Figures 42 and 43 show the SEM micrographs of the upper and lower parts of Fig. 41(a), respectively. Needle-shape crystalline phases are observed in Fig. 42(b). In Fig. 43(b), microstructure of the GC-9 glass-ceramic is also observed. These fractography observations indicate that the delamination occurs within the glass-ceramic for the 1000 h-aged shear specimens tested in H₂-7 vol% H₂O at room temperature. SEM micrographs of the upper and lower parts of Fig. 41(b) are shown in Figs. 44 and 45, respectively. Through EDS analysis, Si, Ba, and O elements are detected in both Figs. 44(b) and 45(b) such that fracture occurs within the GC-9 glass-ceramic layer for the 1000 h-aged shear specimens tested at 800 °C. Microstructural features of the GC-9 glass-ceramic such as needle-shape crystals and aggregated particles are observed in Figs. 44(b) and 45(b). In addition, a considerable amount of micro-voids are found between the aggregated particles and glassy phase in the aged samples.

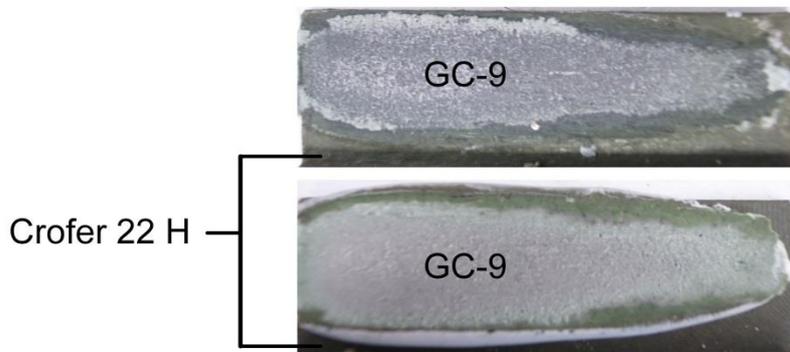
Fig. 41 Failure patterns of 1000 h-aged shear specimens tested in H₂-7 vol% H₂O at (a) room temperature and (b) 800 °C.

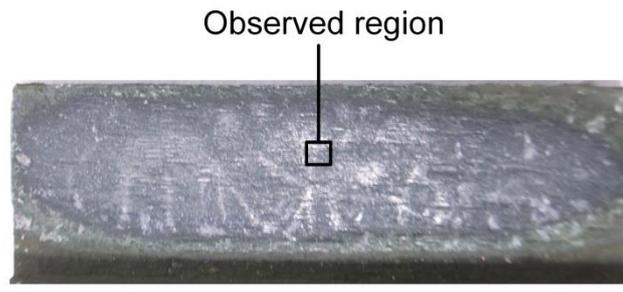
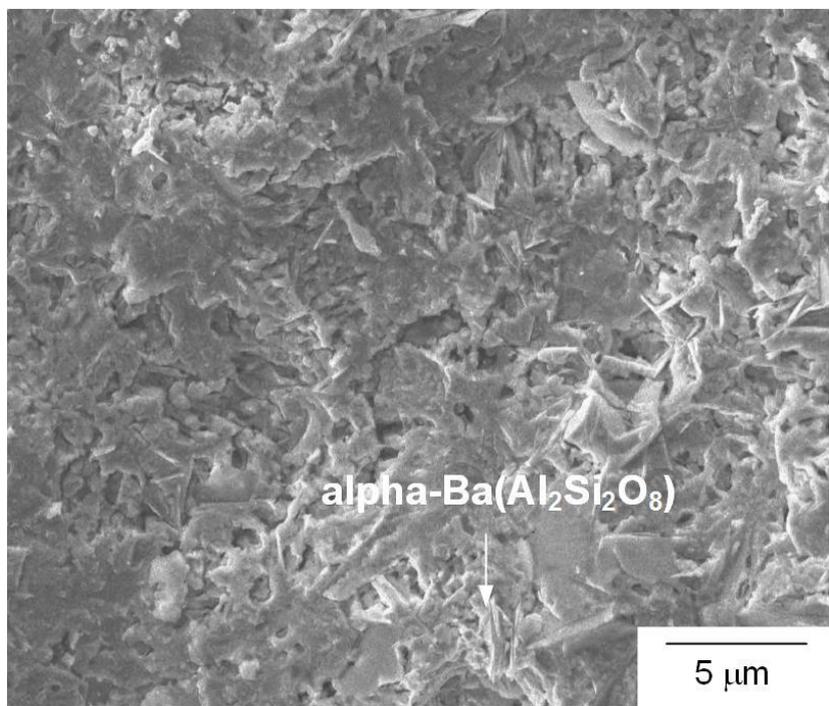
Fig. 42 A fracture surface region of the 1000 h-aged shear specimen shown in the upper part of Fig. 41(a): (a) optical micrograph showing the observed region of SEM; (b) microstructure of GC-9 glass-ceramic.

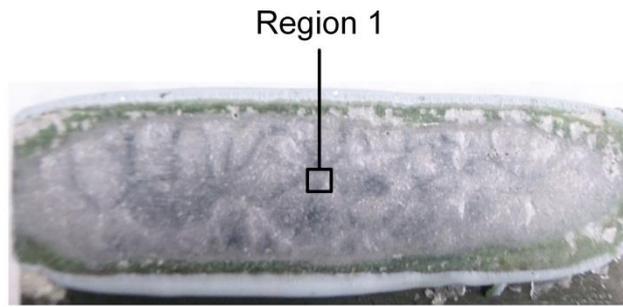
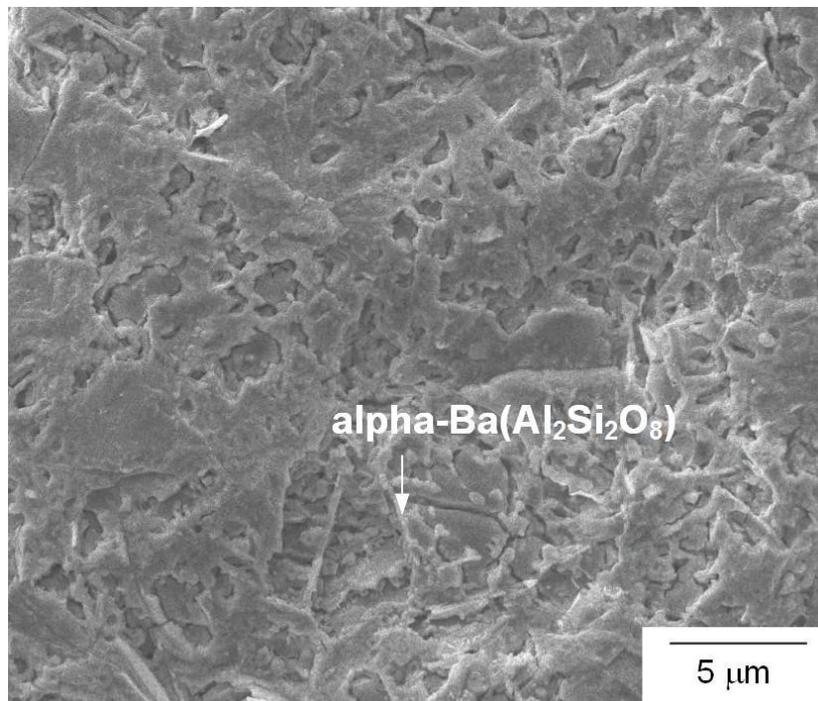
Fig. 43 A fracture surface region of the 1000 h-aged shear specimen shown in the lower part of Fig. 41(a): (a) optical micrograph showing the observed region of SEM; (b) microstructure of GC-9 glass-ceramic.

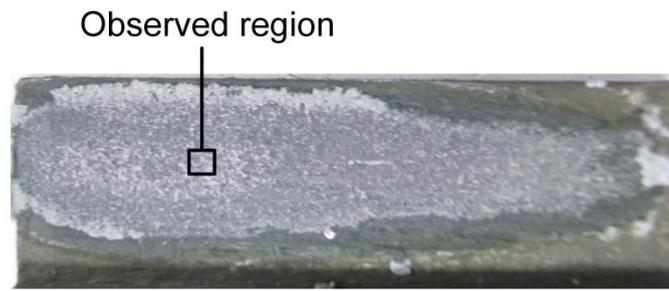
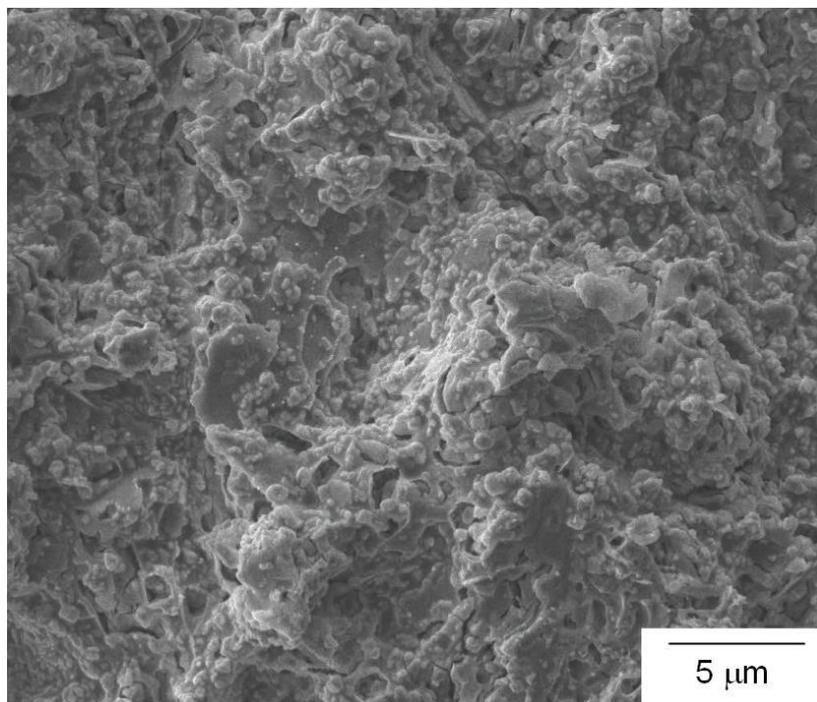
Fig. 44 A fracture surface region of the 1000 h-aged shear specimen shown in the upper part of Fig. 41(b): (a) optical micrograph showing the observed region of SEM; (b) microstructure of GC-9 glass-ceramic.

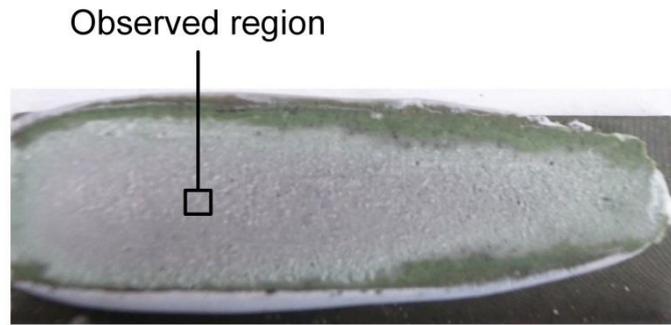
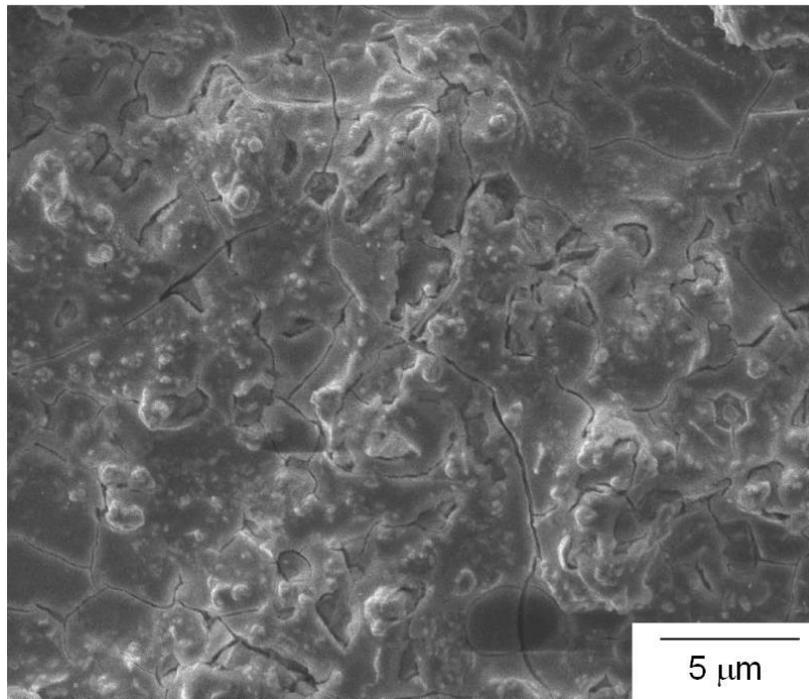
Fig. 45 A fracture surface region of the 1000 h-aged shear specimen shown in the lower part of Fig. 41(b): (a) optical micrograph showing the observed region of SEM; (b) microstructure of GC-9 glass-ceramic.

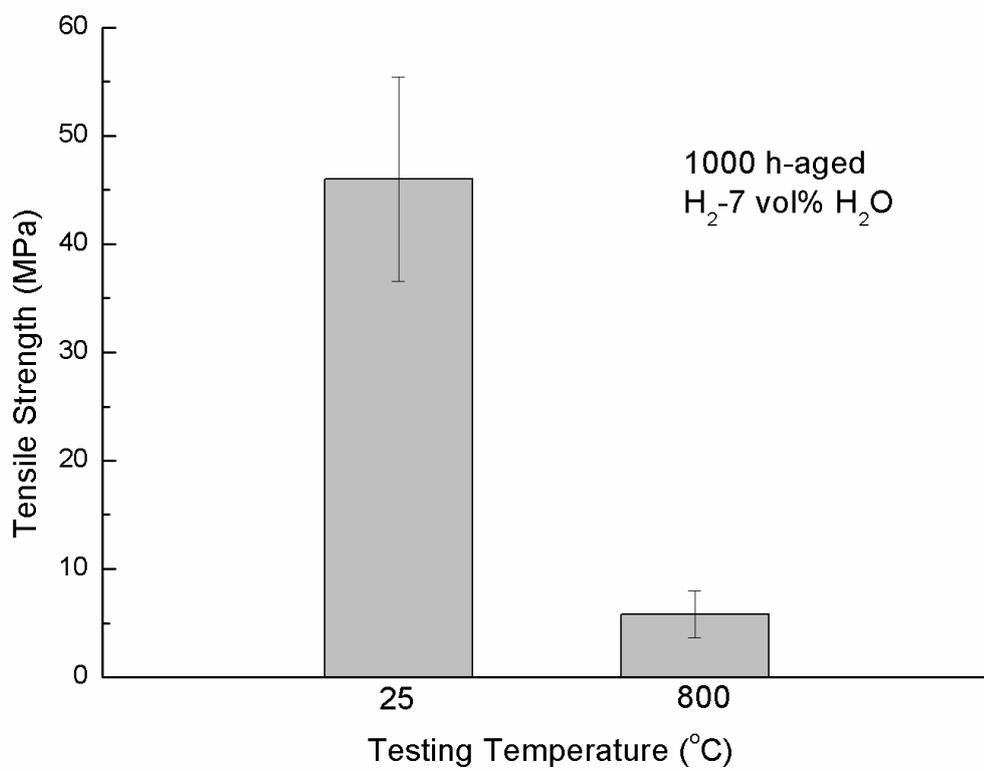
Fig. 46 Tensile strength of 1000 h-aged joint specimens tested in H₂-7 vol% H₂O at room temperature and 800 °C.

Tensile strength of the 1000 h-aged joint specimens tested in H₂-7 vol% H₂O at room temperature and 800 °C is presented in Fig. 46. Under a tensile loading mode, the average joint strength at room temperature is 46.0 MPa and drops to 5.8 MPa at 800 °C because of a high-temperature softening effect. The standard deviation is 9.4 MPa and 2.2 MPa, respectively, for the room temperature and 800 °C. Typical failure patterns of the 1000 h-aged tensile specimens tested in H₂-7 vol% H₂O at room temperature and 800 °C are shown in Fig. 47. The glass-ceramic features are clearly observed in the upper and lower parts of Fig. 47(a) such that the fracture occurs within the GC-9 glass-ceramic layer for the 1000 h-aged tensile specimens tested at room temperature. Figures 48 and 49 show the SEM micrographs of the upper and lower parts of Fig. 47(b), respectively. Similar to that observed in the 1000 h-aged shear specimens tested at 800 °C, needle-shape crystals, aggregated particles, micro-voids between the aggregated particles, and glassy phase are observed in Fig. 49(b). Furthermore, EDS analysis results indicate the existence of Si, Ba, and O elements in both Figs. 48(b) and 49(b). In this regard, fracture occurs within the GC-9 glass-ceramic layer for the 1000 h-aged tensile specimens tested at 800 °C.

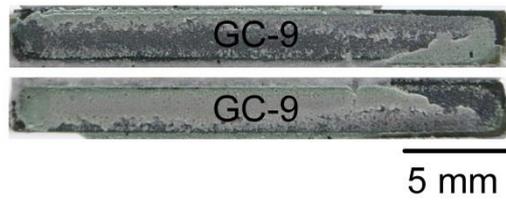
Fig. 47 Failure patterns of 1000 h-aged tensile specimens tested in H_2 -7 vol% H_2O at (a) room temperature and (b) 800 °C.

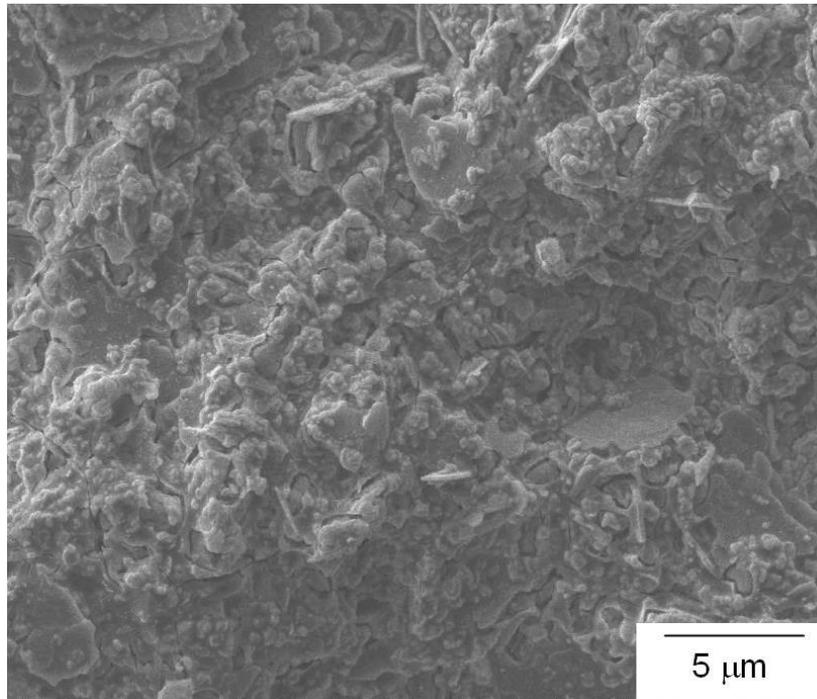
Fig. 48 A fracture surface region of the 1000 h-aged tensile specimen shown in the upper part of Fig. 47(b): (a) optical micrograph showing the observed region of SEM; (b) microstructure of GC-9 glass-ceramic.

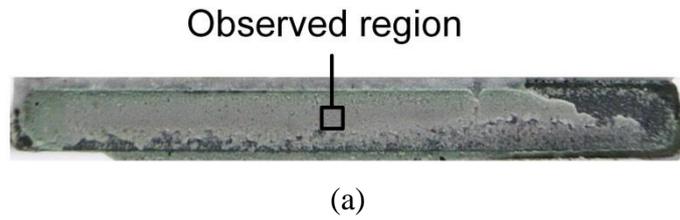
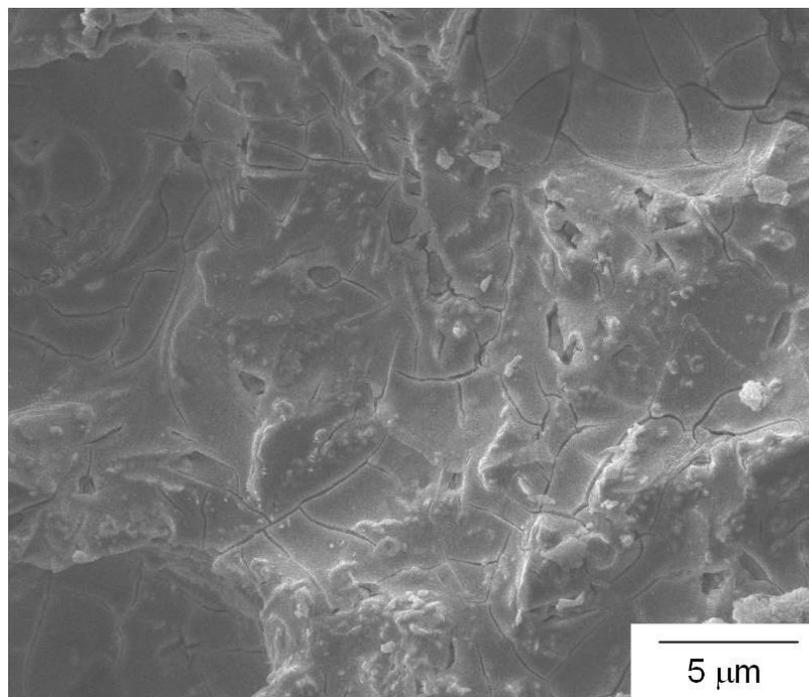
Fig. 49 A fracture surface region of the 1000 h-aged tensile specimen shown in the lower part of Fig. 47(b): (a) optical micrograph showing the observed region of SEM; (b) microstructure of GC-9 glass-ceramic.

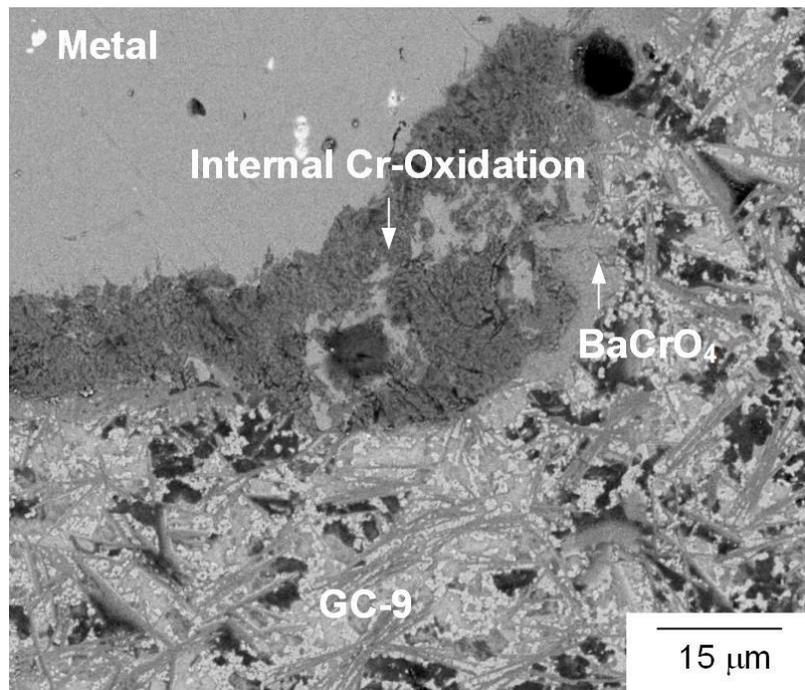
Fig. 50 SEM micrographs (BSE mode) of a cross section of an interface between the GC-9 and Crofer 22 H in a 1000 h-aged specimen: (a) low magnification view; (b) high magnification view

Cross-sectional microstructures at the interface of Crofer 22 H/GC-9 in a 1000 h-aged tensile specimen are shown in Fig. 50. Again, a non-uniform chromate layer and an internal Cr-oxidation zone of steel at the interface are

observed in the cross-sectional micrograph (Fig. 50(a)). However, thickness of the chromia oxide (Cr_2O_3) layer is changed compared to that observed in the 100 h-aged specimens. After a 1000-h aging treatment, the thickness of the chromia layer becomes non-uniform at interface (Fig. 50(b)). The reason is not clear, probably due to depletion of chromia that provides chromium vapor species for interfacial diffusion of chromium [31].

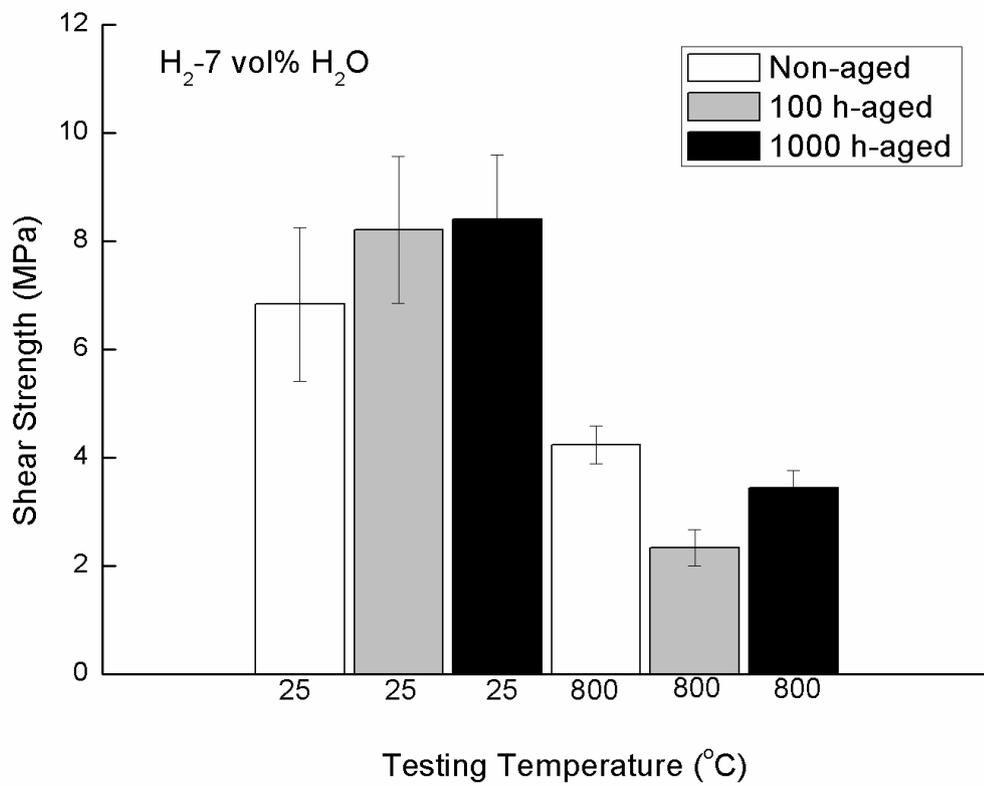
Fig. 51 Shear strength for variously aged specimens tested in H₂-7 vol% H₂O at room temperature and 800 °C.

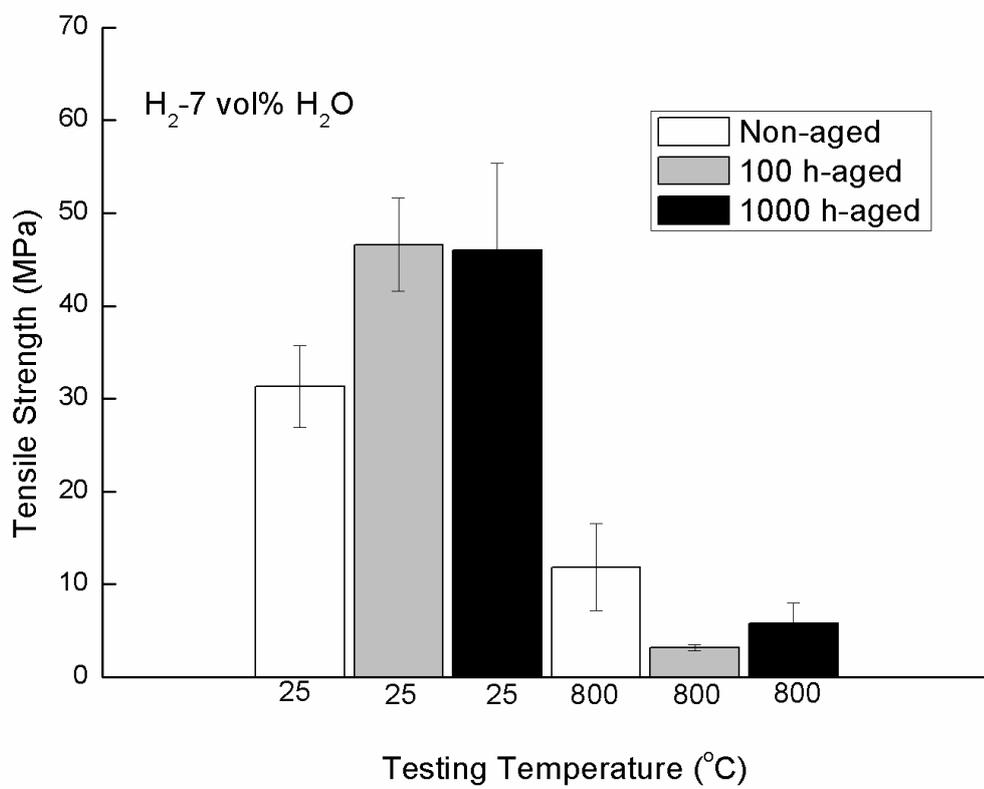
Fig. 52 Tensile strength for variously aged specimens tested in H₂-7 vol% H₂O at room temperature and 800 °C.

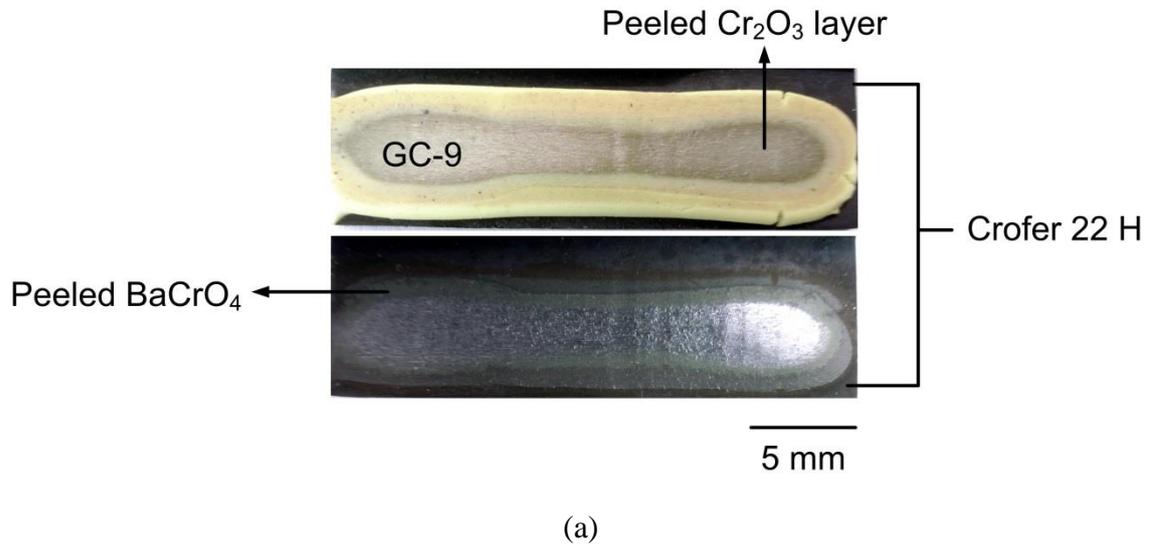
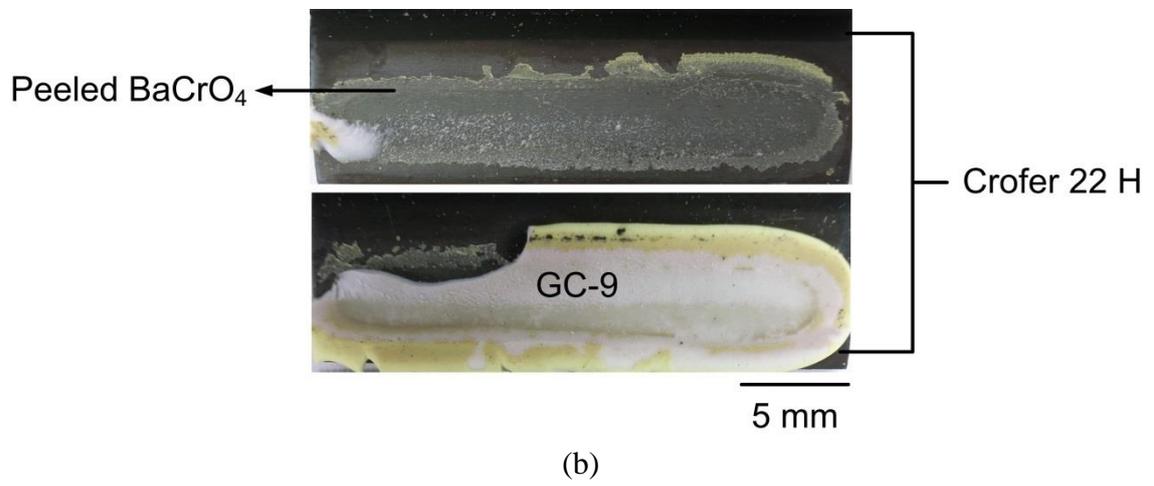
Fig. 56 Failure patterns of non-aged shear specimens tested in air at (a) room temperature and (b) 800 °C. [30]

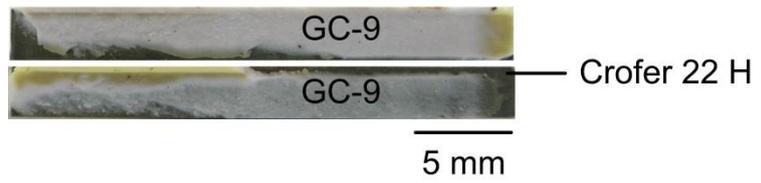
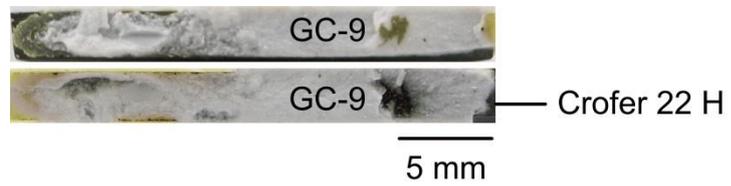
Fig. 57 Failure patterns of non-aged tensile specimens tested in air at (a) room temperature and (b) 800 °C. [30]

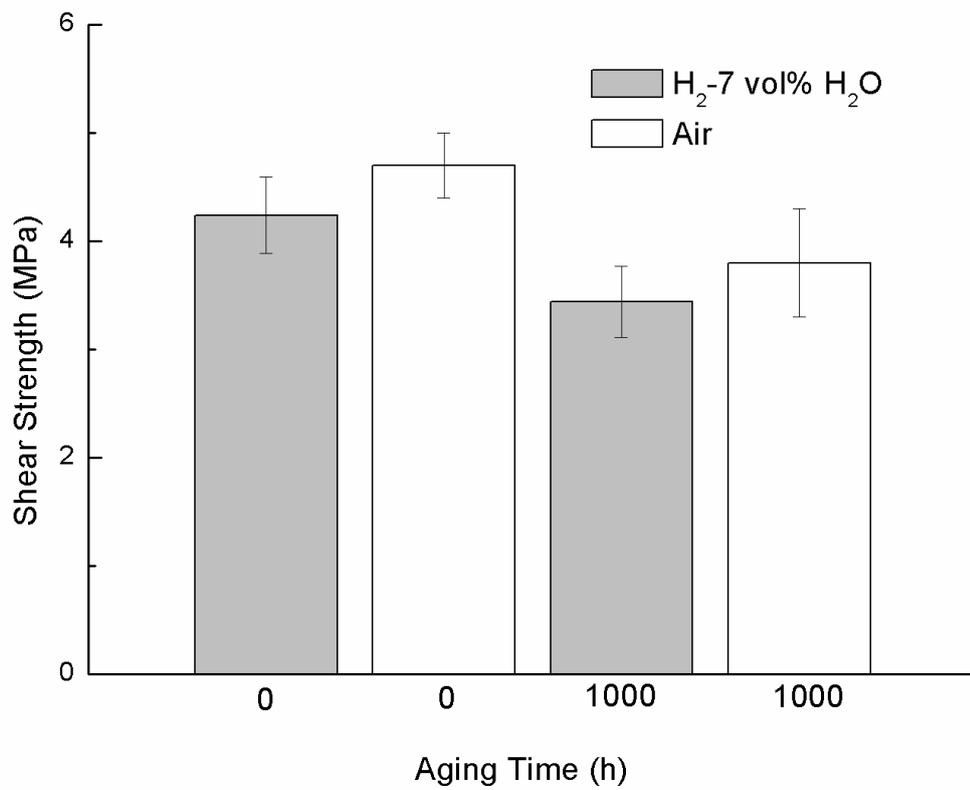
Fig. 58 Shear strength for variously aged specimens tested in H₂-7 vol% H₂O and air at 800 °C.
