核一廠 1 號機 EOC-27 大修燃料水棒連接桿斷開處理專案報告
之修訂 2 版修正內容對照表

**核一廠一號機 EOC-27 大修燃料水棒
連接桿斷開處理專案報告
(Rev.2)**

中華民國 104 年 4 月

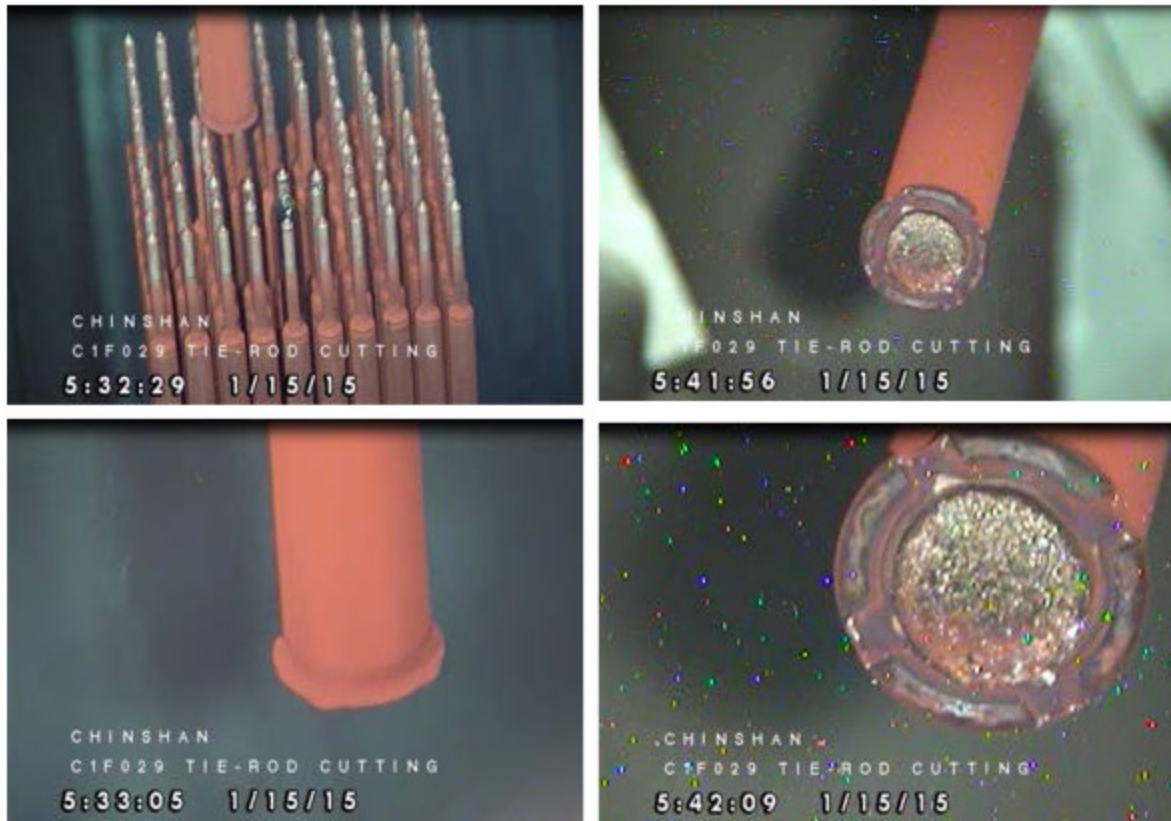
圖 燃料束中之水棒的連接桿(connecting bolt)斷開情形

確認該燃料束中之水棒的連接桿(connecting bolt)斷開(如下圖)。

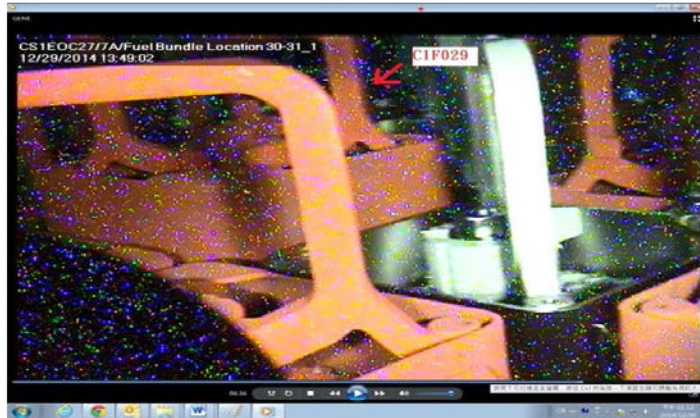
圖2、C1F029燃料匣明顯高於相鄰新燃料之燃料匣

103年12月28日，電廠燃料吊運小組按計畫將C1F029移往規劃座標，在抬升燃料過程運轉員發現重量感測器偵測到有燃料重量瞬間減輕之現象，隨即立刻暫停作業，經檢視燃料填換平台及吊具重量感測元件均正常後，電廠立即通知燃料廠家，並要求燃料廠家派員協助處理後續事宜。圖2顯示該束燃料匣明顯高於相鄰新燃料之燃料匣。

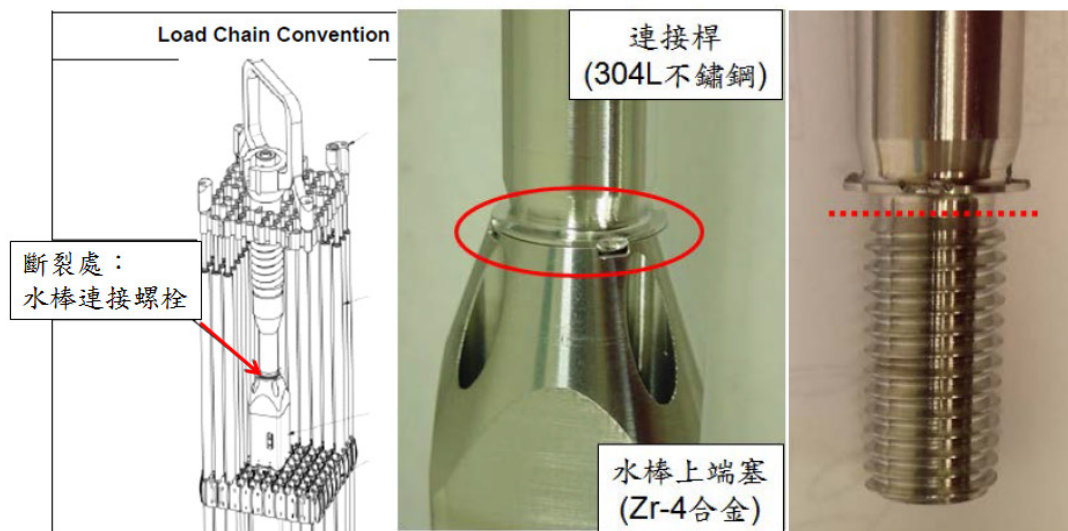
圖3、連接桿與水棒上端塞接合處與斷開位置

9. 連接桿失效：連接桿的最小直徑處是在連接桿上方之壓縮螺帽與連接桿之連接處，但此處並非本次之斷開處。經照射過檢驗證明本次斷開事件是發生在連接桿與水棒上端塞連接螺紋之最小直徑處附近。

在電廠及燃料廠家工作人員後續努力下，順利將 C1F029 燃料束移至用過燃料池，並立即以目視檢查該束燃料，發現水棒連接桿確實已斷開，斷開位置如圖 3。

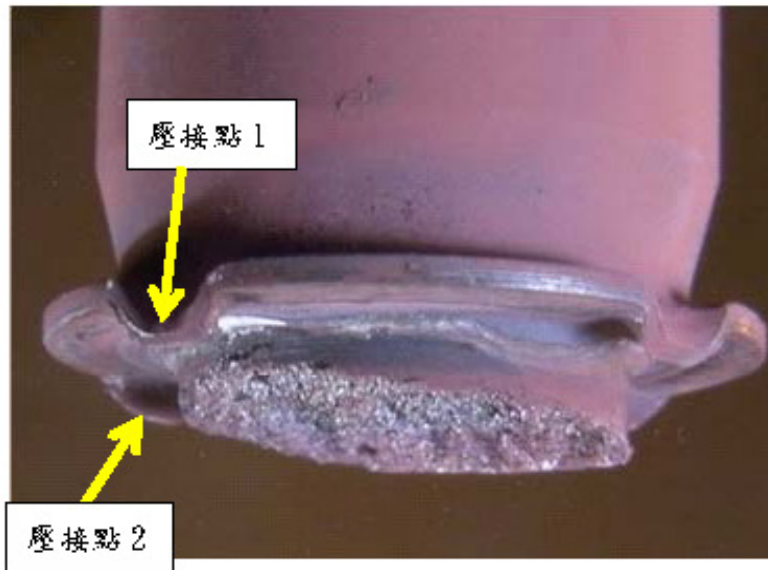
為了肇因分析之所需，核一廠將C1F029燃料內之91支燃料棒安全移出，並重新組裝於新骨架(Cage)內，將重新組裝後之燃料束安全移置燃料池貯放後，工作人員依計畫將此斷開連接桿組件移至國內專業實驗室熱室進行後續檢驗。圖4和圖5為目視檢查照片，顯示連接桿與連接桿承接處斷開處之相對位置關係圖。

圖4、連接桿斷開處

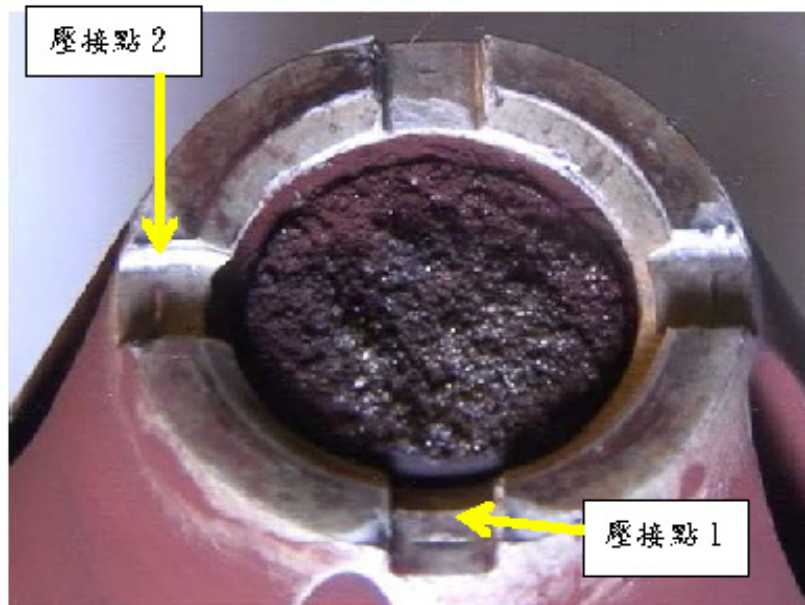
圖5、連接桿承接處斷開處和積垢狀況

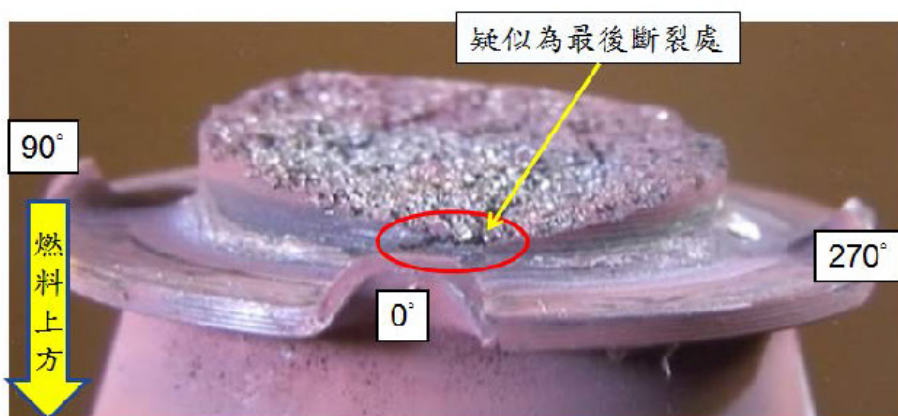
整個破斷面為晶粒感的，在巨觀上並無顯示有塑性變形的跡象。破斷面的平面有輕微的傾斜，在180°的位置最高，0°的位置最低。約有三分之一的破斷表面被大量的橘紅色沉積物覆蓋(約從90°到270°的外圍部分)，在180°位置附近有一處較為平坦的區域，可能是這束燃料在最後吊運時發生斷裂後所造成的機械損傷。其餘的破斷表面則為金屬色。

圖20、破斷面1：0°位置的照片

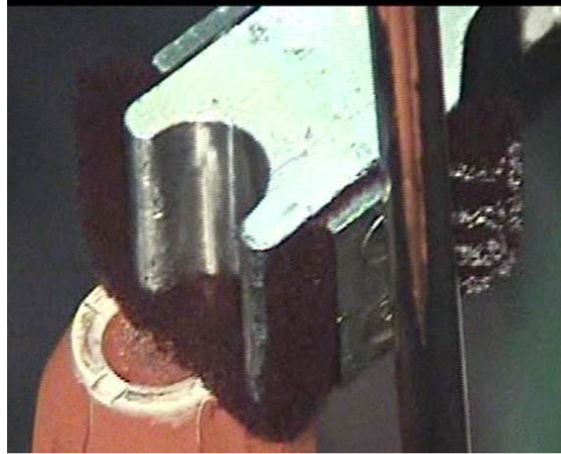
因為在拆除上繫板與上半截連接桿時，以及燃料重組的過程中有大量的積垢漂出並沉積到水棒上端塞處。燃料廠家工作人員為了拍攝該處清楚的照片，曾在核一廠的燃料池中，用工具進行清潔，以移除沉積在上的積垢，如圖23。此清潔的結果，不影響判斷水流阻塞的現象。

圖23、燃料廠家人員利用工具清潔連接桿承接處

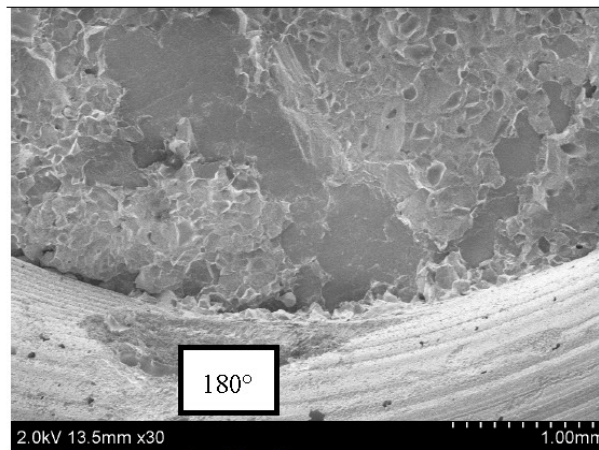
複製膜R1.1 (表面接觸劑量約 $80\mu\text{Sv/h}$)在經過鍍碳之後放入SEM進行分析。幾乎所有的破斷面皆為沿晶破裂的特徵。在 90° 至 270° 的外圍為橘紅色的破斷面上，顯示有相對粗糙的表面，應是氧化物的沉積所造成的。

圖25、複製膜R1.1：180°位置的照片

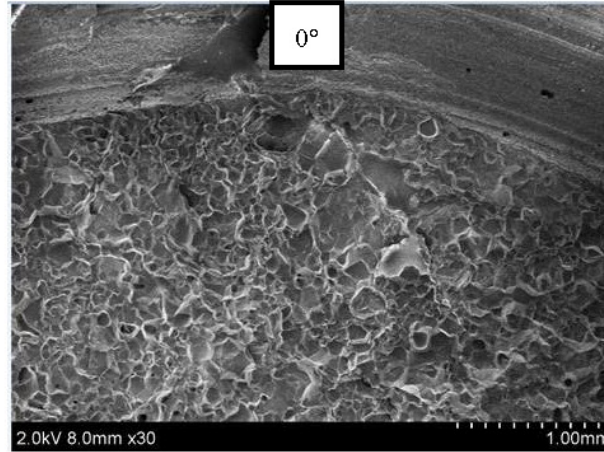
圖26、複製膜R1.1：0°位置的照片，破斷面上有微小裂痕

在靠近 0°位置的破斷面上觀察到最後斷裂時的裂痕。
在圖 26 的上方黑灰色區域並不是真實破斷面的表面特徵，是複製膜製備時產生的人工缺陷。

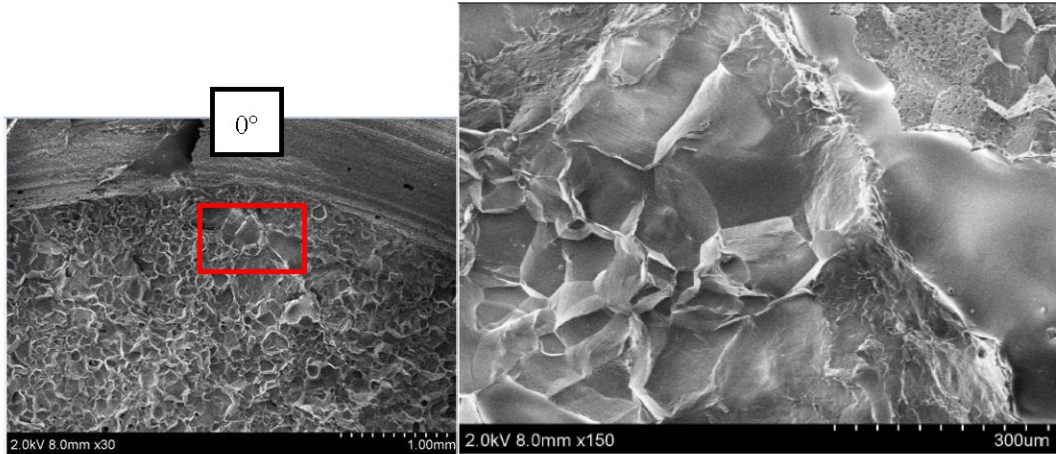
圖28、複製膜R1.1：0°位置的照片，局部發生穿晶破裂的區域

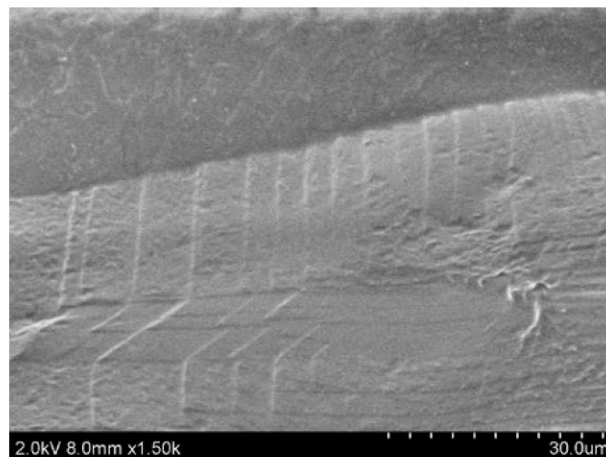
圖29、複製膜R1.1：0°位置的照片，滑移痕跡跨過雙晶晶界

在靠近0°的位置的破斷面應是最終發生斷裂的區域，因為在此區域沒有發現腐蝕產物的沉積且在微觀上有發現滑移痕跡的存在。滑移痕跡的出現只會在材料發生大量塑性變形的區域。這些直線的軌跡發生在晶粒當中，而不是在各個晶粒之間延伸，顯示並不是疲勞破裂的特徵。此滑移痕跡應為晶粒內單一滑移系統(single slip system) 移動在晶面上產生的階梯痕跡(steps)，而不是在週期性應力狀

況下，裂縫尖端多個滑移系統(Multiple slip systems) 同時動作產生的直線軌跡表面特徵，此直線軌跡特徵連續性成長，可橫跨多顆晶粒。這些痕跡明顯地在晶界處發生方向轉變，此現象在材料學中稱做橫向滑移(cross slip)，如圖29。

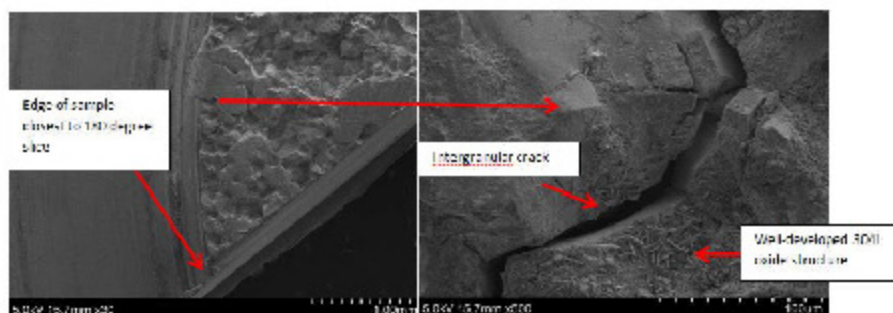
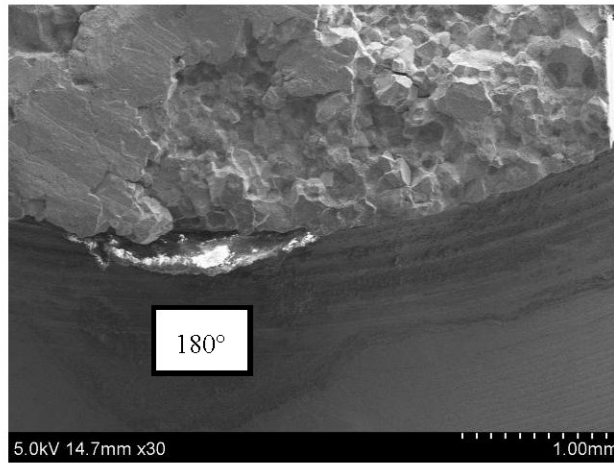
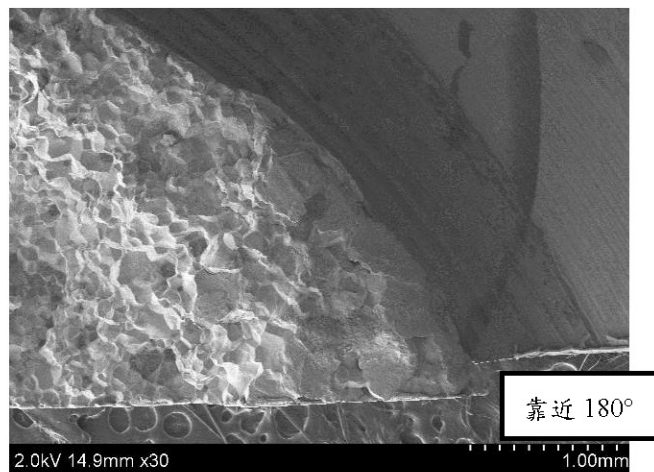
圖32、破斷面1、試片I上之沿晶破裂特徵

圖33、破斷面1、試片II上180°位置之沿晶破裂特徵

圖34、破斷面1、試片III上之沿晶破裂特徵

在破斷面1的試片I上，發現有沿晶破裂的特徵，且金屬晶粒的表面上有大量的氧化物，如圖32、圖33和圖34。在靠近270°的區域的破斷面上雖發現有穿晶裂紋(裂紋方向朝下)，如圖35，但沒有明顯的塑性變形特徵。

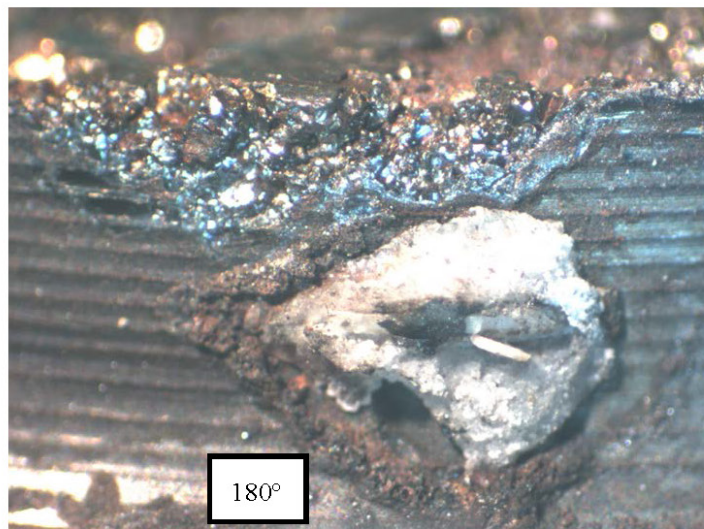
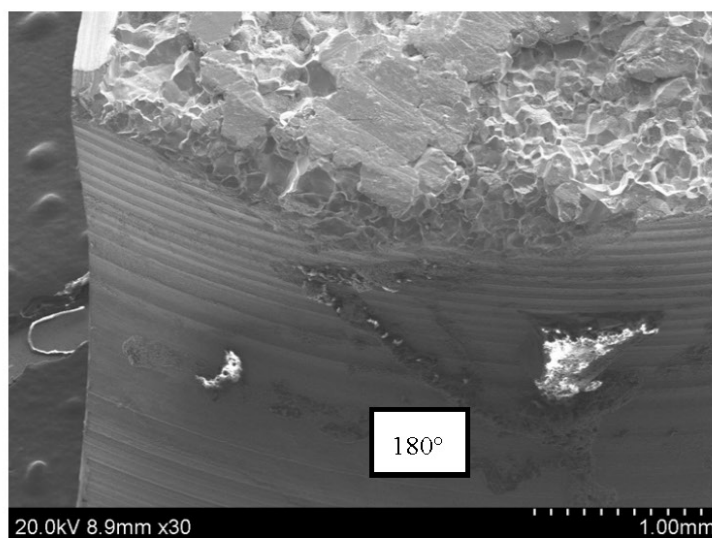
將試片II以檸檬酸進行清洗，移除試片上的積垢、腐蝕物和沉積物後，如圖37和圖38，針對靠近180°位置進行詳細檢驗，結果顯示表面瑕疵的來源是由於連接桿內的金屬或非金屬夾雜物在機械加工後導致其曝露所形成(不是機械加工的缺陷而是機械加工導致材料瑕疵的曝露)。換句話說，在機械加工過程中，材料內部的夾雜物曝露出來或從連接桿表面上移除，此狀況造成連接桿表面的不規則性，可能在局部位置上有不同的化學組成。

圖 37、破斷面 1、試片 II 上靠近 180° 的位置的側面照片(經檸檬酸清洗前)

圖 38、破斷面 1、試片 II 上靠近 180° 的位置的側面 30 倍放大照片(經檸檬酸清洗後)

檢測與製程變更	變更原因
1.於連接桿下端螺牙及無螺紋區域至連接桿凸緣上方 25mm 處執行 PT 檢測，此項檢測僅於連接桿組裝前執行，做完連接桿 PT 檢測後，會依照最終清洗程序再清洗一次。	肇因分析小組認為本次事件是因為有表面瑕疵導致初始事件發生，又正好發生在高應力集中、高中子通量及機械加工之高風險區。與目視檢視相比，液滲檢測偵測表面缺陷或曝露於表面之夾雜物的靈敏度更高。
2. 於連接桿下端螺牙塗抹潤滑劑 ██████ 時，由品質人員進行 100%目視檢查，確認未塗抹至無螺紋區域，此項檢查只可能在連接桿組裝前執行。	肇因分析小組對於無螺紋區域的環境污染物有顧慮。即使 ██████ 已被允許使用，但應只能用在螺紋區域。
3. 於無螺紋區域由燃料廠家工廠品質人員進行 100%目視檢查，確認表面無異常，此項檢查只可能在連接桿組裝前執行。	肇因分析小組認為表面瑕疵是造成裂縫起始的主因。而無螺紋區域是潛在的應力升高區域。

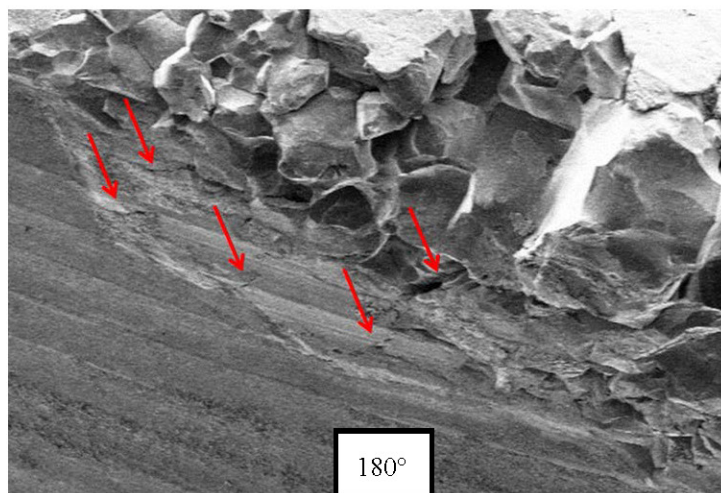
表面瑕疵處可能引發後續孔蝕現象，並導致穿晶裂紋的產生(如

圖40上的紅色箭頭所指)。圖39紅圈處的右半邊已發生明顯的孔蝕為較早期的失效區域，為可能的主要裂紋起始區域。

圖 40、破斷面 1、試片 II 上靠近 180° 的位置的側面 130 倍放大照片(經檸檬酸清洗後)

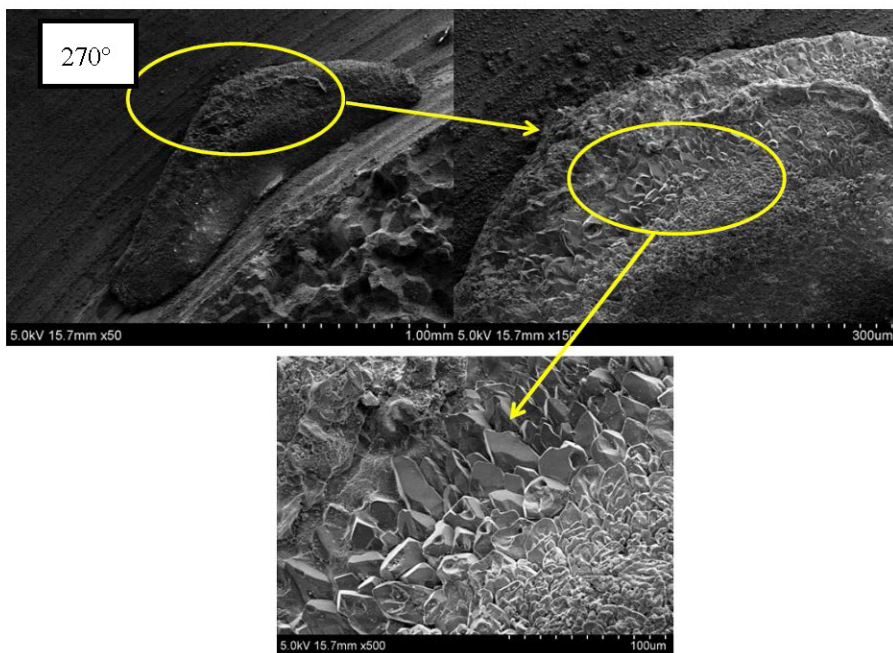
圖 42、破斷面 1、試片 I 上靠近 270° 位置外側的白色物質

靠近 270° 位置的外側白色物質 SEM 照片，如圖 42，從形貌上看起來與積垢(crud)不同。

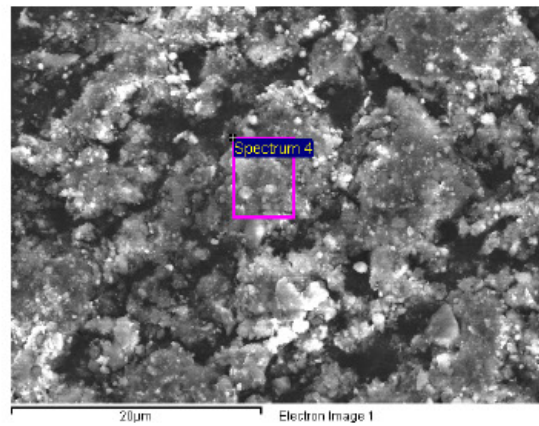
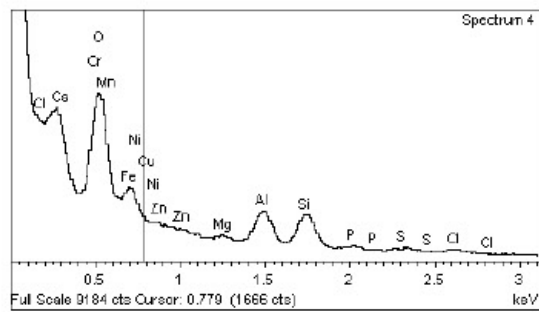
圖 43、靠近 180°位置的白色物質 EDX 分析

對 180°位置的白色物質進行 EDX 分析，顯示有較高的鐵、矽、鋁、鉻和氧化物的訊號，如圖 43；而 270°位置的白色物質，則只有較高的鐵訊號，如圖 44。根據核一廠一號機的運轉水質狀況，此為預期中的且沒有異常的現象。白色物質的沉積量多寡與水流有關，此現象與典型的積垢在燃料束上沉積狀況不同。白色物質可能由積垢、腐蝕產物或爐水冷卻系統中的可溶物質所形成，由許多不同的物質共同組成，造成 EDX 分析結果差異較大。經檢視相關的熱流條件後，在連接桿處可能會產生由 gamma 加熱效果所造成的沸騰現象(註：較易造成白色物質沉積)。白色物質中有明顯的矽含量，在製程上使用的清洗液或潤滑劑並不含矽，因此矽的來源可能是自爐心冷卻系統。然而，白色物質與裂縫起始並無關聯性。

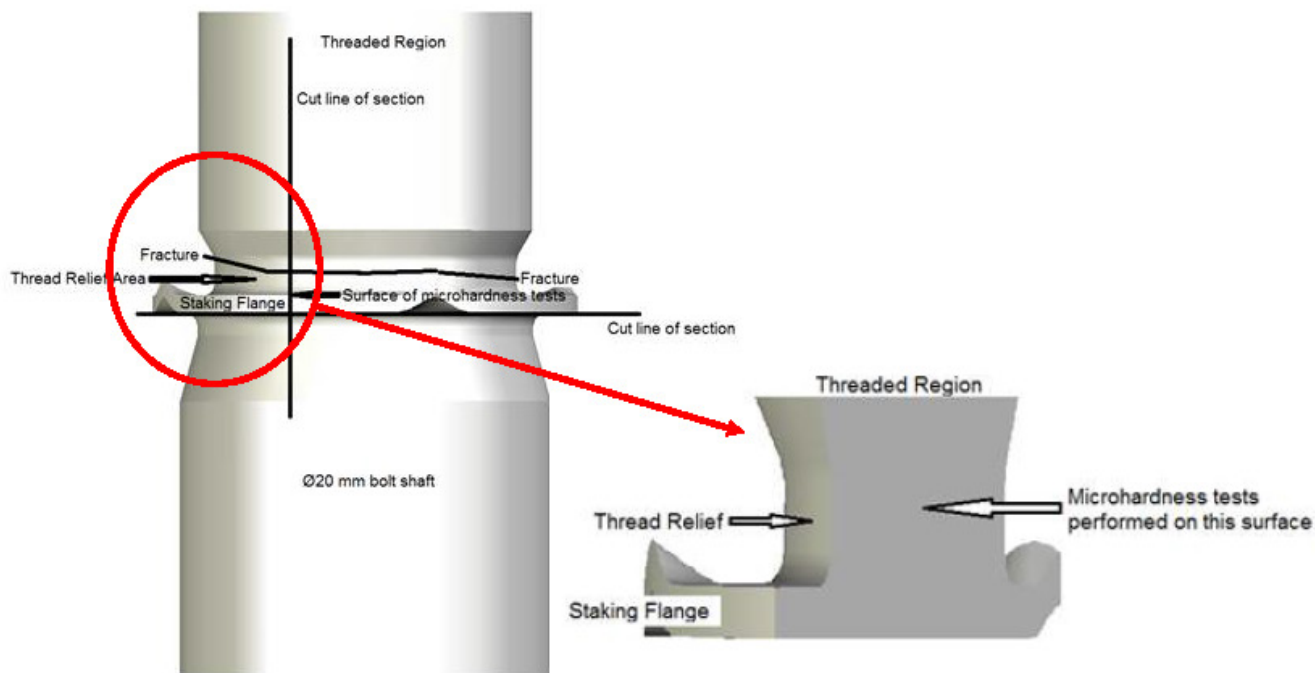
圖 45、試片 I 從連接桿上取樣的位置和微硬度的量測位置

為了進行金相分析和微硬度量測，已對破斷面1的試片I進行了橫切、鑲埋、研磨和拋光。圖45為試片I從連接桿上取樣的位置和微硬度的量測位置。在試片做蝕刻(金相分析樣品製備的最後一道手續)之前已先完成了微硬度的量測。表5為試片I上不同位置的微硬度量測結果，相關量測位置對應如圖46，結果顯示其硬度較同一批次的庫存材料(未受輻射照射)高。

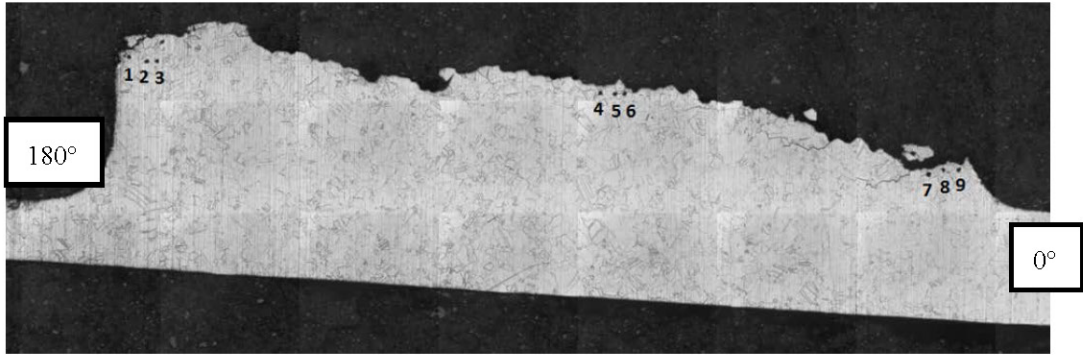
圖 48、破斷面 1、試片 IIa 上不同位置量測維氏微硬度

同樣地，已將破斷面 1 的試片 II 再進行切割，分成試片 IIa 和 IIb，如圖 47。試片 IIa 進行了鑲埋、研磨和拋光，並完成了金相分析與微硬度量測。與試片 I 的作法相同，在試片做蝕刻之前已先完成了微硬度的量測，表 6 為試片 IIa 上不同位置的微硬度量測結果，相關量測位置對應如圖 48。試片 IIa 的硬度亦較同一批次的庫存材料(未受輻射照射)高，與試片 I 的結果相同。

受輻射照射後之材料硬度的上升，可對應到材料強度的上升和延展性的下降。不論材料硬度的上升是受到輻射照射或冷作效應，或是兩者的共同效應，材料機械性質的改變是可預期的。

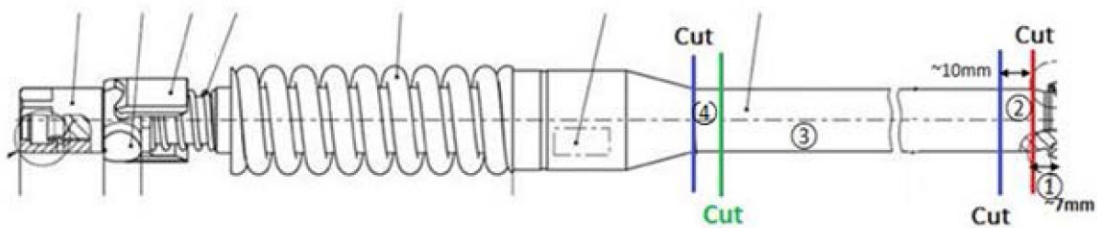
圖 49、連接桿軸上量測微硬度之位置

為了更進一步瞭解中子通量對材料微硬度的影響，對本次斷開的連接桿軸上不同位置進行量測，測量位置如圖 49 上的 ④，共測量了 5 個點的微硬度，結果整理如表 7。其結果與預期相符，④的位置位在有效燃料區上方不遠處，中子通量較低，材料硬化的效應不如連接桿斷開處來的高。

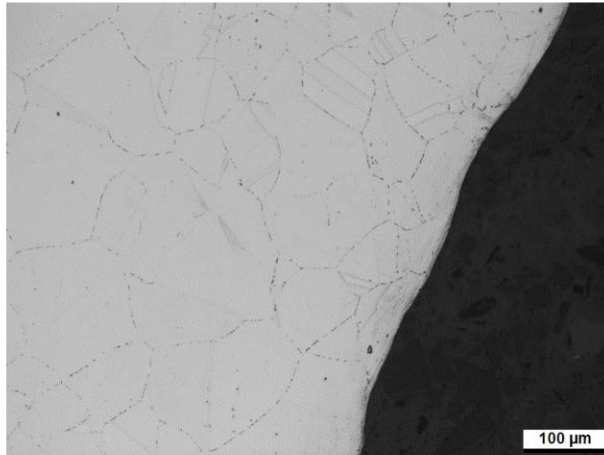
圖55、無螺紋區域靠近螺牙根部的金相分析照片(經蝕刻後可顯現出晶界)

在無螺紋區域靠近螺牙根部的金相照片中，只有顯示晶界輪廓但並無冷作的證據，如圖55。此外依照ASTM 262A標準進行晶界腐蝕測試和依照德國標準DIN EN ISO 12732(類似ASTM G108標準)進行電化學動電位再活化(electrochemical potentiokinetic reactivation, EPR)測試，測試結果顯示庫存材料皆符合性能要求。

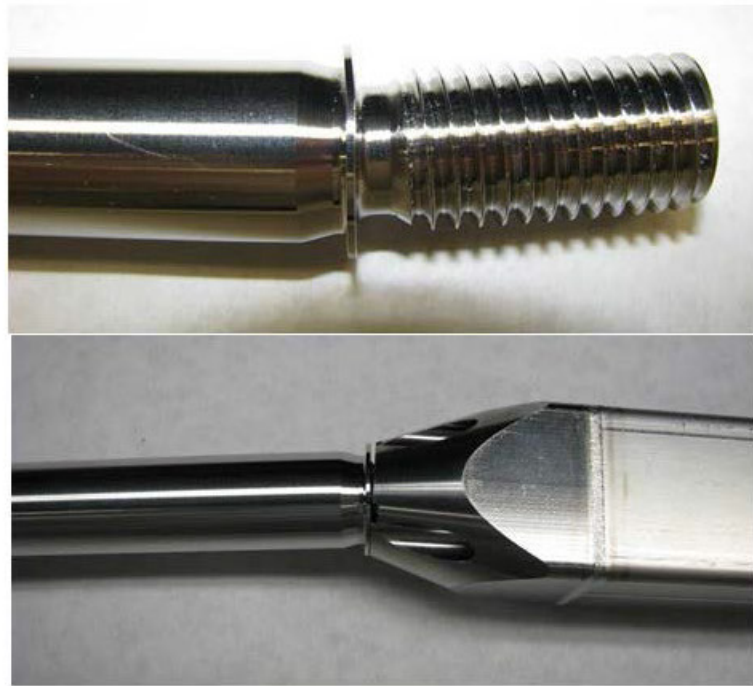
圖59、連接桿經測試後之狀況

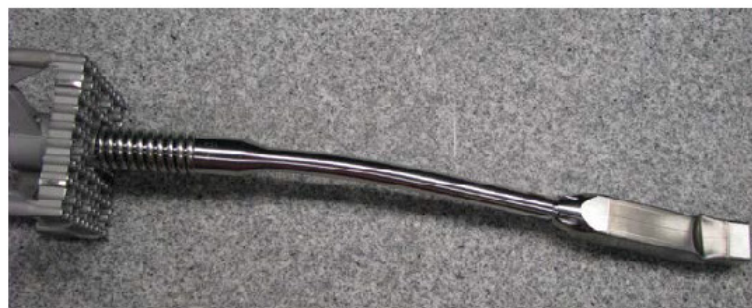
接桿進行PT檢測，判定是否有裂紋存在於無螺紋區域。測試結果顯示，當負荷大於1,800磅(大於2.5倍的吊運規範)時，上繫板、連接桿和水棒皆未發生塑性變形。經PT檢測後，未在連接桿無螺紋區域發現裂紋。接下來繼續增加壓縮負荷至3,600磅時，連接桿發生嚴重變形且鋁合金水棒發生破裂(如圖61)，上繫板把手有輕微受損(如圖62)。經PT檢測後，未在連接桿無螺紋區域發現裂紋。

圖61、經測試後的連接桿和水棒

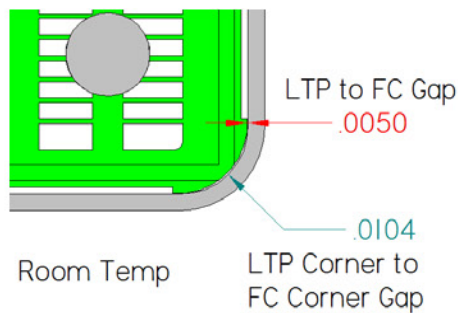
用室溫下，下繫板的(LTP)最大外圍尺寸和燃料匣(FC)的最小內圍尺寸，計算出LTP-FC間隙為0.005吋，在角落處之間隙為0.0104吋，如圖63。

圖63、室溫下之LTP-FC尺寸計算

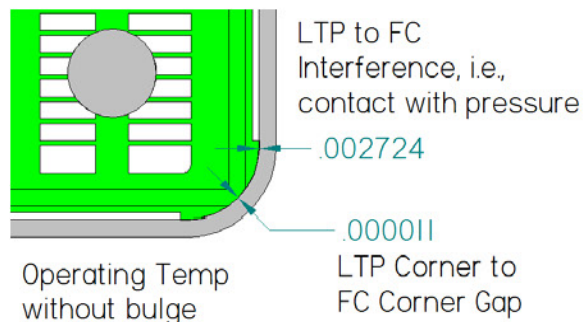
在運轉溫度下，不鏽鋼之熱膨脹係數較鋁合金高，因此有熱膨脹差異效應，此時計算出LTP-FC間隙(0.002724吋)可能發生干涉(interference)，在角落處只剩下很小的間隙(0.000011吋)，如圖64。

圖64、運轉溫度下之LTP-FC尺寸計算

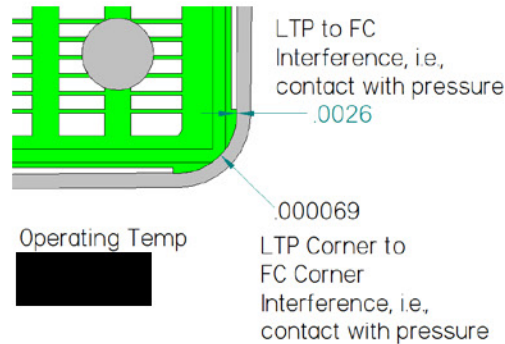
當考慮燃料匣的腫脹(elastic bulge)時，會在燃料匣角落產生向內的變形。同樣考慮運轉溫度下熱膨脹差異效應，假設此時的腫脹量為 ████████，造成LTP-FC間可能發生干涉(0.0026吋)，在角落處亦可能發生干涉(0.000069吋)，如圖65。

圖65、考慮腫脹時，運轉溫度下之LTP-FC尺寸計算

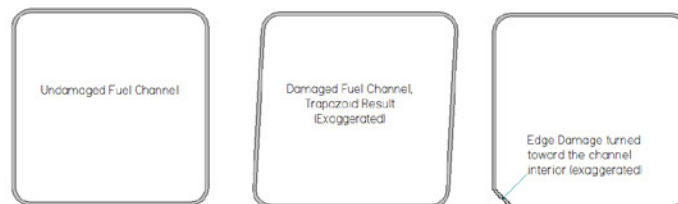
除了熱膨脹差異和燃料匣腫脹(elastic bulge)兩個效應外，還可能在燃料匣底部因未預期的吊運狀況造成損傷，造成燃料匣與下繫板間的頂緊，誇張的示意圖，如圖66，但經查閱燃料廠家與核一廠的燃料吊運紀錄，確認未發生此現象。

圖66、燃料匣損傷示意圖

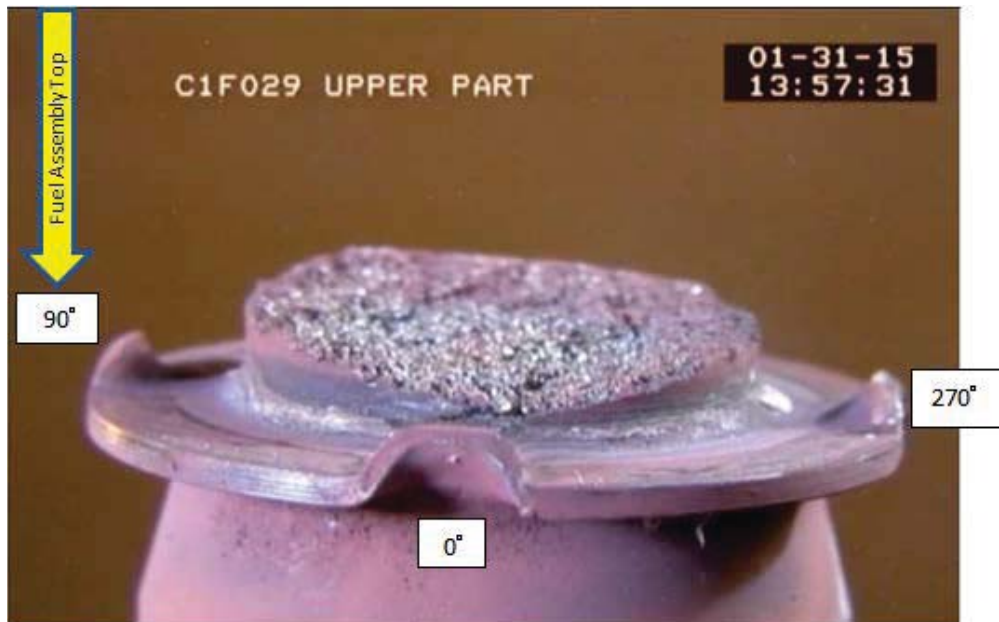
Figure 20. Close-up of FF1 at 0° position

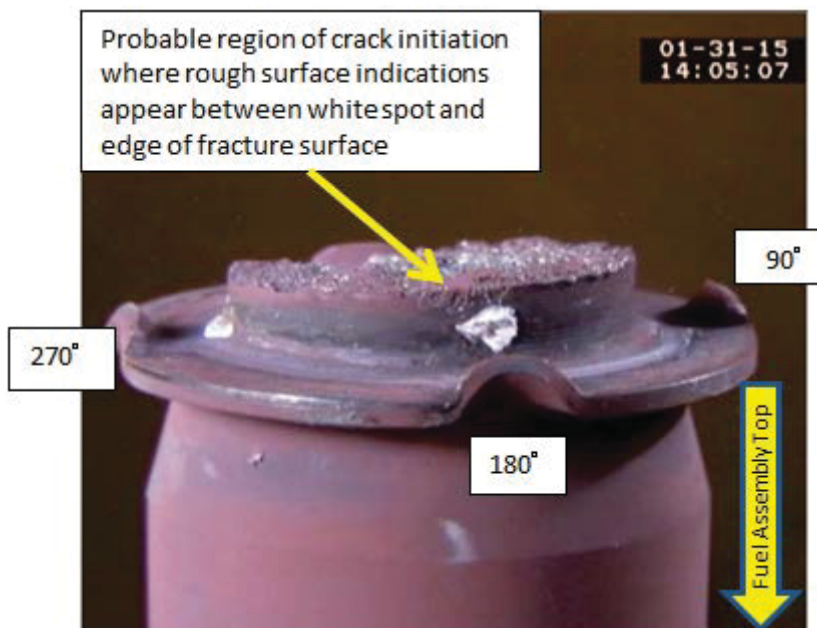
Figure 21. Close-up of FF1 at 180° position showing rough surface indications

On initial observation, the surface indications shown in Figure 21 in the machined thread relief transition area of the fractured end of the Connecting Bolt is not a surface that would have been created by a sharp cutting tool used in a normal machining operation in unblemished material during manufacturing of the Connecting Bolt. The surface indications can be further described as shallow rounded profile depressions. A defect caused by machining of unblemished material (e.g., from a worn cutting tool) would have a shape that would be in line with the cutting tool used during turning on a lathe and thus would be shaped more like a long oval with sharp angled ends. The Connecting Bolt manufacturing drawing, A1C-810304-1, has a surface finish requirement just below the General Notes (Zone E9). The surface finish callout is for a default finish of Rz16 (which applies to the thread relief features) in accordance with ISO 1302.

The surface indications shown in Figure 21 would not have been acceptable to a Rz16 finish and if present to the extent seen in the figure during manufacturing would have been observed by the machine operator or quality inspector (at the supplier), or AREVA source inspector or AREVA ANF-Karlstein torquing and staking operator before assembly of the Connecting Bolt to the WC UEP. As the review of records determined, no abnormality was found during fabrication. If a much smaller surface defect caused either by a mechanical deformation or removal of a non-metallic inclusion during manufacturing was present, visual inspection may not be sufficient to identify this kind of surface indication. In order to increase the sensitivity to reveal a surface indication and provide a higher safety margin, an inspection using dye penetrant will be done in the interim until an improved ultrasonic methodology is approved.

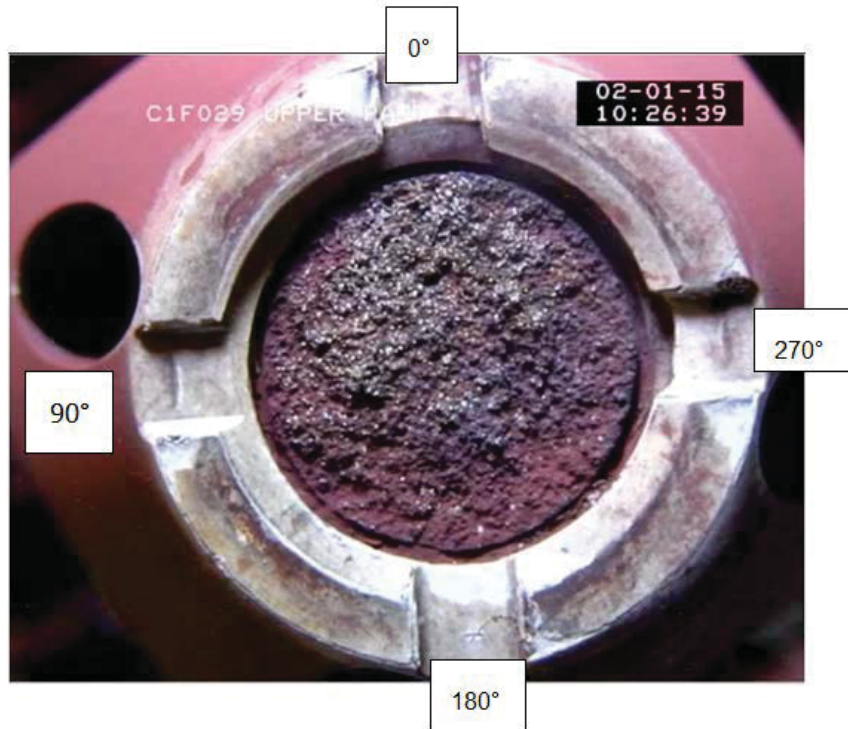
The lower surface of the fracture face contained within the upper end plug will be referred to as Fracture Face 2 (FF2). The examination of FF2 is in agreement with the observations of FF1; Figure 22. The fracture face meets the outer surface in the 180° circumferential position near the thread runout. The mating surface of the end fitting appears metallic bright, but it must be considered that it was treated with Scotchbrite prior to packaging at Chinshan for transportation to INER.

Figure 22. Close-up of FF2 contained within the WC UEP.

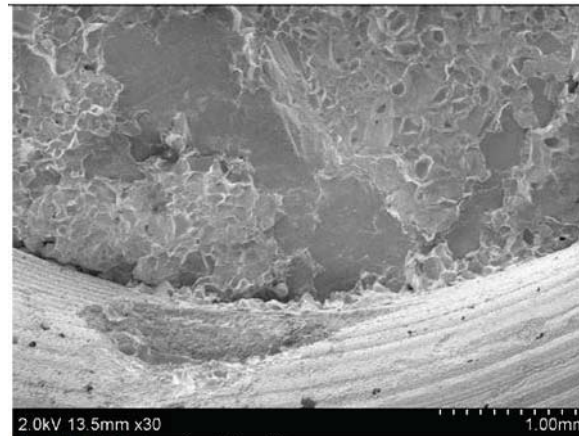
The majority of the fracture face in the reddish areas (90° to 270°) shows rather rough grain surfaces caused by an extracted oxide deposit and a surface with a higher degree of oxidation (see Figure 25 taken at 180°).

Figure 25. R1.1, 180°.

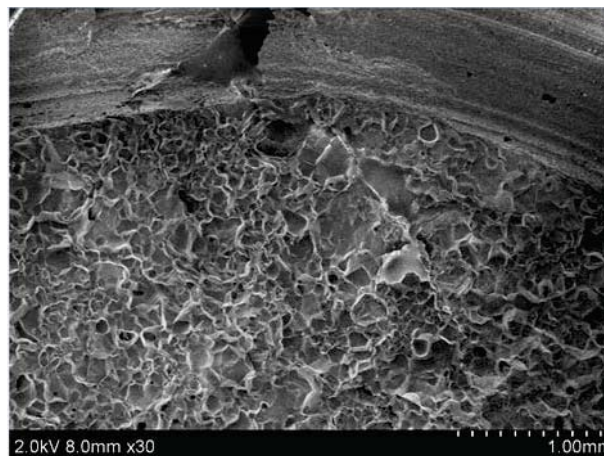
Figure 26. R1.1, 0° position, showing trace of small crack.

At the 0° circumferential position on the fracture face a, crack can be seen (see Figure 26). The large feature seen near the top of the figure is an artifact of the replica and not from the actual fracture surface.

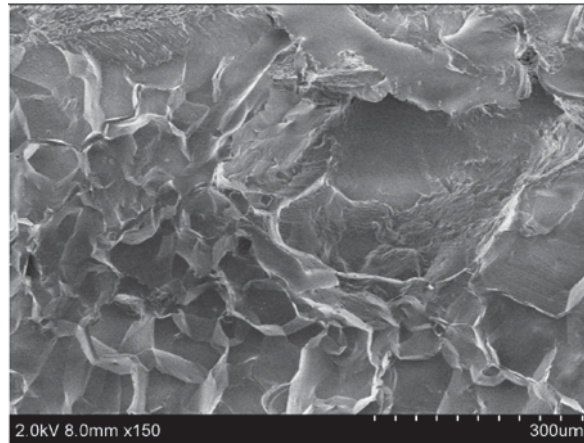
Figure 27. R1.1, 0° position, local transgranular area attributed to final fracture.

Only a small fraction of the fracture face seems to possess a transgranular fracture characteristic (see Figure 27 and Figure 28). This area can most probably be attributed to the final ruptured area.

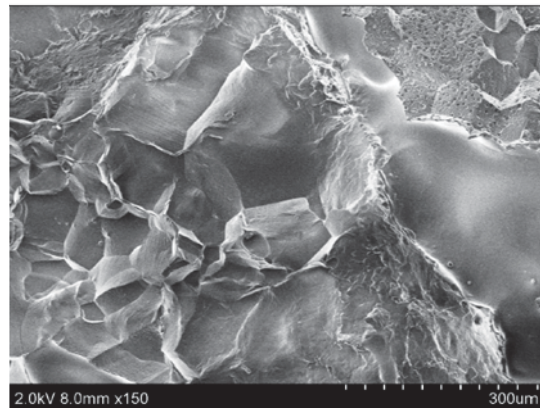
Figure 28. R1.1, 0° position, local transgranular area of the final overload failure.

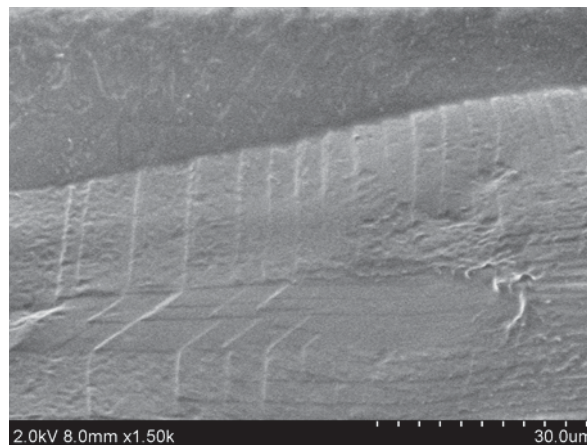
Figure 29. R1.1, 0° position, slip lines crossing a twin boundary.

The region near 0° shows little corrosion product with evidence of slip bands that likely represent the fresh fracture surfaces formed at the latest stage of failure. The slip bands indicate significant plastic deformation. The linear steps clearly represent slip bands and not fatigue marks as they do not run through grains, but rather remain associated with individual grains. Any movement over grain boundaries typically showed cross-slip, evidenced by a complete shift in the direction of the striation (see Figure 29).

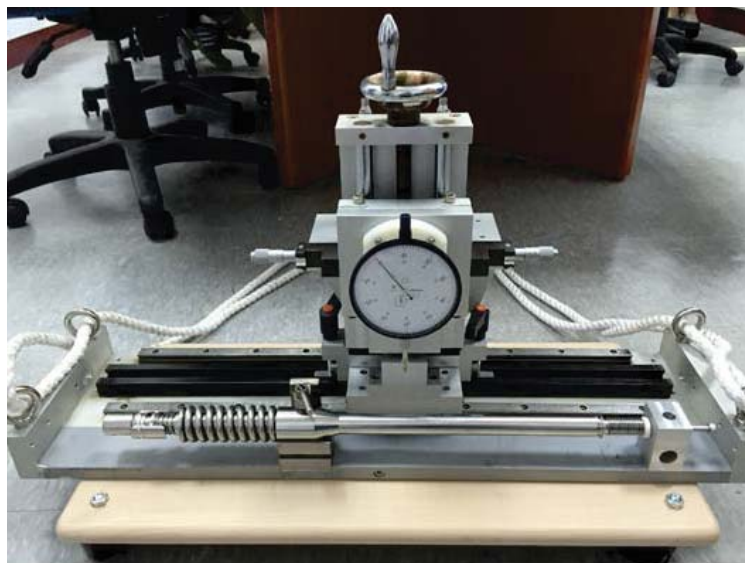
Figure 30. Straightness measurement setup.

An inspection of the straightness of the failed Connecting Bolt was performed by INER. Figure 30 shows the setup used for the dimensional inspection. Inspection of the bolt did not indicate any significant plastic deformation in the bolt shaft. Subsequent detailed analysis of the results by AREVA concludes the Connecting Bolt is within the permissible drawing tolerances [4].

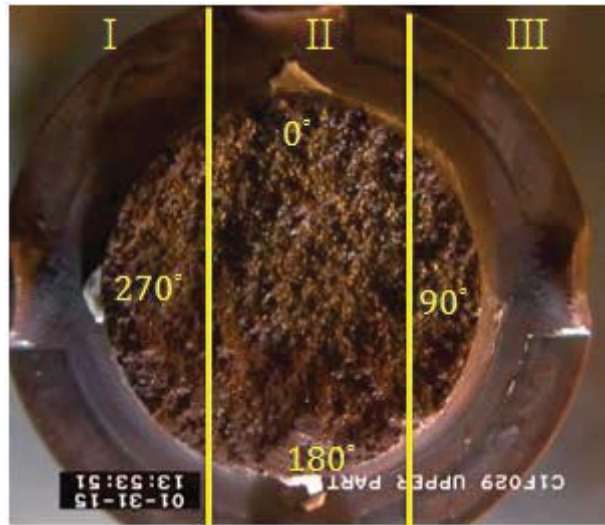
Figure 31. FF1 layout for sectioning.

Once INER developed tooling to perform cutting within the hot cell, efforts were focused on sectioning FF1 in order to reduce the dose rate of individual sections to permit removal of the sections from the hot cell for SEM and EDX examination. The initial sectioning performed is shown in Figure 31.

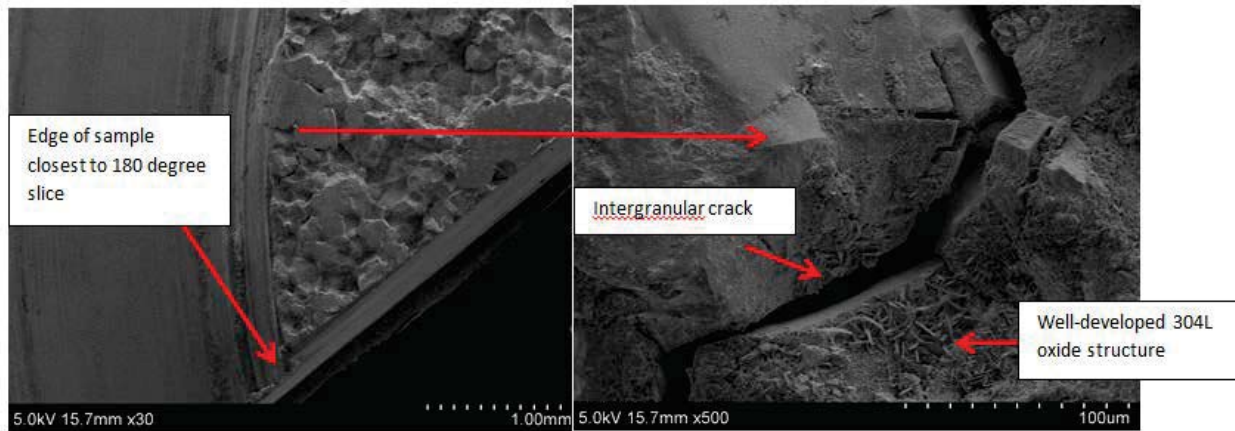
Figure 32. FF1, Specimen I showing evidence of intergranular cracking.

Most of the surfaces of all three Specimens of FF1 shown in Figure 32, Figure 33, and Figure 34 exhibit intergranular cracking. Grain faces appear covered with heavy oxides. In areas from the 270° Position around to the 0° Position and continuing to the 90° Position transgranular cracks are observed (see Figure 35). The transgranular cracks represent a much smaller proportion of the fracture surface than the intergranular cracks. There is no apparent plastic deformation in the material at the 180° Position determined to be most likely site of crack initiation.

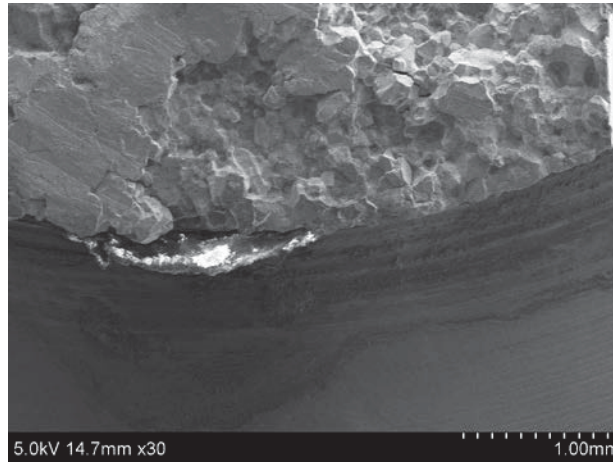
Figure 33: FF1, Specimen II, 180 °Position, showing evidence of intergranular cracking.

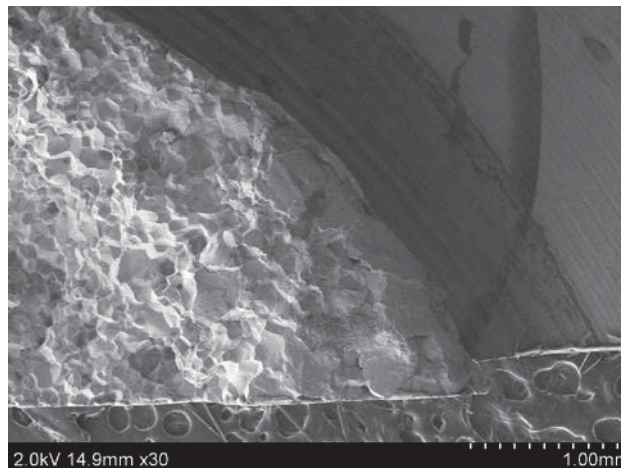
Figure 34: FF1, Specimen III, showing evidence of intergranular cracking.

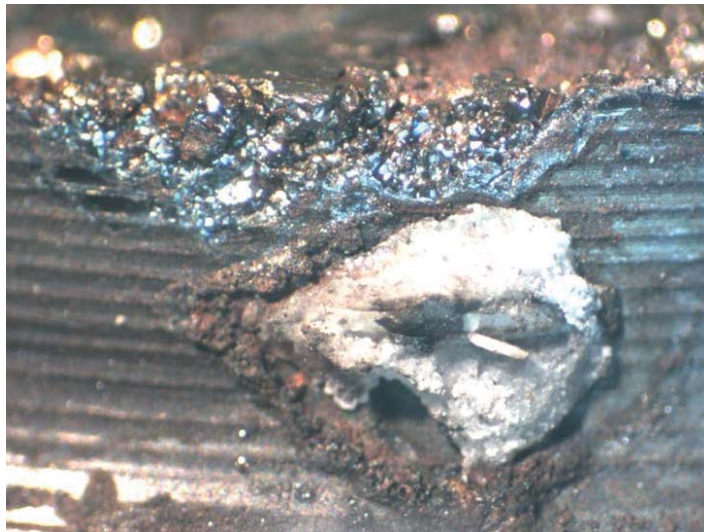
Figure 37. Side view of FF1, Specimen II at 180° Position before citric acid cleaning.

After cleaning and examining Specimen II with citric acid (to remove the crud, corrosion, and deposits, see SEM micrographs in Figure 37 and Figure 38), it is possible that the surface indications at the 180° Position originated as metallic or non-metallic inclusions which were uncovered by the machining operation (i.e., not a machining defect but a material defect exposed by machining). Stated differently, it is possible that during machining, an inclusion was exposed and likely removed from the bolt. This led to a surface irregularity, potentially with edges of a differing local chemistry.

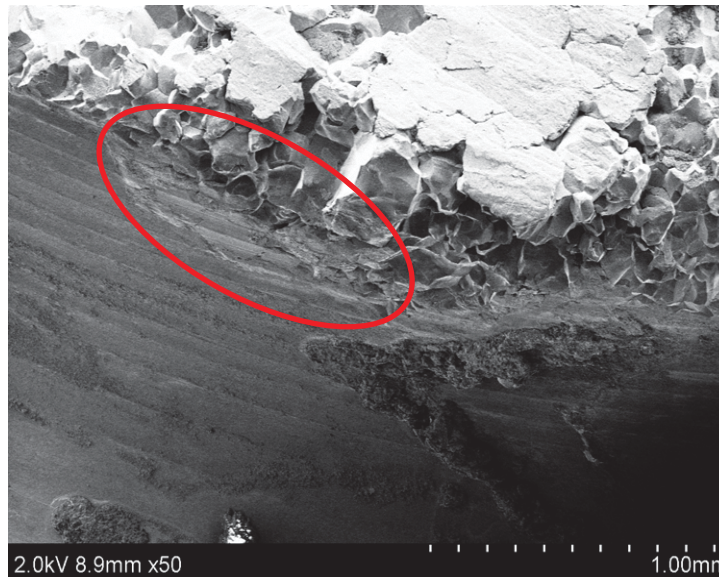
Figure 39. Side view (50x) of FF1, Specimen II at 180° Position (after cleaning).

This interpretation is based on the appearance of the material within the red circle below in Figure 39, and multiple machining passes running through the surface imperfection area. The color appearance of the local area as shown in the SEM images could be driven by differences in overall orientation, angle, and distance/focal length compared to the rest of the surface. Additionally, if an inclusion resulted in a local difference in chemistry, this area could have experienced different oxidation kinetics from the rest of the surface, once again leading to color differences.

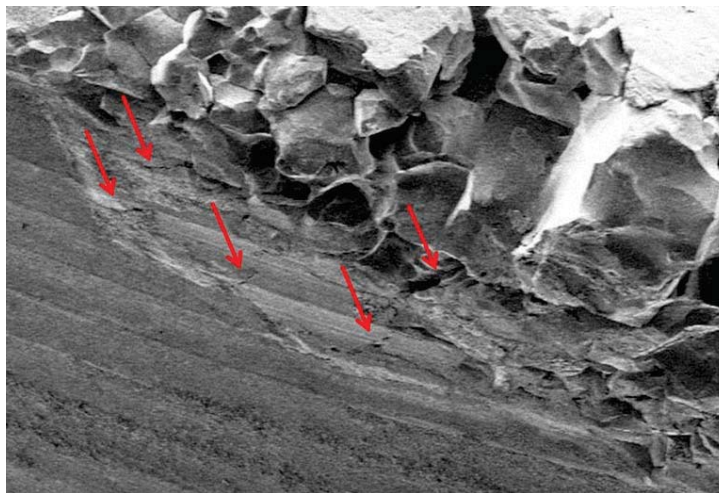
Figure 40. Side view (~130x) of FF1, Specimen II at 180° Position (after cleaning).

These surface defects could have subsequently initiated corrosion pits which led to transgranular crack initiations (examples of which are indicated by red arrows in Figure 40). The region to the right of the red circle is the more advanced failure region, where significant pitting has already occurred and likely where the primary cracks initiated.

Figure 40 highlights various instances of transgranular crack initiation sites within this region associated with more recent crack initiations. An additional image at the 180° Position (Figure 41) shows another potential inclusion (within the oval), similarly oriented to the site already discussed. Inclusions of this size are not expected, nor are a history of their occurrence in this product documented. Therefore, if these images are the result of inclusions, it would be unexpected to see others elsewhere on the surface of the bolt.

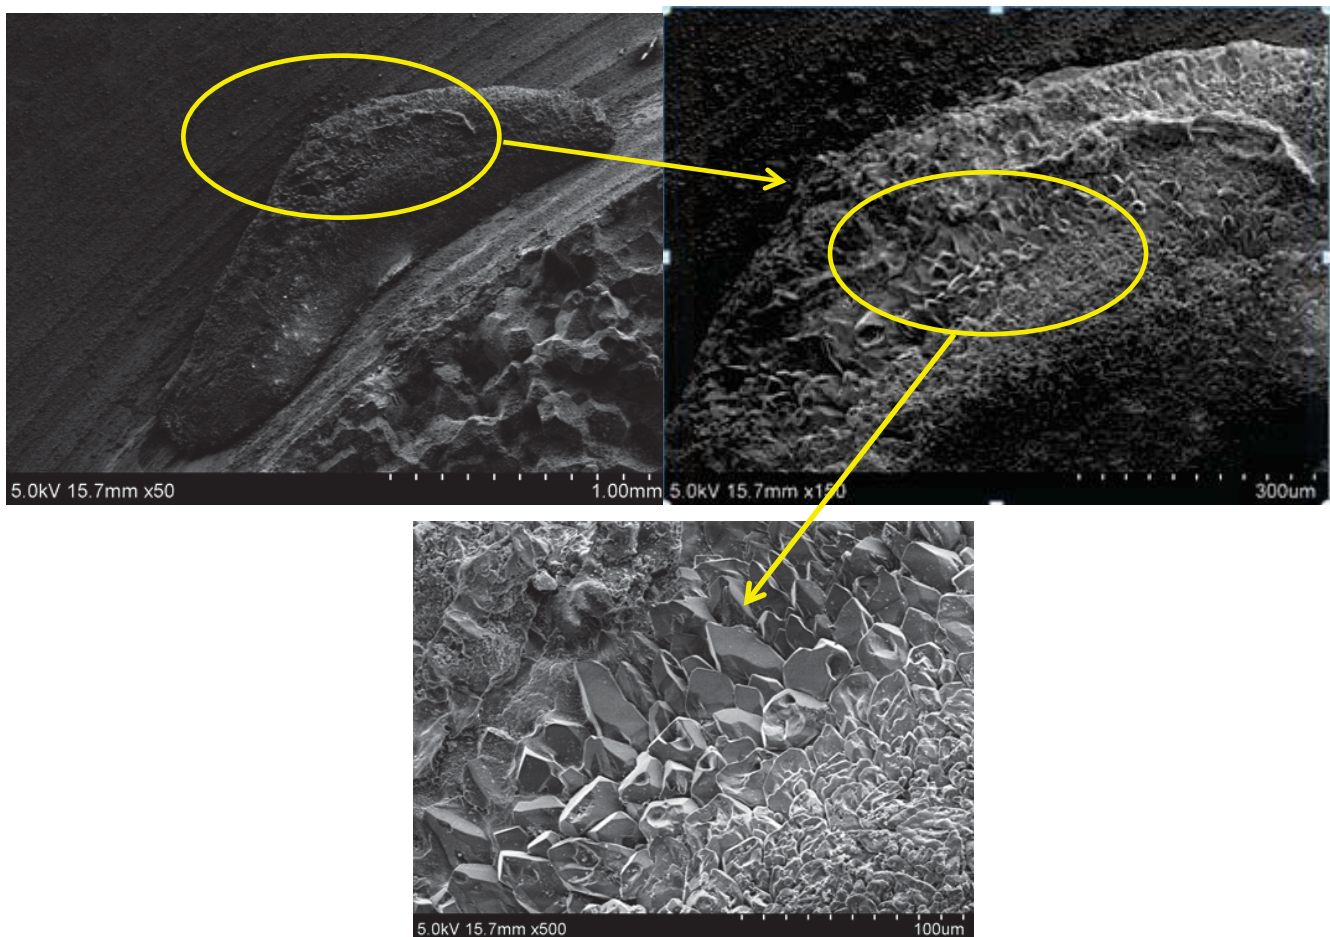
Figure 42. FF1. Specimen I close-up of White Spot near 270° Position.

An SEM examination of the White Spot near the 270° Position (see Figure 42) displays a morphology that indicates boiling is likely occurring in the annulus.

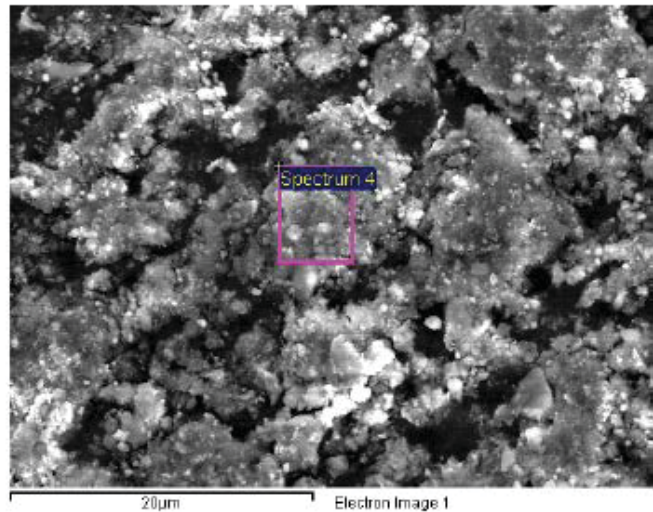
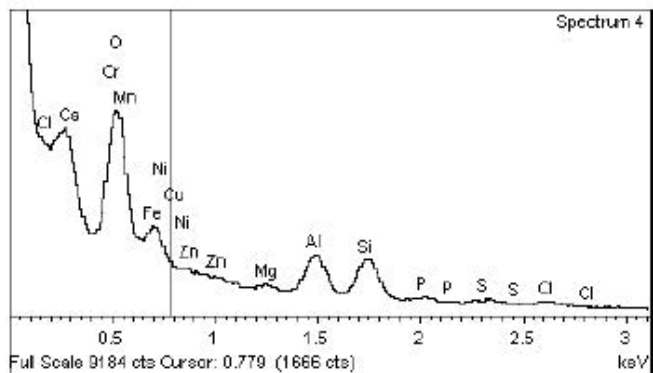
Figure 43. EDX of White Spot near 180° Position.

SEM-EDX of the white deposit at the 180° Position indicates elevated levels of Fe, Si, Al, Cr and oxides (see Figure 43) whereas the 270° Position only indicates elevated Fe, Si and oxides (see Figure 44). These results are expected and not unusual given the water chemistry of Chinshan Unit 1. It was also noted that the deposit was not conductive. The amount of the deposit suggests involvement of water flow rather than the typical crud deposits seen on fuel assemblies. These variations are believed to indicate that the white deposits consist of many various components, likely deriving from crud, corrosion products, and soluble species of the RCS. A review of thermal-hydraulic conditions at the connection indicates that boiling due to gamma heating could occur. The significant presence of silica in the white deposit, which is not an elemental component of any of the cleaning fluids or lubricants used during manufacturing, suggests some contribution of the RCS to formation of these deposits. However, at this time, no direct link between the white deposit and crack initiation exists.
