核一廠 1 號機 EOC-27 大修燃料水棒連接桿斷開處理專案報告
之修訂 2 版修正內容對照表

**核一廠一號機 EOC-27 大修燃料水棒
連接桿斷開處理專案報告
(Rev.2)**

中華民國 104 年 4 月

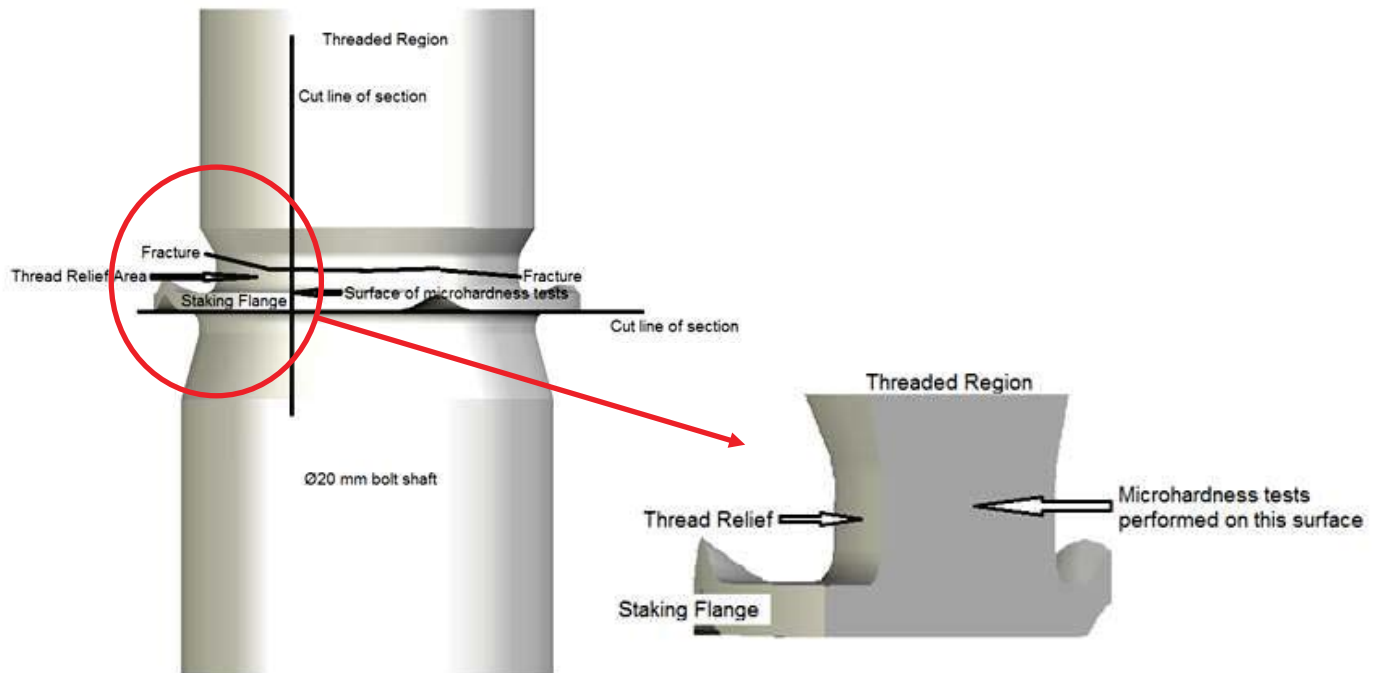
Figure 45. Location of Specimen I microhardness tests within the Connecting Bolt.

Specimen I of FF1 was cross-sectioned, mounted, ground and polished in preparation for metallography and microhardness measurements. Figure 45 shows the orientation of Specimen I in the Connecting Bolt and where the microhardness measurements were taken. The microhardness tests have been done prior to etching (the last step of metallography sample preparation). The hardness of different points is shown in Table 6 according to the optical microscope picture shown in Figure 46. Hardness measurements provided by INER are much higher than measurements of archived material from the same bar stock (see Section 7.10.1).

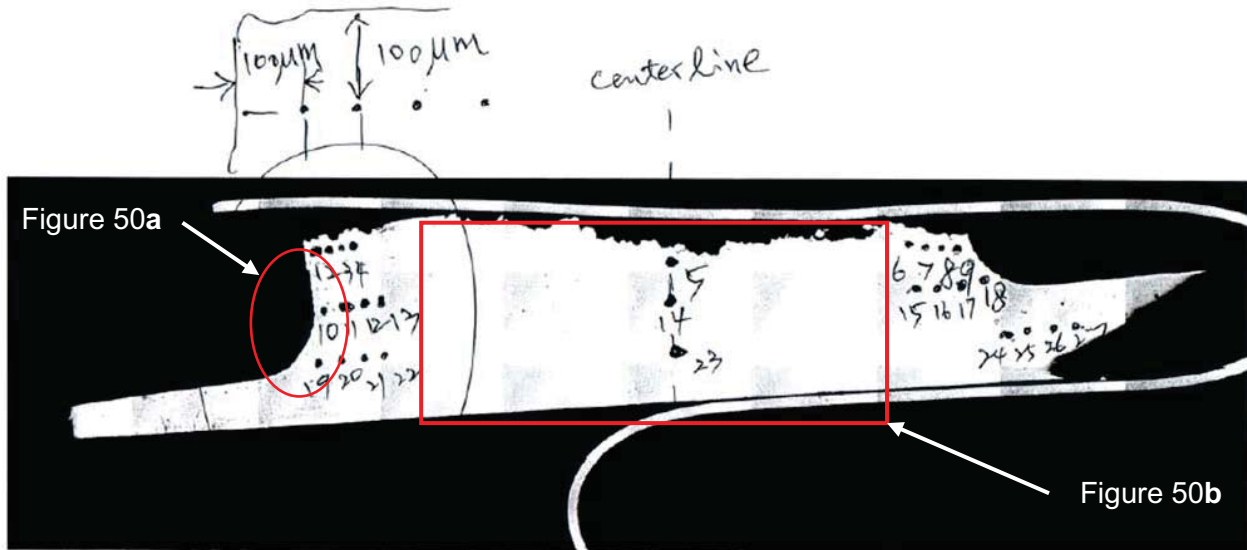
Figure 46. Location of microhardness measurements of FF1, Specimen I

Location	1	2	3	4	5	6	7	8	9
Hardness (HV0.5)	338	335	329	341	321	338	324	332	302
Location	10	11	12	13	14	15	16	17	18
Hardness (HV0.5)	338	321	341	345	335	348	327	341	351
Location	19	20	21	22	23	24	25	26	27
Hardness (HV0.5)	347	335	313	321	338	324	331	317	335

- c. The structure of the cross sections (both irradiated and archive bolts) do not show indication of significant coldwork across the bar's diameter (for the irradiated case, see Figure 46 and Figure 48)

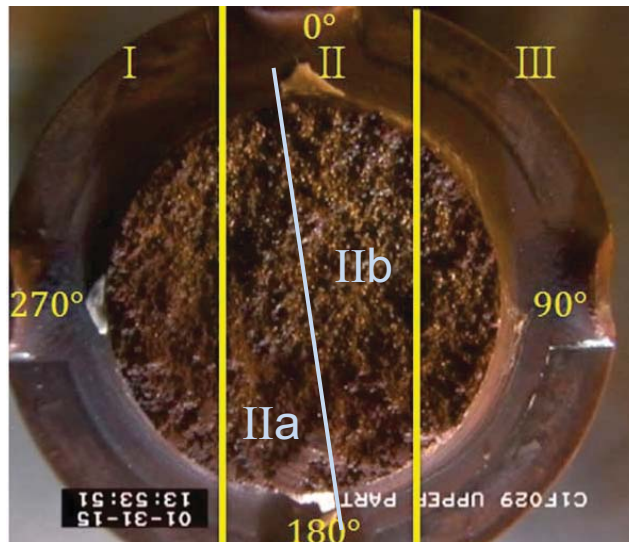
Figure 47. Location of Specimens IIa and IIb within FF1.

Similarly, Specimen II of FF1 was cross-sectioned into two Specimens IIa and IIb as shown in Figure 47. Specimen IIa was mounted, ground and polished in preparation for metallography and microhardness measurements. As with Specimen I, the microhardness tests have been done prior to etching and the hardness measurements at different points are shown in Table 7 according to the optical microscope picture shown in Figure 48. As with Specimen I, the hardness measurements of Specimen IIa, are much higher than measurements of archived material from the same bar stock (see Section 7.10.1).

Increased hardness values, such as seen in the irradiated samples, will correspond to increased strength levels and decreased ductility of the material. This change in mechanical properties is expected whether the increased hardness is attributed to irradiation, coldwork, or a combination of both.

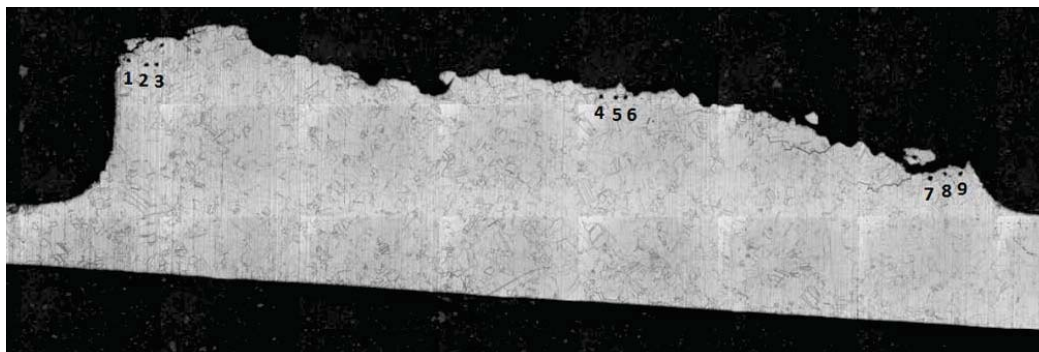
Figure 48. Location of microhardness measurements taken on Specimen IIa.

Location	1	2	3	4	5	6	7	8	9
Hardness (HV0.5)	338	320	323	318	335	326	318	344	329

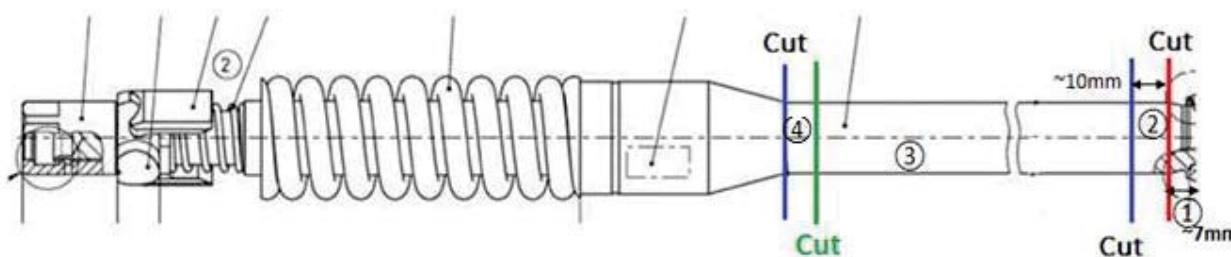
Figure 49. Location of microhardness measurements on Connecting Bolt shaft.

To better understand the influence irradiation on microhardness, measurements were also taken across the diameter of a specimen removed from the Connecting Bolt shaft at location ④ shown in Figure 49. The five measurements taken are shown in Table 8 and are consistent with what would be expected at a short distance above the active fuel zone with reduced fluence.

Location	1	2	3	4	5
Hardness (HV0.5)	195	187	185	178	203

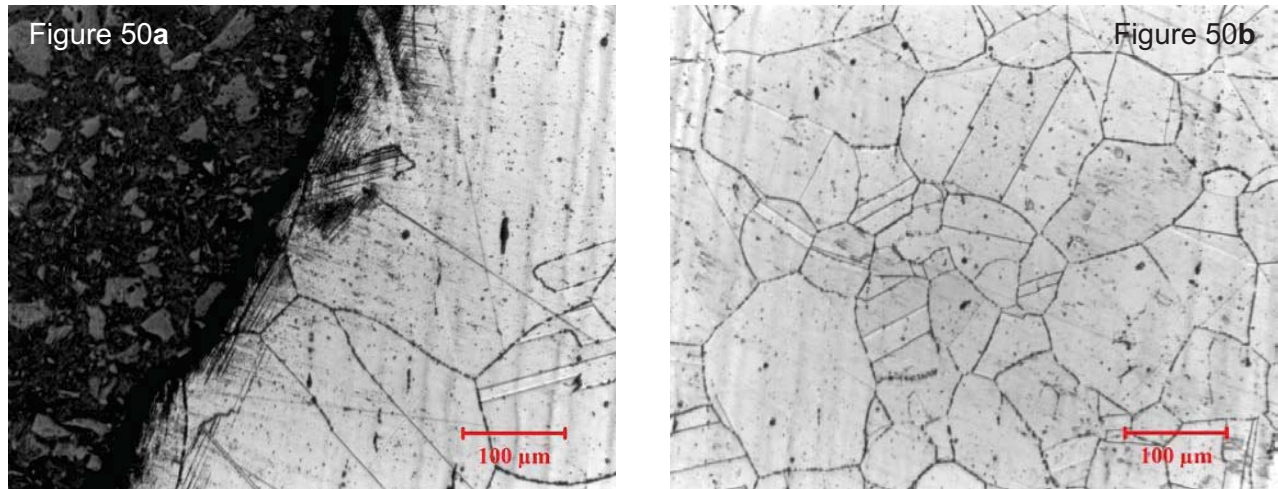
Metallographic examination of the cross-section of Specimen I, shown above in Figure 46, was completed after polishing and etching the sample. Similar to the archive material discussed in Section 7.10.1, the grain boundaries are heavily decorated (Figure 50). Additionally, while coldwork at the surface resulting from the machining operations is evident, no signs of coldwork through the bulk of the material exist. This result corresponds well with the residual stress measurements performed on archive samples discussed in 7.10.3.

Figure 50. Polished and etched micrograph of FF1, Specimen I, showing detail of grains.

- a. There are surface indications at the 180° position of the thread relief outer diameter
- b. The surface of the thread runout (both irradiated and archive bolts) is slightly coldworked at the surface to a depth of less than 50 µm (for the irradiated case, see Figure 50)

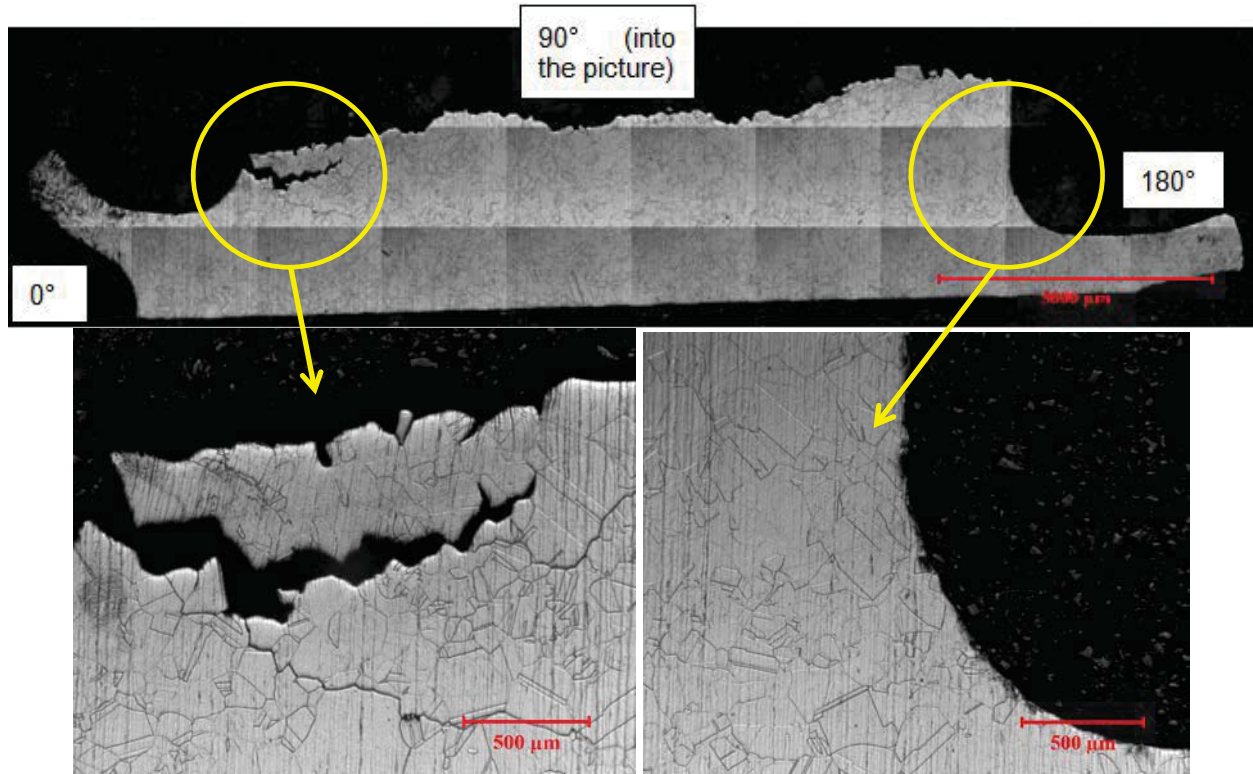
Referring to Figure 47, Specimen IIb was similarly mounted, polished and etched. Photomicrographs shown in Figure 51 reveal a similar microstructure with heavily decorated grain boundaries.

Figure 51. Specimen IIb after mounting, polishing and etching.

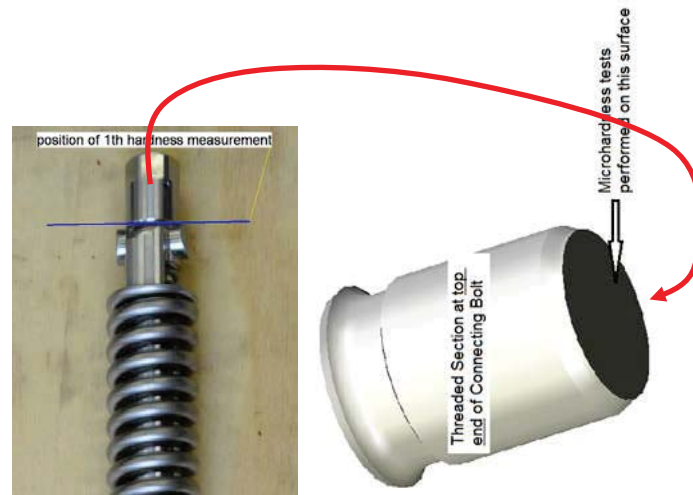
Figure 52. Location of microhardness measurements on top end of archive Connecting Bolt.

An unirradiated, archive Connecting Bolt from the same material bar stock lot of the failed bolt at Chinshan was examined. The first section taken at the top end of the archive Connecting Bolt is shown in Figure 52. This location was selected because the Connecting Bolt lower end was still attached and staked to the WC UEP at the time and testing at the top end would provide an expedited set of hardness values to compare against the micro-hardness values of the fractured Connecting Bolt. The locations and values of each measurement are shown in Figure 53.

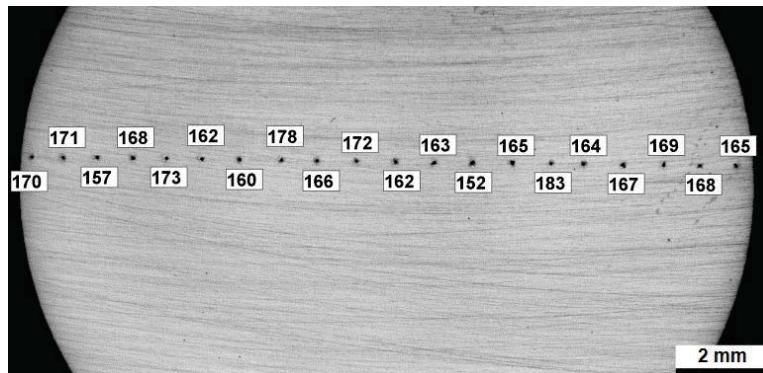
Figure 53. Microhardness measurements of top end of archive Connecting Bolt.

The mean hardness along the cross-section is 167HV0.5 (± 7). These values are expected for an as-fabricated alloy 304L component, and they are much lower than the measured microhardness values of the irradiated fracture face (see Table 6).

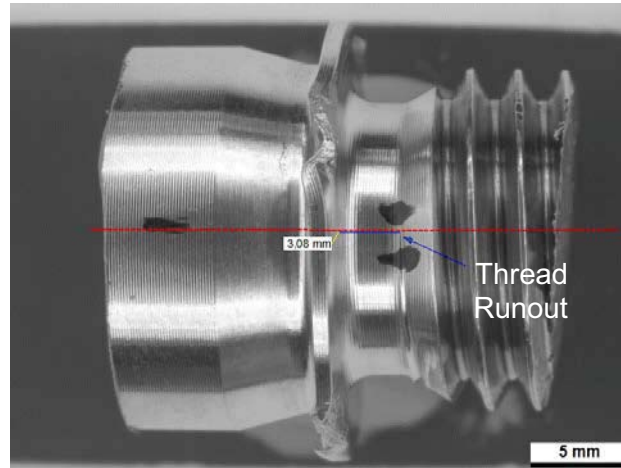
Figure 54. Position of section S2, thread runout labeled.

Microhardness measurements in the region of the thread runout as shown in Figure 54 and close to the region measured on the failed bolt (see Figure 46) near to the surface (in area where coldwork due to machining is expected) show values of approximately 160 -180 HV0.5, on average.

The Connecting Bolt was disassembled from the WC UEP and a visual examination of the threaded region showed no unacceptable surface indications. A section through the lower end thread relief area was prepared as shown in Figure 54.

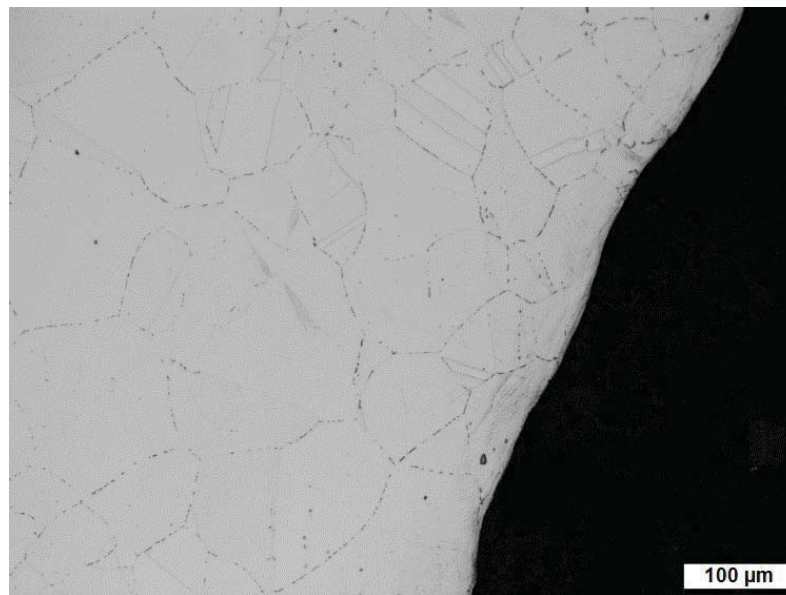
Figure 55. S2, detail etched, decorated grain boundaries.

A photo micrograph of the section near the thread runout (see Figure 55) shows decorated grain boundaries with no evidence of coldworking.

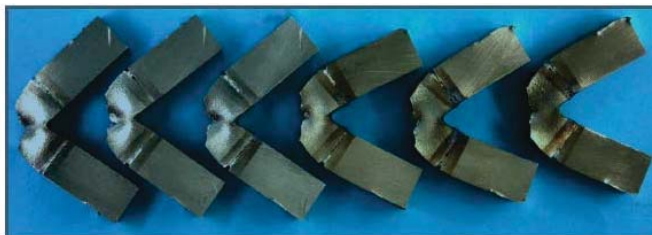
Figure 57. Charpy-V Impact Test Specimens after Testing.

Charpy-V Impact Toughness tests on specimens taken from archive Connecting Bolts were performed and no unexpected results (no complete fractures as shown in Figure 57) were found.

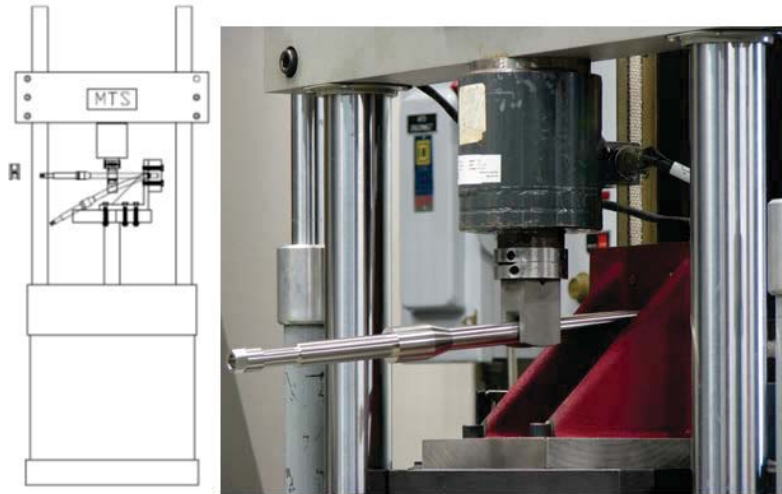
Figure 58. Lateral Load Test Setup.

The load was applied at a static rate, stopping at 300 lbs. and 600 lbs. to remove the Connecting Bolt from the fixture and perform a liquid dye penetrant test to identify cracks. Figure 58 shows a depiction of the test set up.

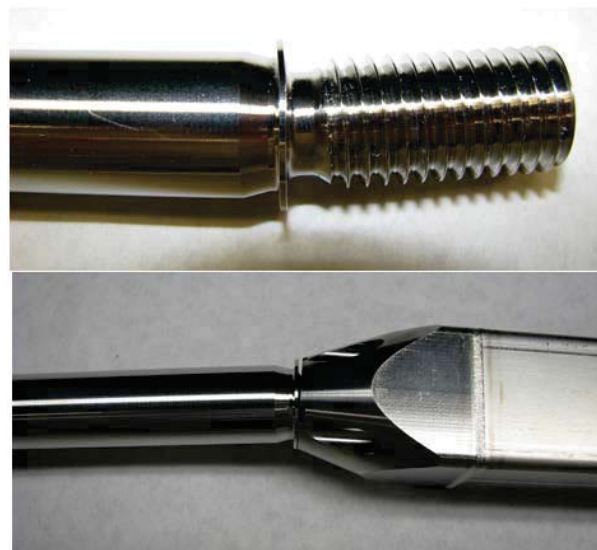
Figure 59. Connecting Bolt Condition after Testing.

The results of the test showed that for both test loads, there were no indications of a crack in the thread relief area of the Connecting Bolt (see Figure 59). Also, the magnitude of the Connecting Bolt bending after testing would be noticed by AREVA Operations personnel, and the installation of the cage assembly into the fuel assembly fabrication fixture would not be possible. Figure 59 also shows the fit-up of components following testing (Note: WC UEP not used to restrain Connecting Bolt during testing).

In conclusion, it is not possible for a crack to have been generated in the connecting bolt as a result of mishandling in the AREVA manufacturing process.

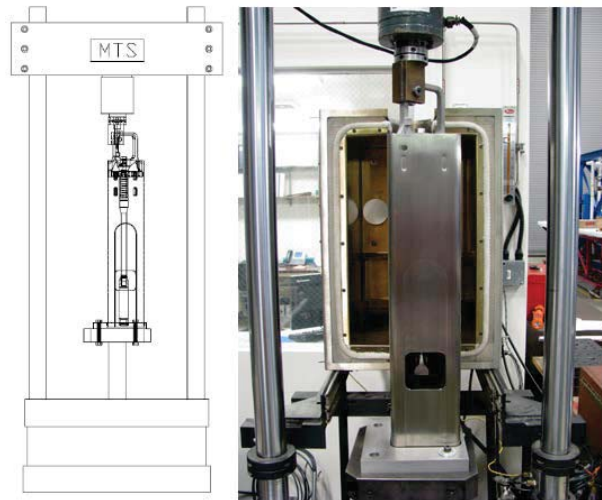
Figure 60. Offset Compression Test Depiction.

relief is located on the side of the assembly opposite to where the load is applied such that the stress intensity is maximized. Figure 60 shows a depiction of the test set up.

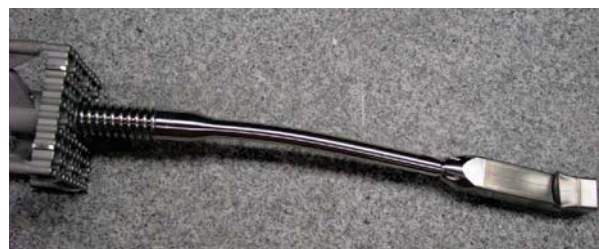
Figure 61. Connecting Bolt and WC after Testing.

The offset compressive load test was reset and loaded until the load chain buckled. At a load of 3,600 lbs., there was significant bending in the connecting bolt and the water channel was collapsed (see Figure 61). The UTP bale handle showed minor damage (see Figure 62). The dye penetrant test performed at this load did not indicate cracks in the thread relief area of the Connecting Bolt.

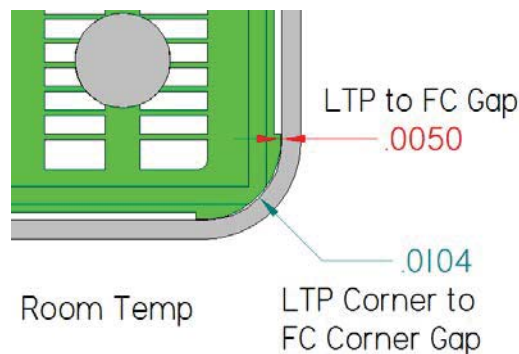
Figure 63. C1F029 LTP and FC Fit-up at Room Temperature.

At room temperature, the limiting LTP to FC gap (using the largest LTP exterior envelope and the smallest FC interior envelope) is 0.0050 inch and an LTP Corner to FC Corner Gap of 0.0104 inch as shown in Figure 63.

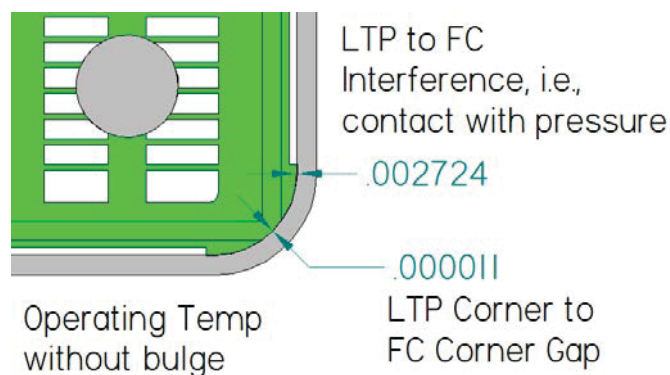
Figure 64. C1F029 LTP and FC Fit-up at Operating Temperature without FC Bulge.

At operating temperature and with the effect of differential thermal expansion, the limiting LTP to FC gap (using the largest LTP exterior envelope and the smallest FC interior envelope) shows a possible interference of 0.002724 inch while at the corner there remains a very slight gap as shown in Figure 64.

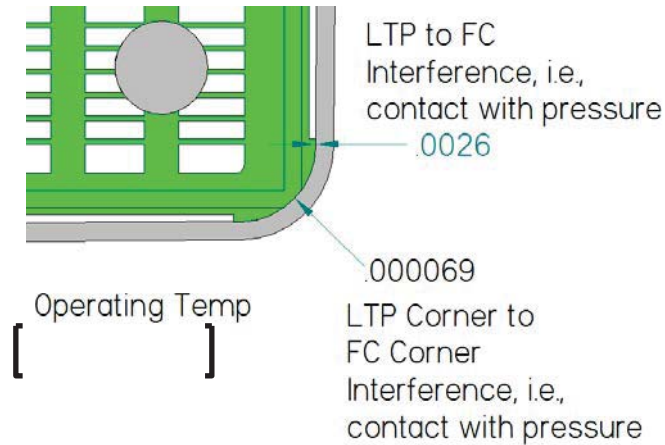
Figure 65. C1F029 LTP and FC Fit-up at Operating Temperature with FC Bulge.

When the effect of elastic fuel channel bulge is considered, there is an inwards deformation of the FC corners. Assuming an elastic bulge of [] inch combined with the effect of differential thermal expansion, the limiting LTP to FC gap (using the largest LTP exterior envelope and the smallest FC interior envelope) shows a possible interference of 0.0026 inch and, at the corner, there can also be an interference of 0.000069 inch as shown in Figure 65.

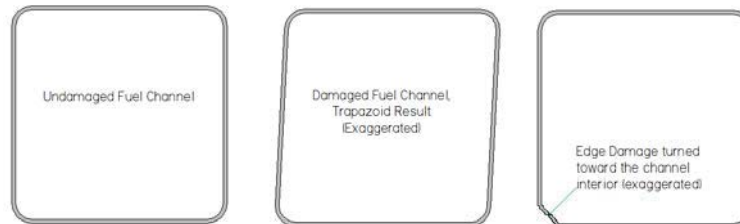
Figure 66. Possible Effects of FC Damage (exaggerated for understanding).

In addition to the effect of differential thermal expansion and elastic channel bulge, there can be the possibility of damage to the lower end of the FC due to an undetected handling event. Examples are shown in Figure 66 with exaggeration to aid understanding.

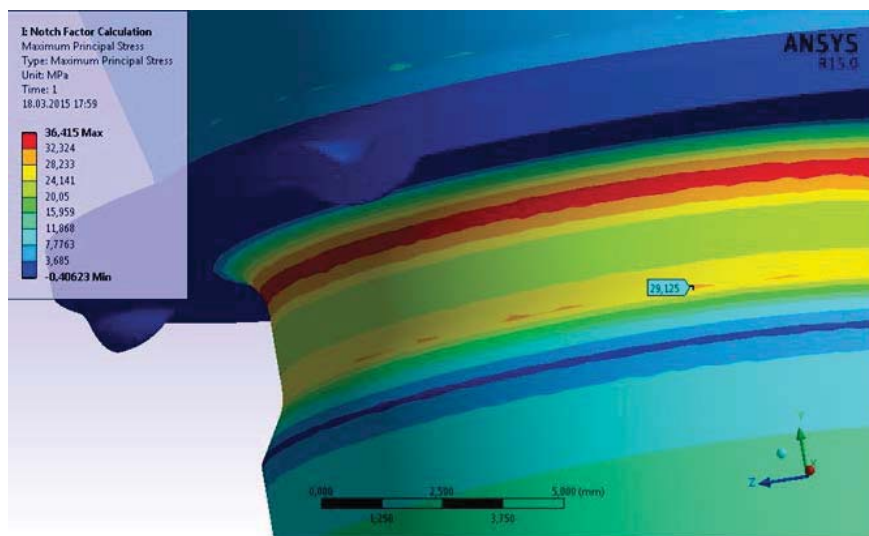
Figure 67. Finite Element Model of thread relief.

The uniform force from the higher growing FC causes a tensile stress of 81.4 MPa (on the circumferential surface of the thread relief) during the first cycle (includes consideration of a notch factor of [] for the minor thread diameter runout into the thread relief transition). The notch factor can be approximately 4 to 10 for a geometry with an initial crack. See Figure 67 below.

Compared to a 304L material minimum yield value of 117 MPa (representative value based on material testing and 0.2% offset, at operating temperature), this stress level suggests IGSCC can be considered as a crack initiation mechanism together with the other contributing factors considered in the RCA. As the threshold irradiation level for IASCC is reached during the 2nd cycle, the IASCC mechanism becomes more pronounced during the remaining time in the reactor.

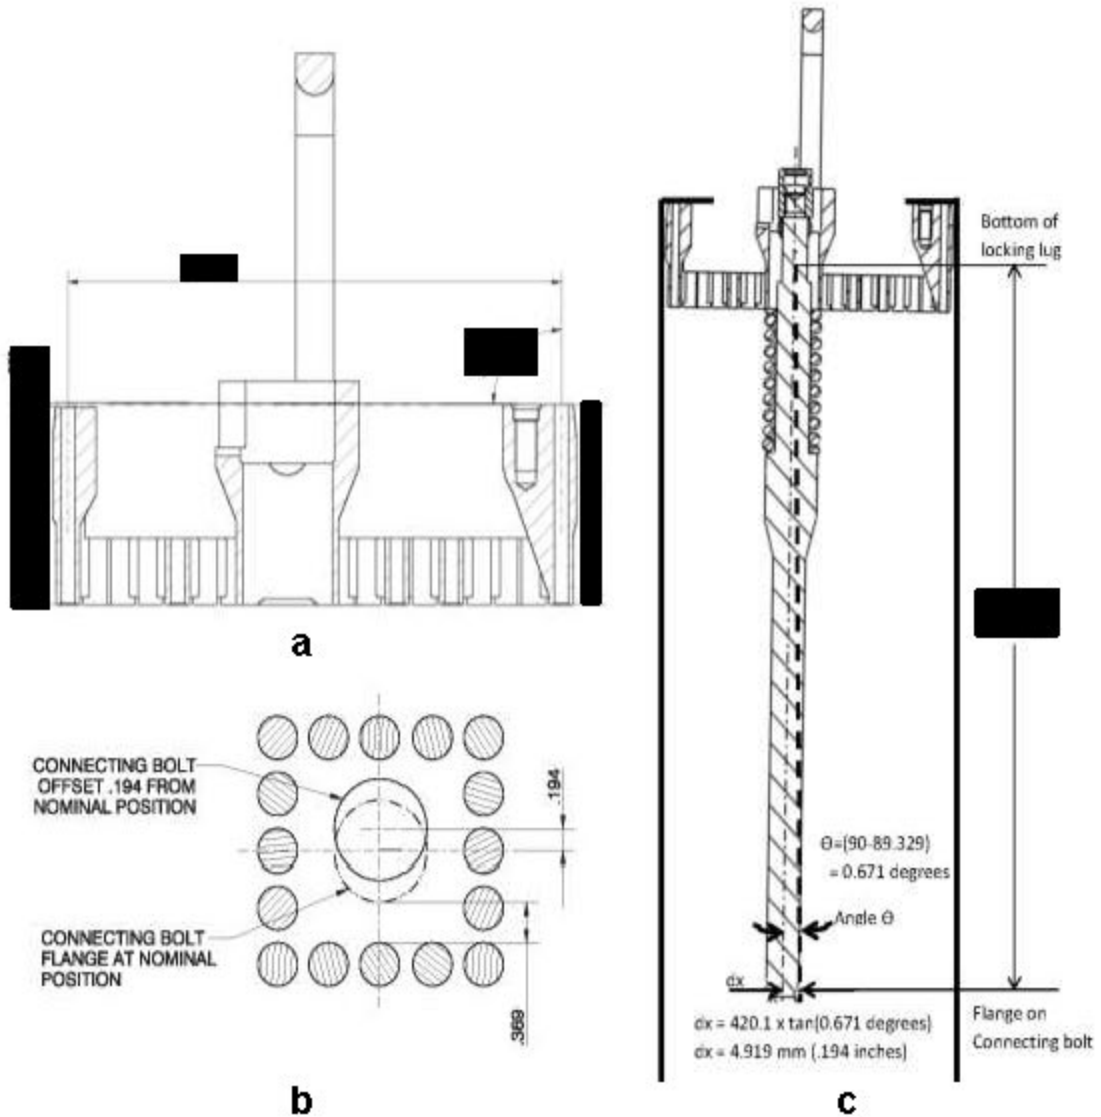
圖 6-1 基於允差和幾何時上繫板的最大傾斜

加計原來的水平撓曲 4.919mm, 總水平側向移動最大間距為 6.257mm, 連接桿亦不會跨過連接桿與鄰近燃料棒的 0.369 英吋 (9.373mm) 的最小間距。

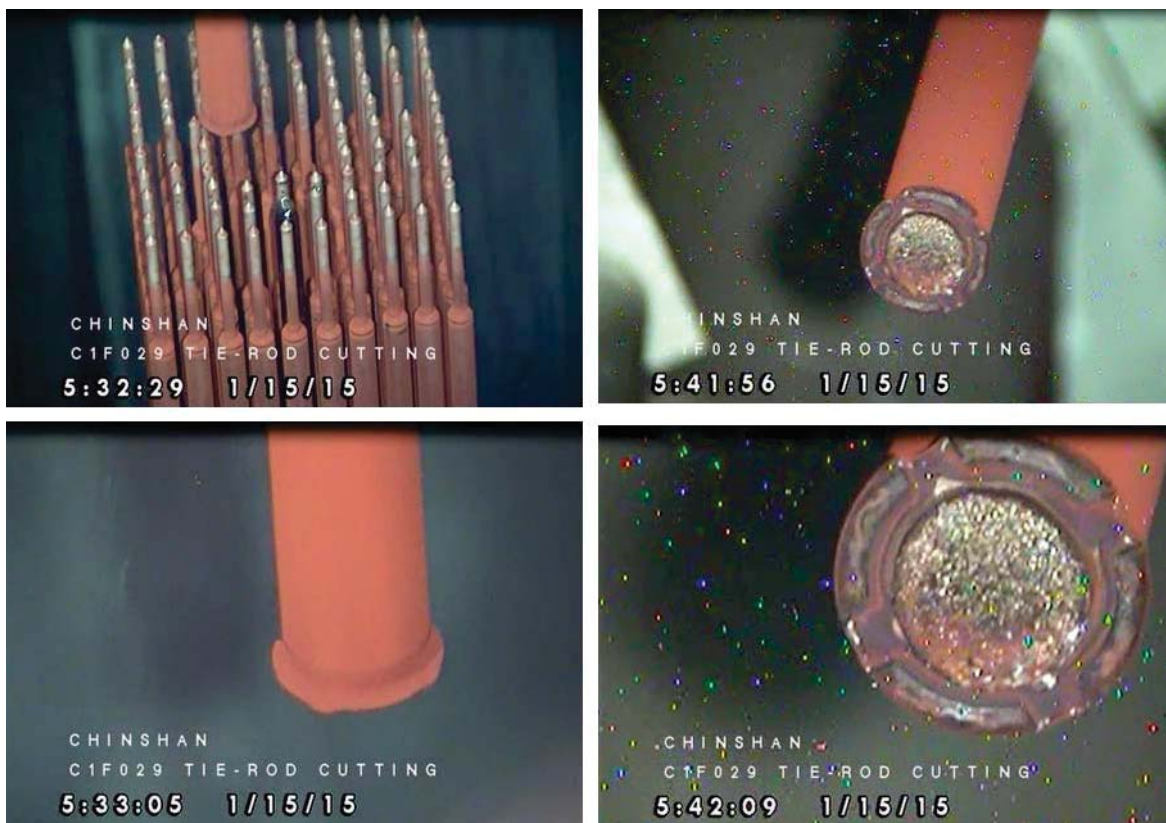
圖 1-1 燃料 C1F029 水棒連接桿斷開處目視圖

When attempting to raise an ATRIUM™-10¹ bundle (assembly ID C1F029) from the core during a refueling outage at the Chinshan Unit 1 BWR in Taiwan, the load sensor units showed a sudden loss of load. Visual examinations revealed evidence of a failure in the load chain at the joint between the connecting bolt and the water channel upper end fitting.

At the time of this report, examination of the load chain failure is ongoing and the root cause is not final. Visuals confirmed that the failure is located in the stainless steel connecting bolt just above the threads (Figure 1-1). Figure 1-2 illustrates the approximate location of the failure in the harmonized advanced load chain (HALC).

Figure 1-1 Visuals showing the location of the failure on the Chinshan bundle C1F029

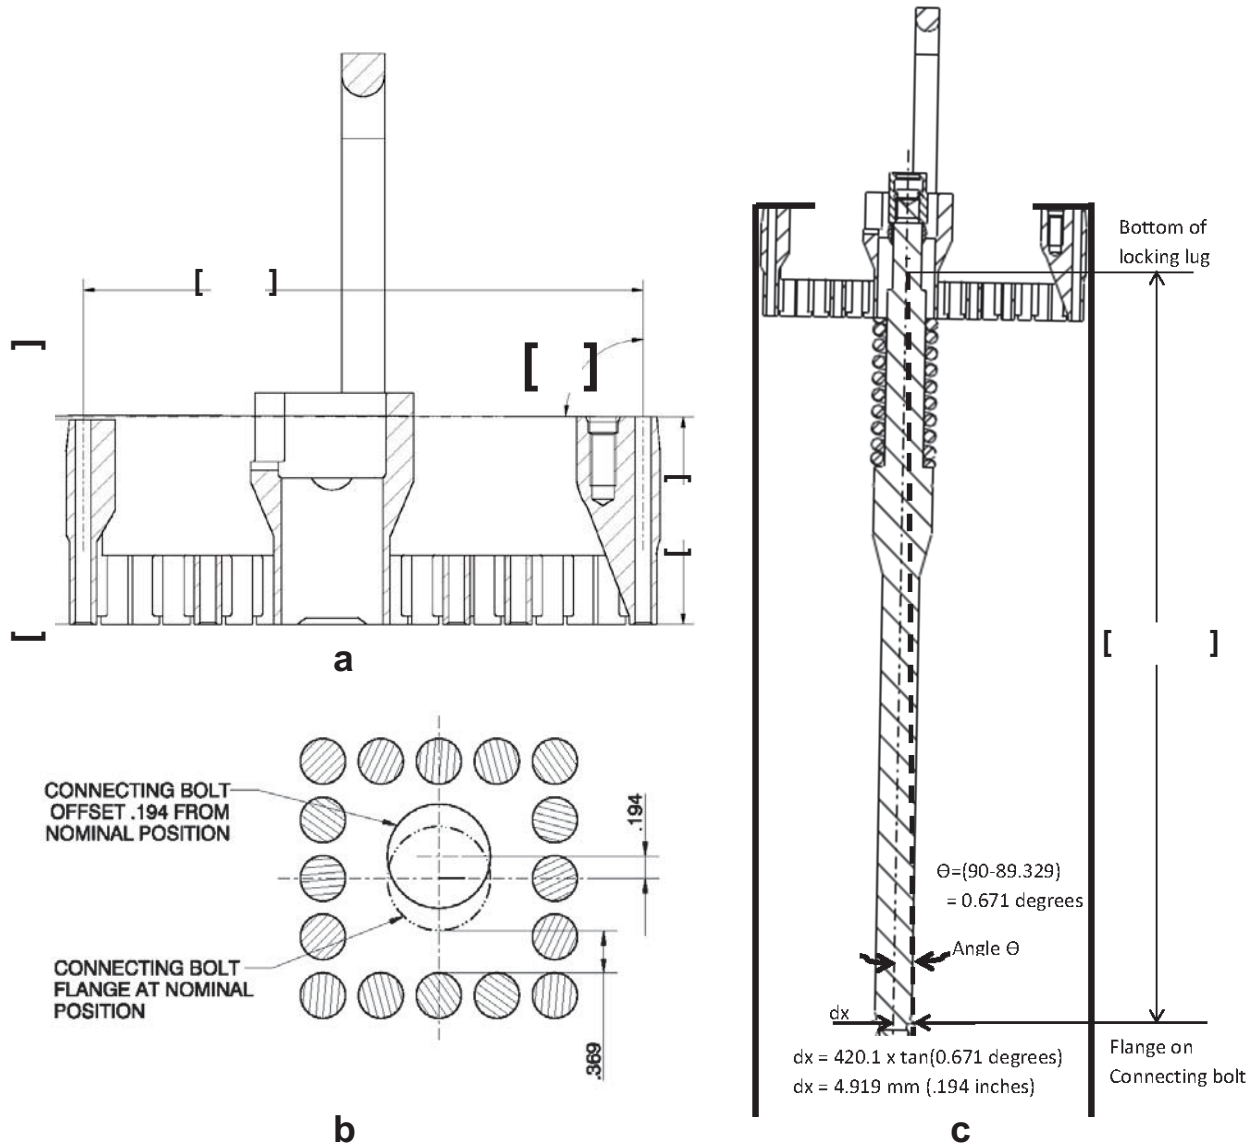
Figure 6-1 UTP showing maximum tilt based on tolerance and geometry

In the unlikely event that the connecting bolt did come loose, the connecting bolt would not displace enough to overcome the minimum gap between the connecting bolt and fuel rods. In the case of the UTP becoming cocked in the fuel channel (Figure 6-1), the worst case movement of the connecting bolt would be 0.194 inches at the connecting bolt flange in any direction. This cocking (tilting) can happen because the threaded post and the opposite corner post on the UTP are different heights []. In addition, both Fuel Channel gussets must be perpendicular with the side of the channel by [] inches. Using trigonometry, this results in a maximum tilt of 0.671 degrees from horizontal (or 89.329 degrees from vertical) as shown in Figure 6-1a. This tilt will also translate to the connecting bolt, as presented in Figure 6-1c. Using trigonometry, the horizontal deflection at the flange can then be determined (by conservatively using the length of the connecting bolt from the seat of the locking lug to the flange being []). The resultant horizontal deflection is 4.919 mm (or 0.194 inches), which will not overcome the minimum connecting bolt to fuel rod gap, as shown in Figure 6-1b. Once in this

position, the force of the compression spring on the UTP precludes any lateral movement of the connecting bolt inside the UTP. Therefore the connecting bolt would not overcome the minimum connecting bolt to fuel rod gap of 0.369 inches.

Channel bow will not distort the fuel rod spacing and will not change how the upper tie plate interacts with the fuel channel and fuel channel fastener. The analysis shown in Figure 6-1 already takes into account worst case variable tolerances allowed in manufacturing, in order to calculate the maximum possible tilt angle. Therefore the conclusions remain valid under excessive channel bow conditions.
