Nuclear Fuel Performance

Department of Nuclear Regulation
Atomic Energy Council, R.O.C

AEC/NRC Bilateral Technical Meeting
May 31 to June 2, 2005

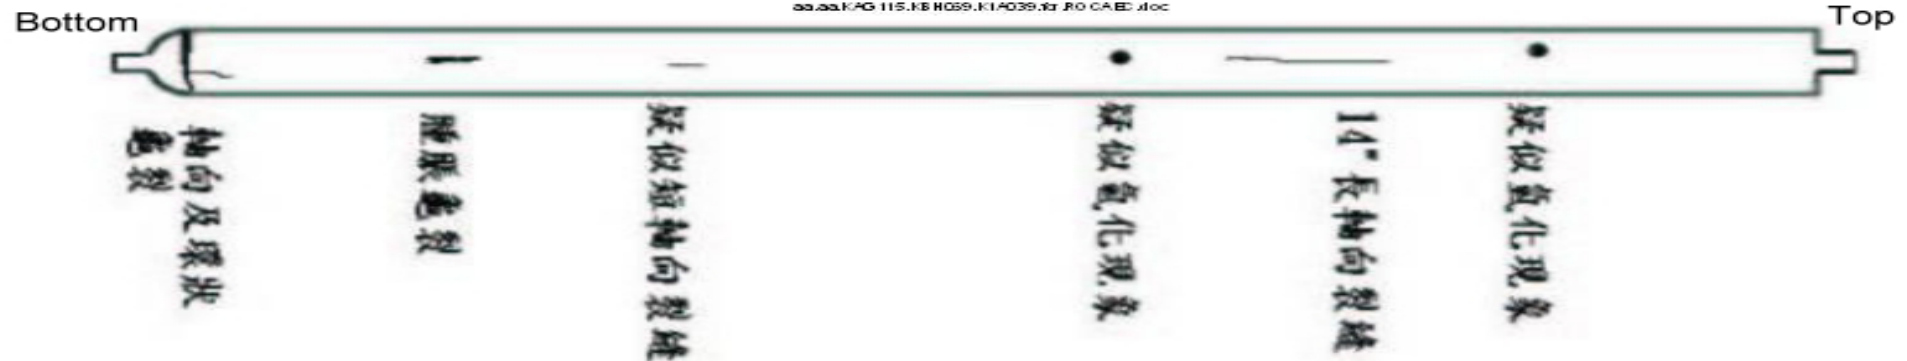
Fig 1. Kuosheng Unit 2 Cycle 16 LHGR (kW/ft) of KAG115 Rod F-02 During the April 13, 2003 Control Rod Sequence Exchange

A - 99.5%CTP Prior to the sequence exchange. Adjacent control rod was at 30.	F - 84.9%CTP Power ascension to rated. Adjacent control rod was fully withdrawn.
B - 99.5%CTP Prior to fully withdrawn the adjacent control rod.	G - 90.6%CTP Power ascension to rated. Adjacent control rod was fully withdrawn.
C - 90.4%CTP After the adjacent control rod was fully withdrawn (from 30 to 48).	I - 94.9%CTP Power ascension to rated. Adjacent control rod was fully withdrawn.
D - 65.2%CTP Power ascension to rated. Adjacent control rod was fully withdrawn.	K - 99.7%CTP Rated power reached. Adjacent control rod was fully withdrawn.
E - 75.3%CTP Power ascension to rated. Adjacent control rod was fully withdrawn.

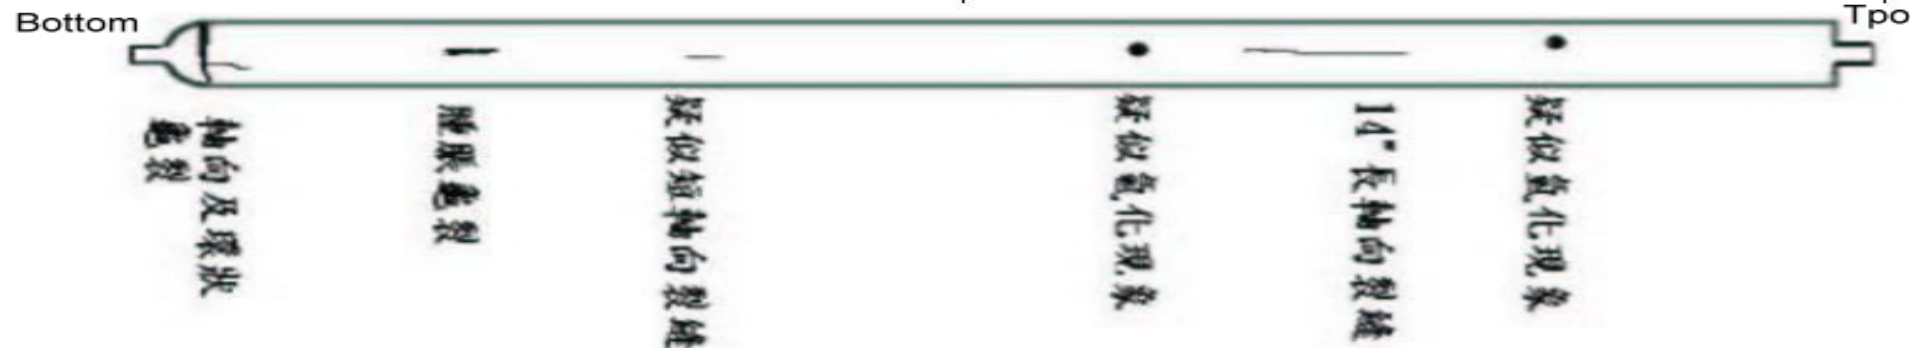
Fig 2. Kuosheng Unit 2 Cycle 16 LHGR (KW/ft) of KAG115 Rod F-02 During the September 7, 2003 Control Rod Sequence Exchange

A - 99.8% CTP Prior to the sequence exchange. Adjacent control rod was fully withdrawn.

B - 58.2% CTP Prior to inserting adjacent control rod.

C - 61.0% CTP After the adjacent control rod was inserted from 48 to 16.

D - 58.5% CTP Prior to adjusting the adjacent control rod.

E - 66.4% CTP After adjusting the adjacent control rod from 16 to 30

F - 72.5% CTP Power ascension to rated. Adjacent control rod was at 30.

G - 79.8% CTP Power ascension to rated. Adjacent control rod was at 30.

H - 97.6% CTP Power ascension to rated. Adjacent control rod was at 30.

I - 99.9% CTP Rated power. Adjacent control rod was at 30.

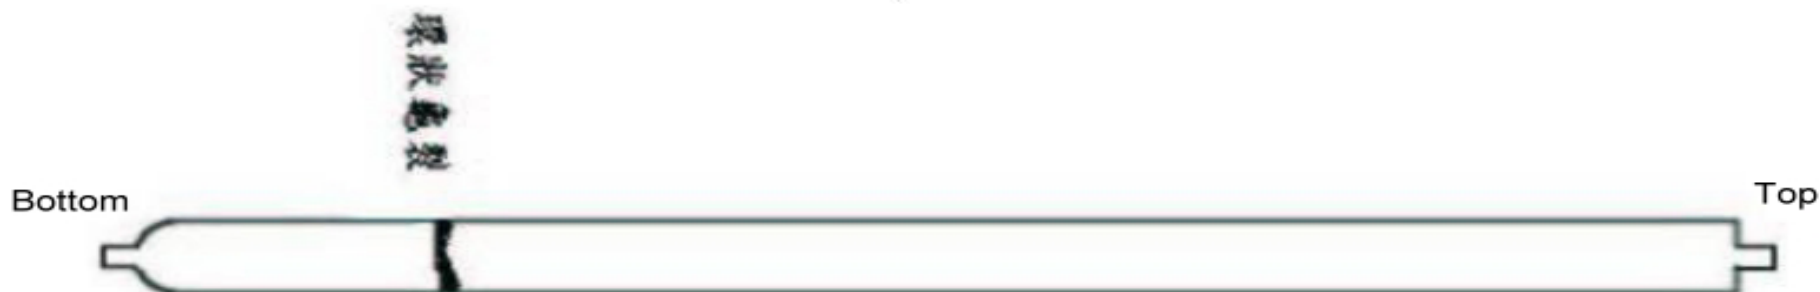
A - 99.8% CTP. Adjacent control rod was at 48 (Fully withdrawn) prior to sequence exchange.	E - 72.5% CTP. Adjacent control rod was at 28. Rod adjusted & Power Ascension.
B - 50.9% CTP. Adjacent control rod was at 48 (Fully withdrawn) prior to sequence exchange.	F - 79.8% CTP. Adjacent control rod was at 28. Power Ascension.
C - 57.5% CTP. Adjacent control rod was at 8. Rod in new pattern.	G - 97.6% CTP. Adjacent control rod was at 28. Power Ascension.
D - 66.4% CTP. Adjacent control rod was at 16. Rod adjusted & Power Ascension.	H - 99.8% CTP. Adjacent control rod was at 28. Rated power reached.
