RPV Support Skirt Anchor Bolt Fracture Event at Kuosheng Unit 1

**Taiwan Power
Company**

2012/6/20

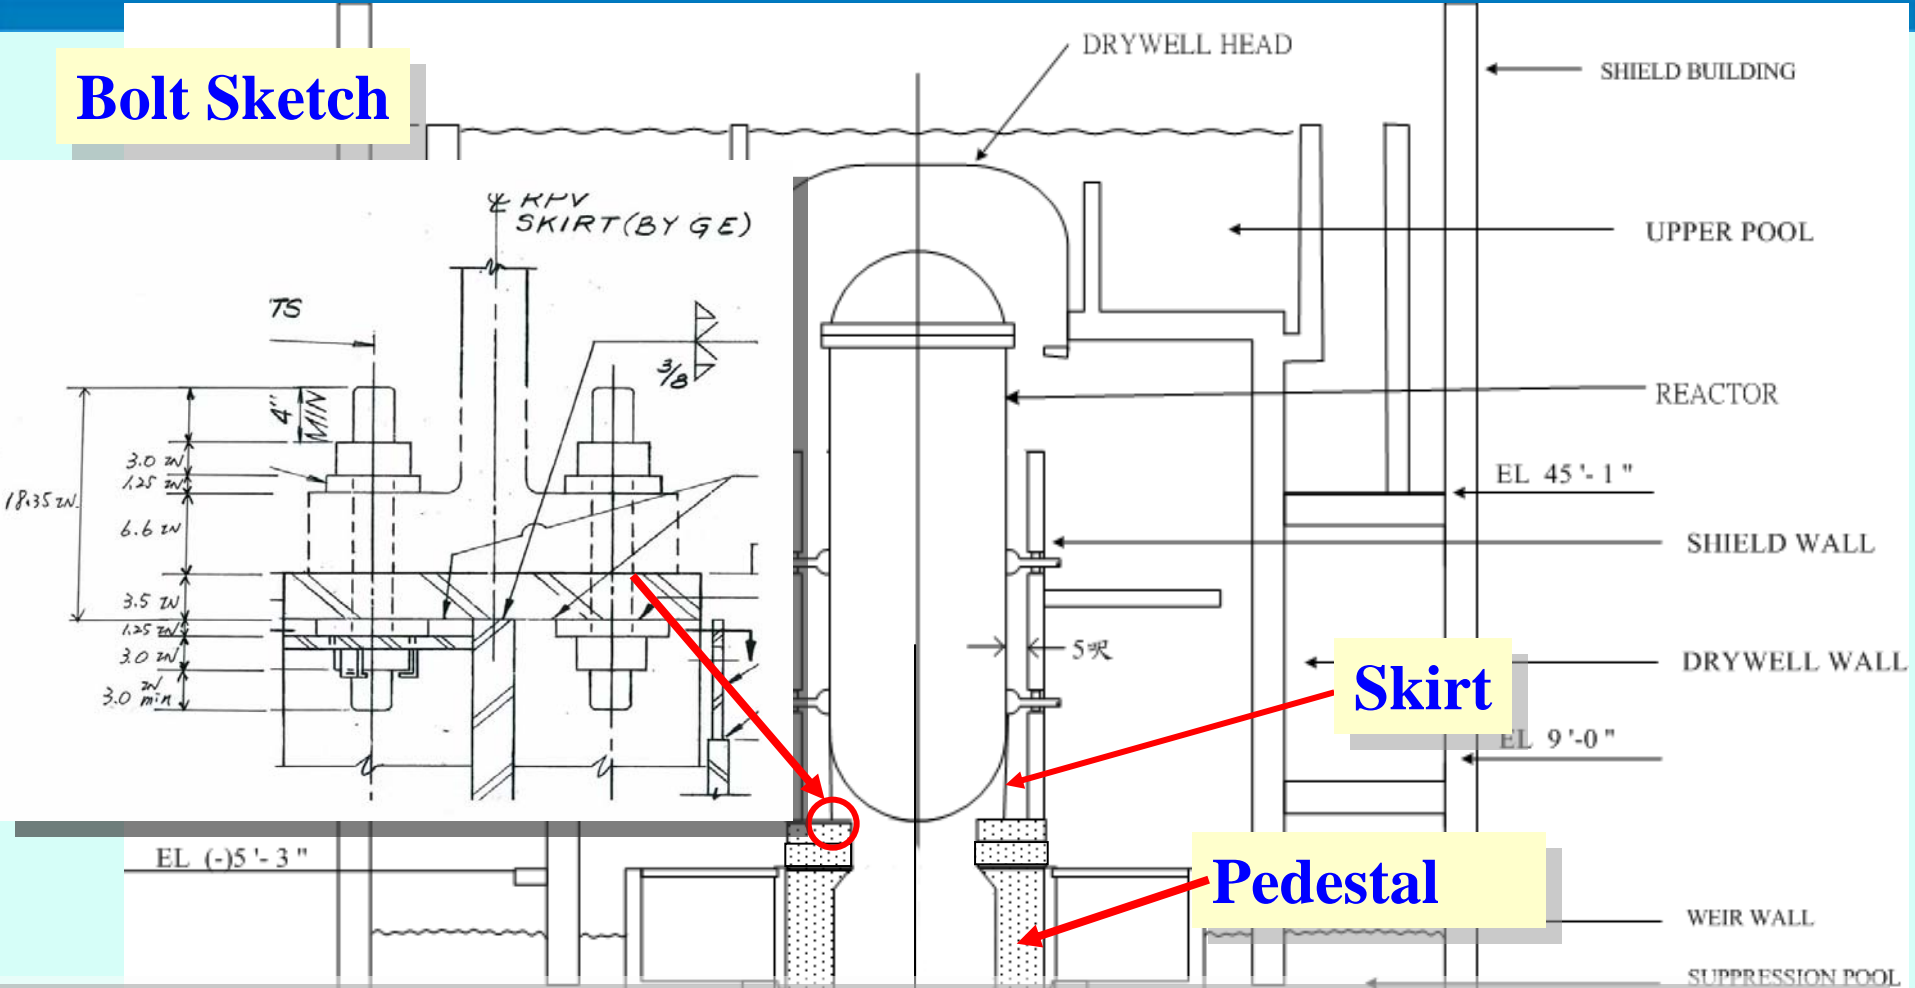
Bolt Sketch

1. The function of the anchor bolts is to prevent sliding between pedestal mounting plate and RPV support skirt flange.
2. The weight of the reactor and the internal components rely on reinforced concrete pedestal.

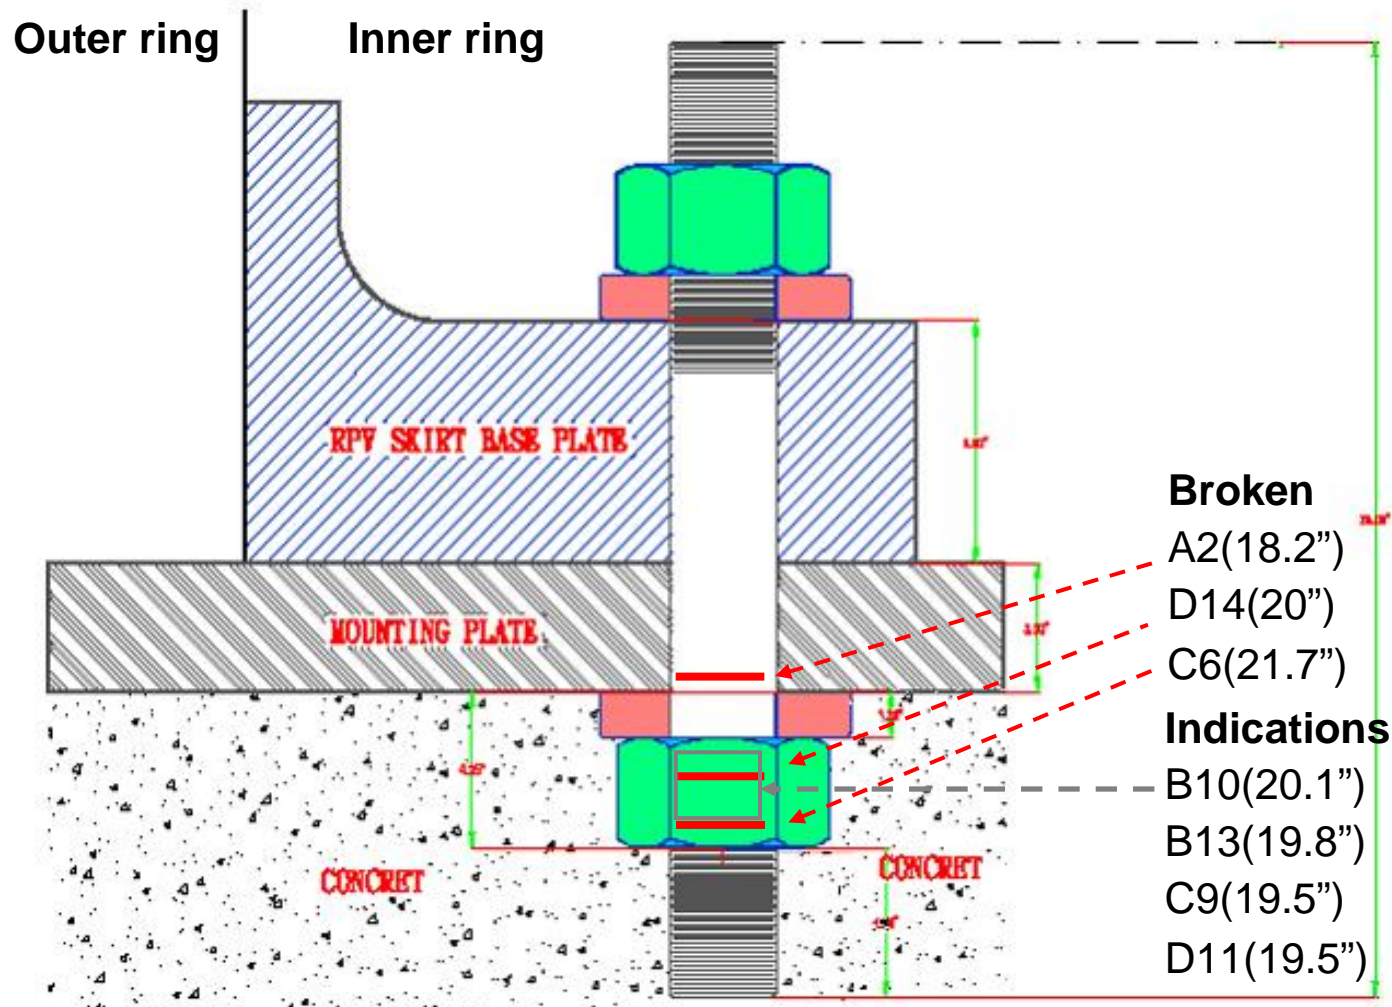
Fracture/Indication Locations Sketch

Physically Broken(A2)

Failed Bolt(D14)

Indication
(C9, D11)

Indication
(B10, B13)

Failed Bolt(C6)
