Recent Material Aging Degradation Related Issues

Department of Nuclear Regulation
Atomic Energy Council, Taiwan

The Fifth USNRC/TAEC Bilateral Technical Meeting
Washington D.C. June 21-22, 2007

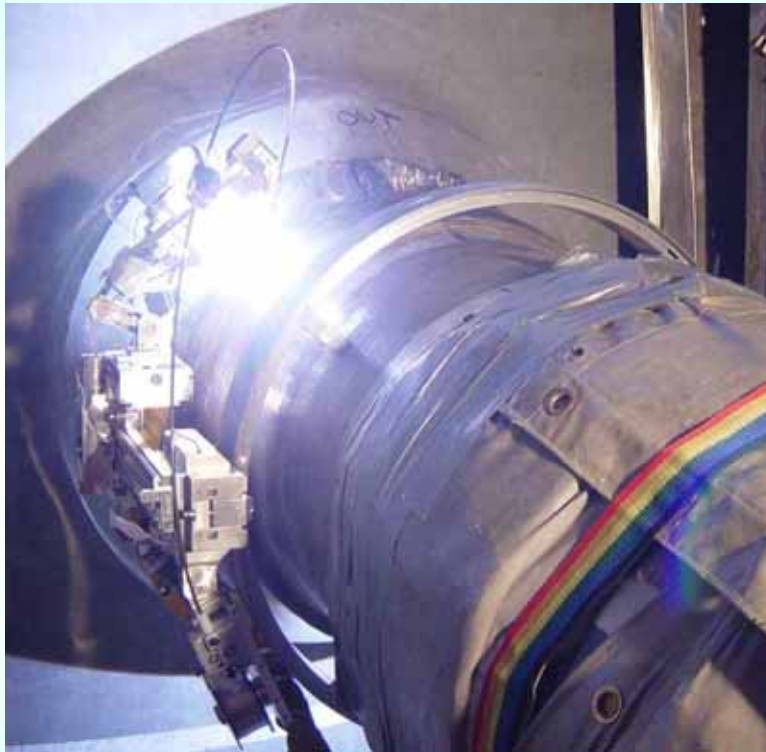
Two axial cracks at the N1A-F1 dissimilar metal weld

- TPC repaired it by weld overlay reinforcement

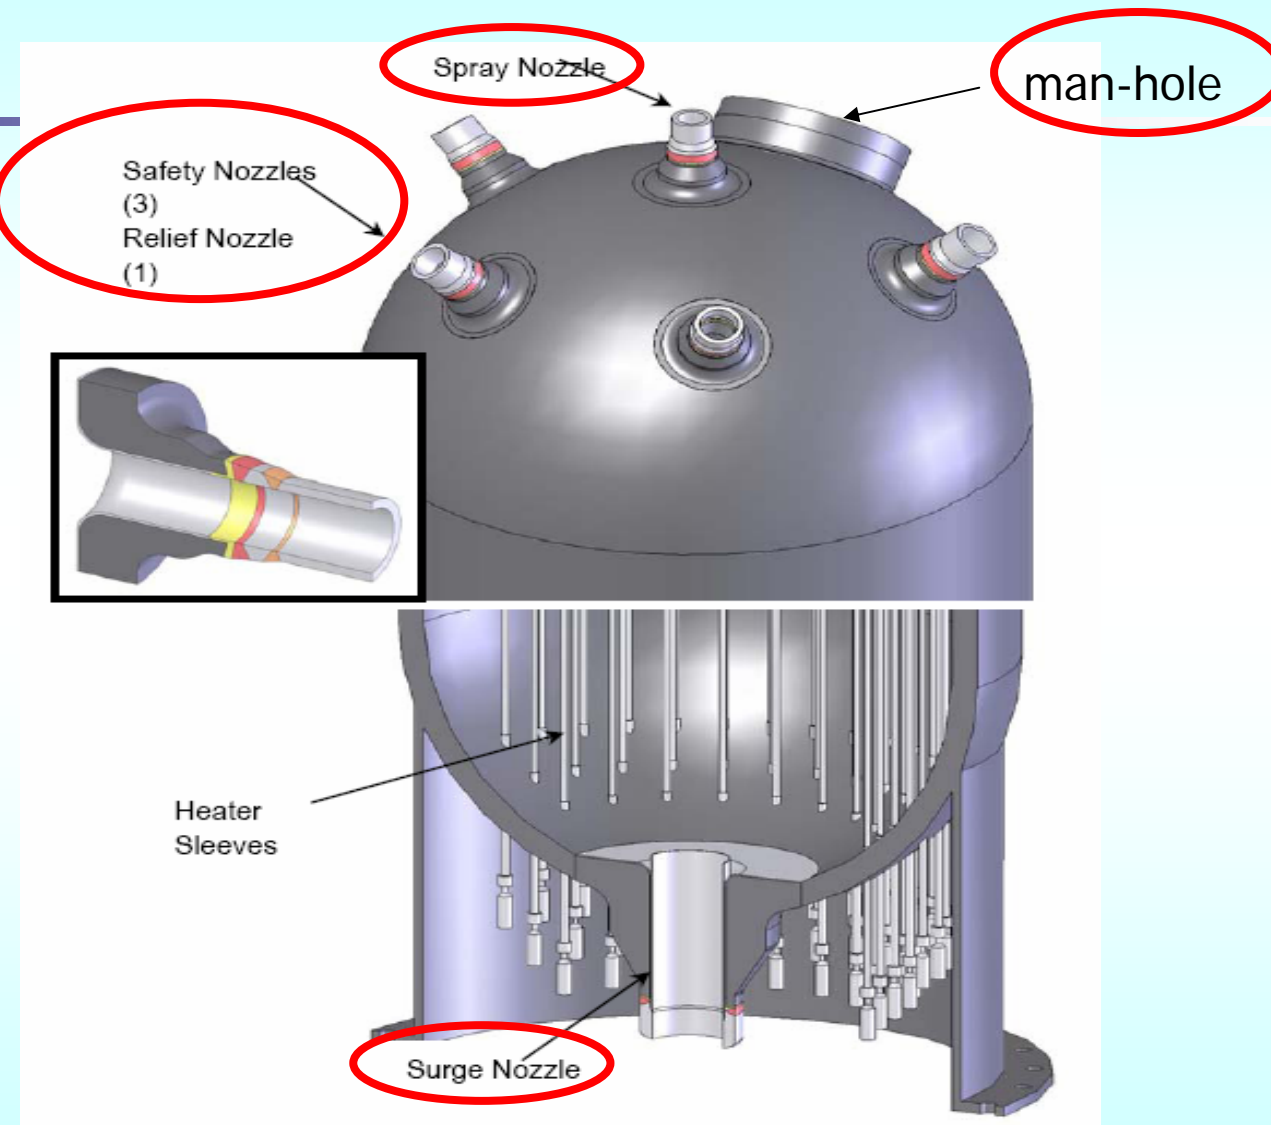
Westinghouse Design PWR Plants
Pressurizer Alloy 82/182 DM Weldment Locations

- Vessel Head Penetrations /ECT, UT, VT/ - No Flaws
- Vessel BMI Penetrations /VT/ - No Leakage
- Steam Generator Tubes /ECT,UT/ - Plugging Rate <1.8%
- **PZR Penetrations Weld /UT,PT,RT/ - One Acceptable Flaw at unit 2 Spray Nozzle DM Weld**
- Reactor Vessel Hot & Cold Leg Nozzle Welds /UT,PT/ - No Flaws
- Steam Generator Nozzle Welds /UT,PT,VT/ - No Flaws, No Leakage
