2008 AEC-NRC Bilateral Technical Meeting

AEC's Regulatory Action after Earthquake on Japanese Kashiwazaki-Kariwa NPP

May 13, 2008
Wen-Chun Teng
Section Chief
Department of Nuclear Regulation
AEC

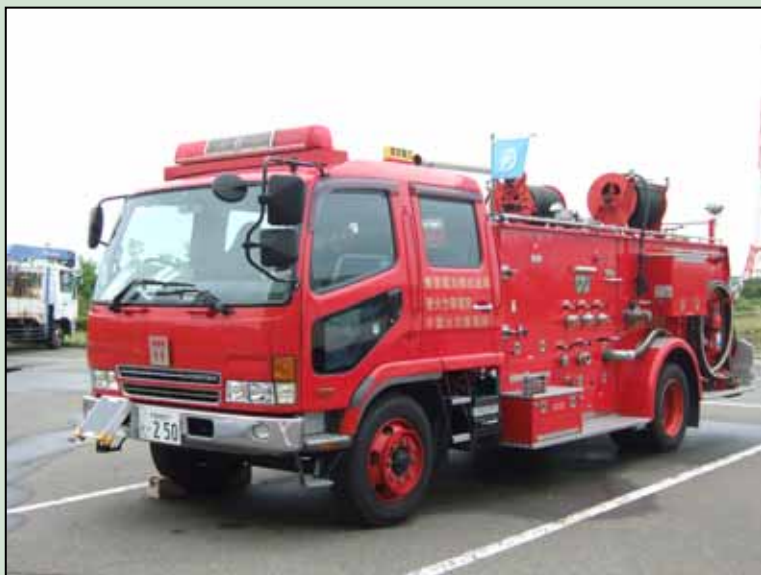
Exterior view of the chemical fire engine 1.

Improvements for resolving the issue (Transformer fire)

- Reinforcement of the in-house fire fighting corps.
 - Forming a fire-fighting corps on round-the-clock standby.
 - Deployment of chemical fire engine and fire engine with a water tank.
 - Setting up a hotline with the Main Control Room.

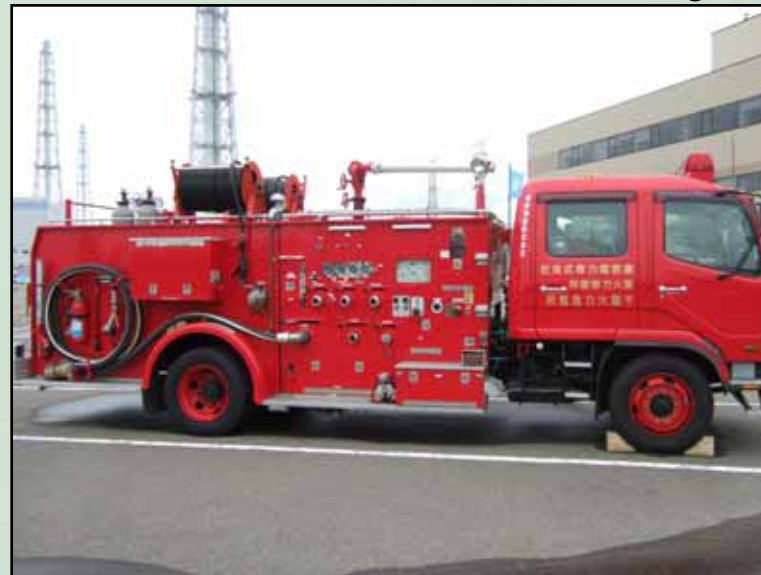
Exterior view of the chemical fire engine 2.

The fire engines and personnel have been on round-the-clock standby on the station premises since the evening of July 19.

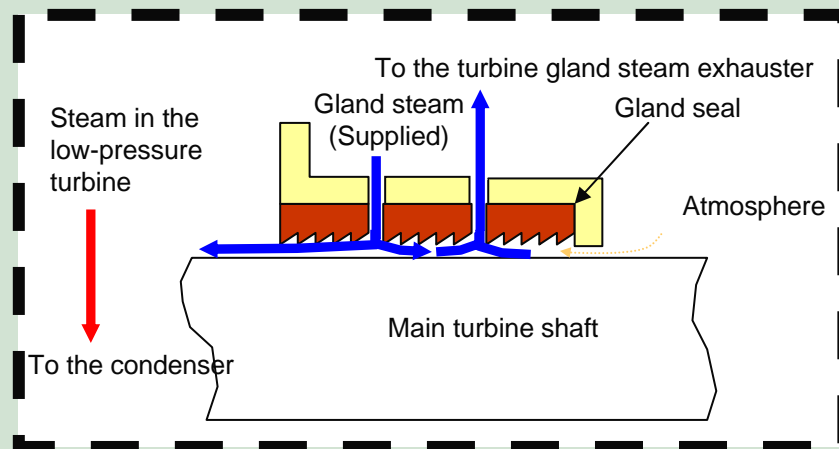
Normal condition

Quake-induced Event #3: Minuscule Amount of Airborne Radioactivity Released into the Air from Unit 7

- **Approx. 4×10^8 Bq of iodine and 2×10^6 Bq of particulate matter released.**
- **Radiation dose: 2×10^{-7} mSv \ll 1 mSv (public dose limit).**
