The Flood in the Unit 2 Reactor Building of the Lungmen NPP during Typhoon SINLAKU

Ming-Te HSU
Deputy Director
Department of Nuclear Regulation
Atomic Energy Council, Taiwan

7th USNRC-TAEC Bilateral Technical Meeting
Washington D.C. May 11-13, 2009

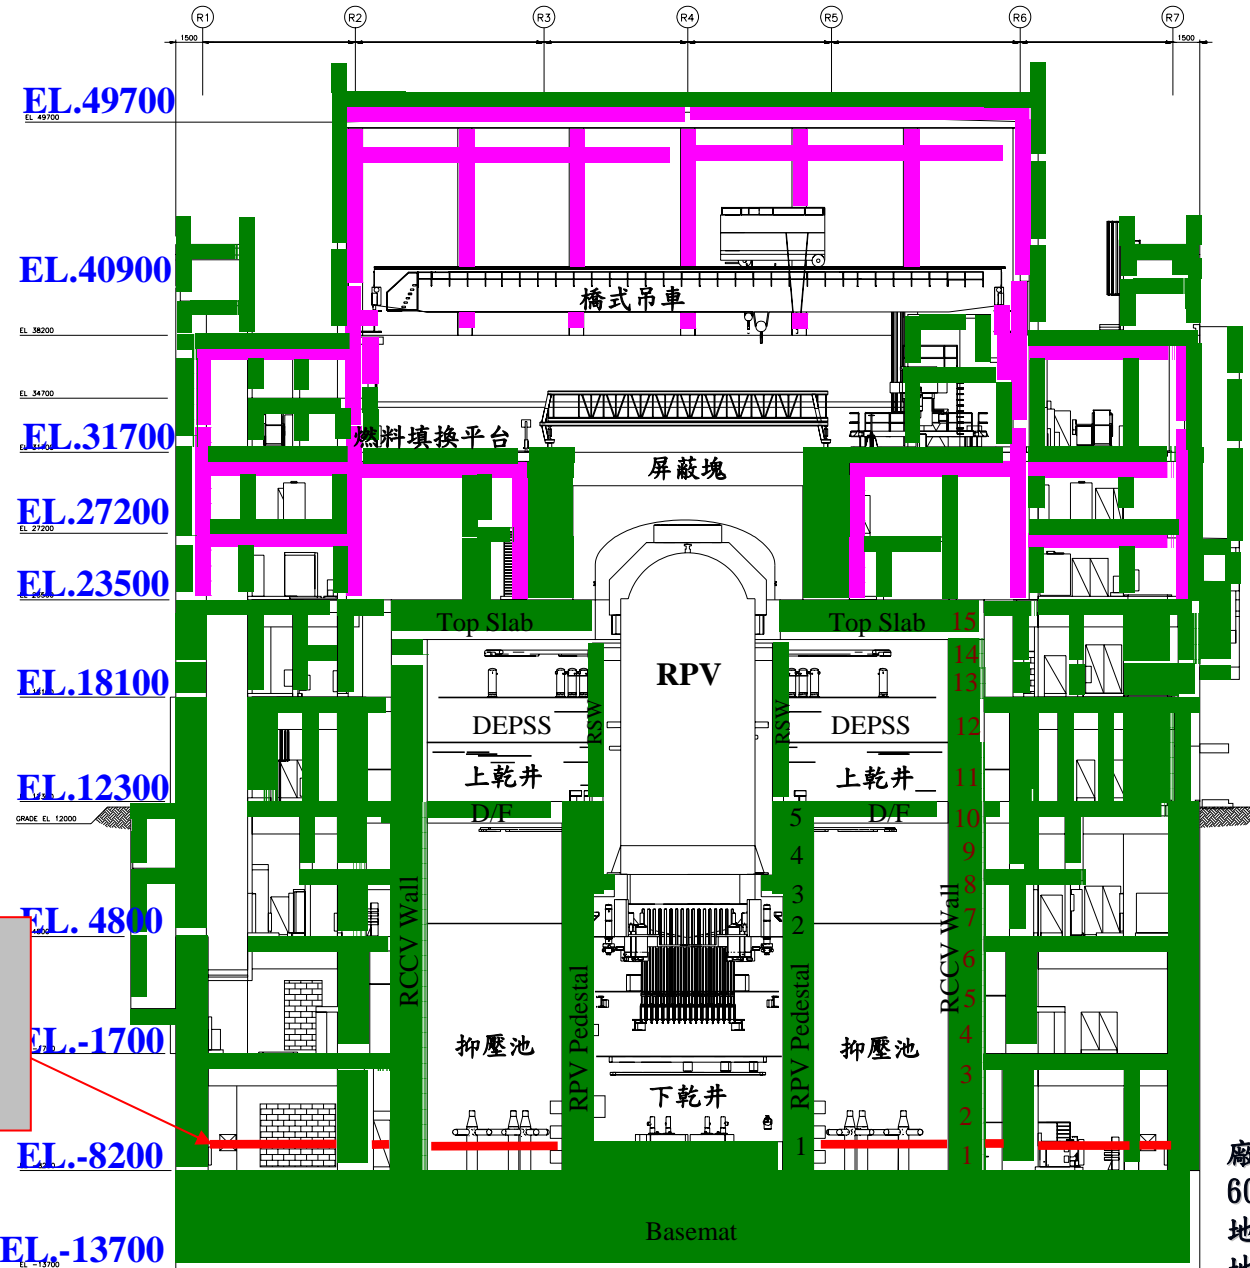
RB EL.-8200 Flooding Sketch Map

- The water flew through the hole into the RB, and flooded the pumps (not submersible pump) equipped at the basement (EL. -8200) . These 8 sets of non-submersible pump failed to function.
- The flood level eventually reached about 2 meters. (inside of RB)

Flooding
Level:
2meters
