Nuclear Reactor Regulatory Overview

M. T. Hsu
Deputy Director

Department of Nuclear Regulation
Atomic Energy Council

The Fifth USNRC-TAEC Bilateral Technical Meeting
Washington D.C. June 21-22, 2007

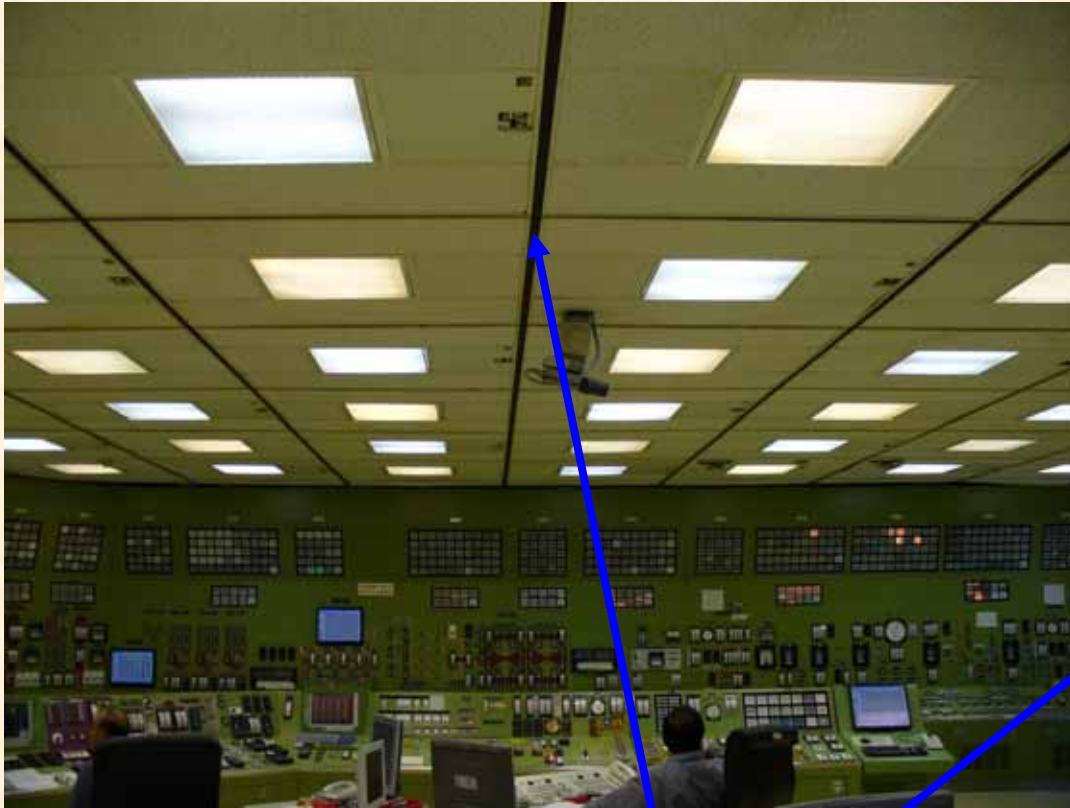
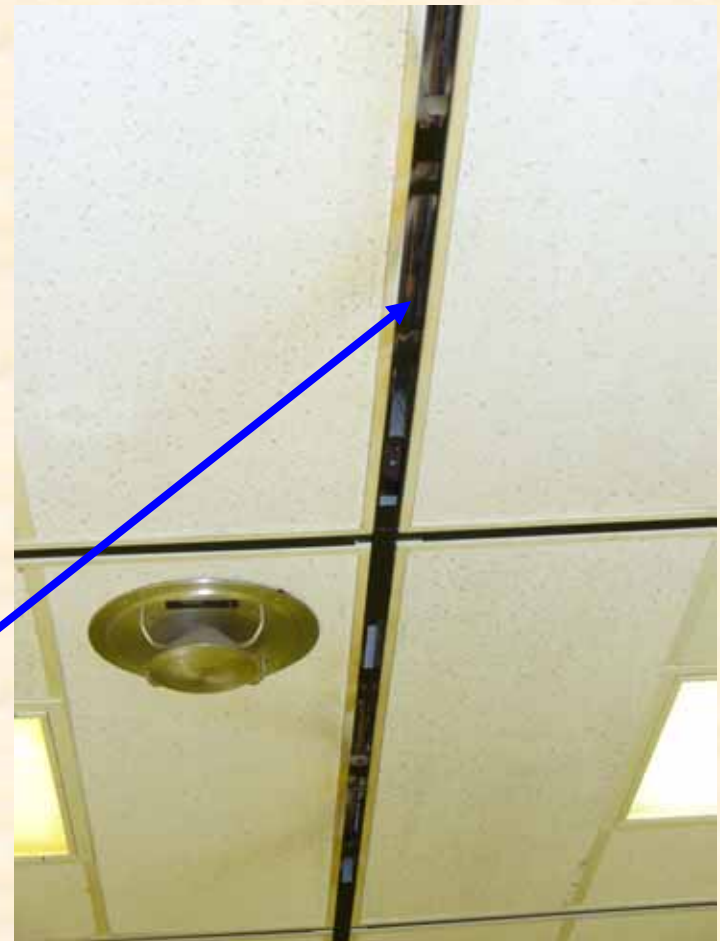
Ventilation outlet

- After the earthquake, plant staffs followed the procedure 582.1 “checklist of significant equipment after shutdown due to strong earthquake” to examine the integrity of SSCs of both units (except inaccessible areas of unit #1) .
- The result showed that there is no major damage on all SSCs of two units .Minor damages are as following items:
 1. some RCP C/T cable ducts connection are loose(unit #2)
 2. some water and oil spilt from Spent fuel pool and EDG fuel oil storage tank.
- Lots of dust accumulated inside ventilation pipe floated down from top ceiling of main control room during & after the earthquake.
